# CYCLONE TESTING STATION

## **STATIC BEHAVIOUR OF CORRUGATED ROOFING UNDER SIMULATED WIND LOADING**

**TECHNICAL REPORT No. 33**

**M. MAHENDRAN**

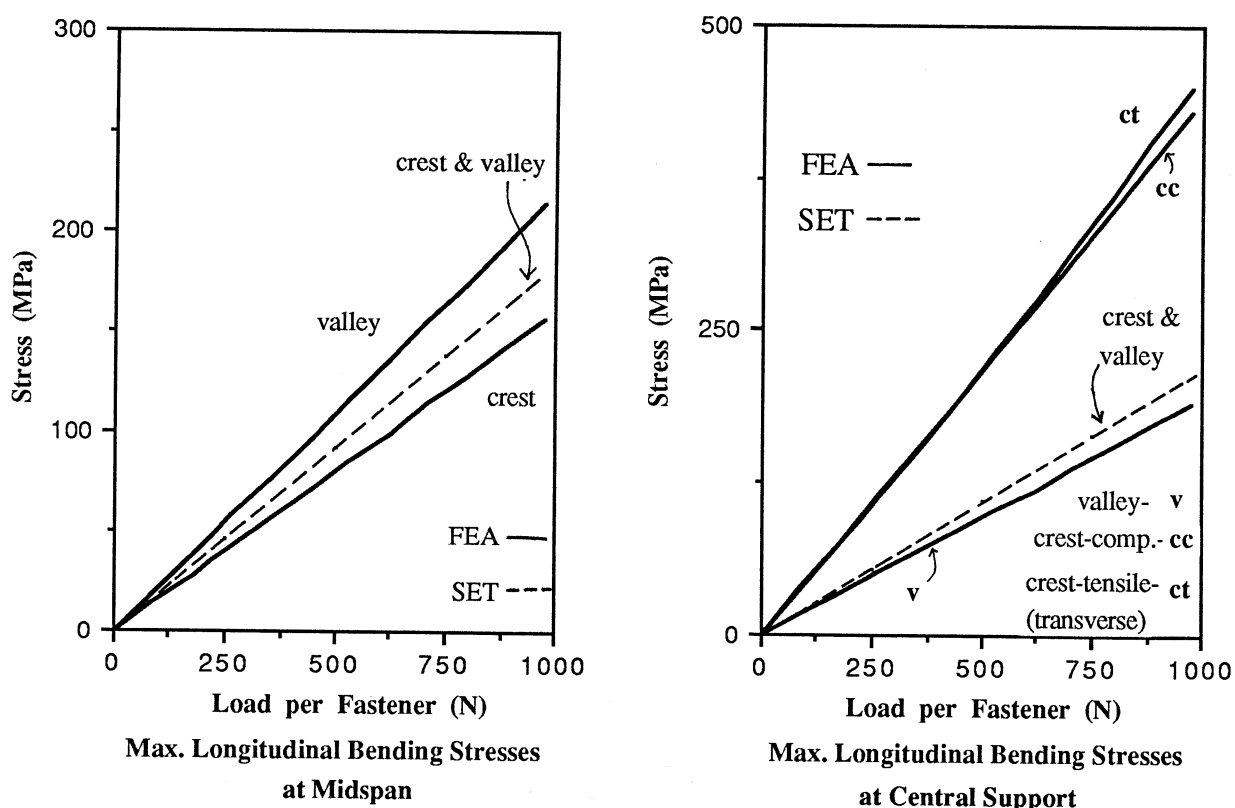
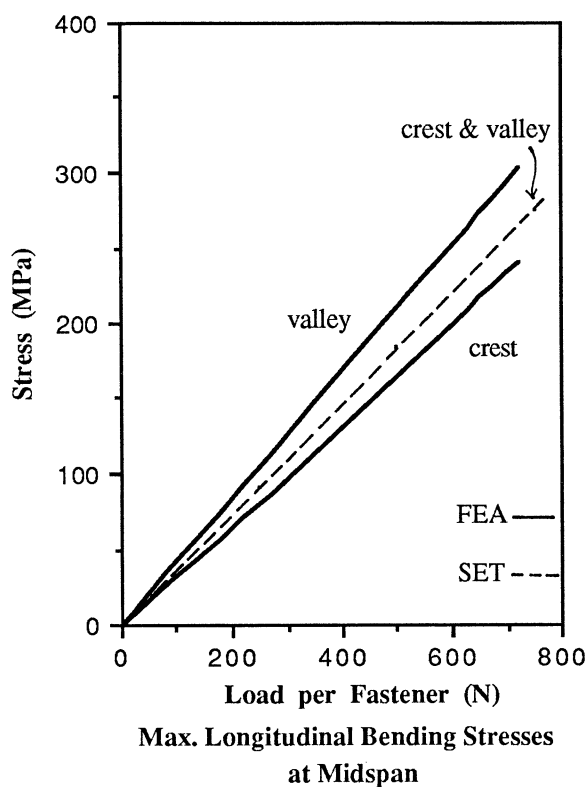
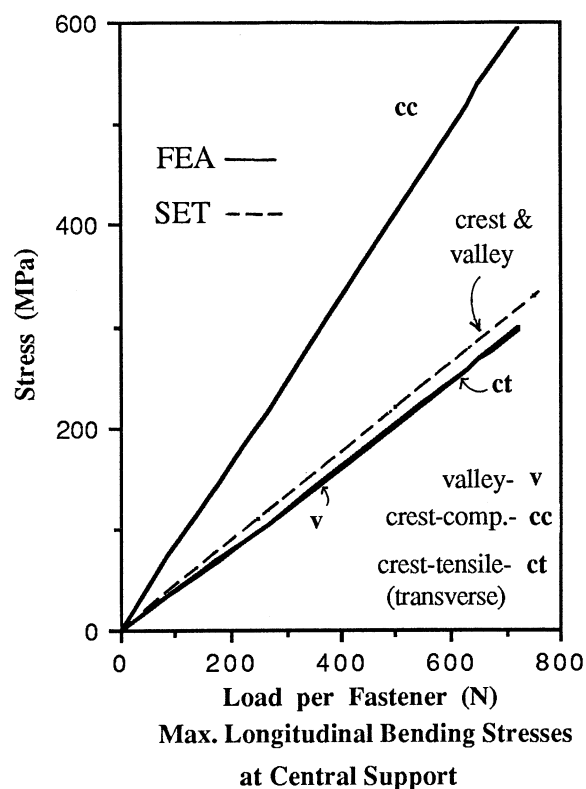
Figures 21 (a) to (c) present the results of maximum longitudinal bending stresses at midspan and central support from the FEA and SET for roofing of short span, medium span (500 mm) and long span. Although stresses at midspan crests and central support valleys are tensile and those at midspan valleys are compressive, they are plotted using absolute values. The longitudinal bending stresses are mainly of membrane type along the span as the out-of-plane bending components are quite insignificant. Therefore, the difference between the top and bottom surface stresses is very small and in these figures, only the greater stress is plotted. Experimental results regarding stresses are not available for comparison with these analytical results. The SET stress results were obtained using the simple pure bending formula for the corresponding bending moments of a two-span continuous beam. The same value of second moment of area of the corrugated roofing calculated in Section 4.1.2 was used in these stress calculations. Except at the central support crests, the results from the FEA and SET are in good agreement. This is to be expected as cross-sectional distortion is absent in this case.

Figure 21. Stresses in Corrugated Roofing  
Fastened at Every Crest

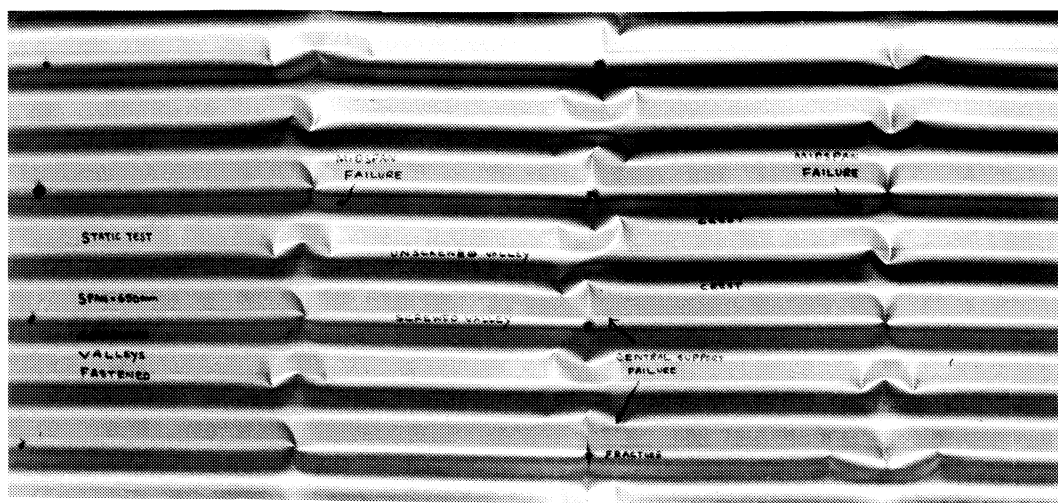
direction at each of the screwed valleys of the central support and in some cases the central support crests also failed by buckling. In the case of short span roofing, one of the central support fasteners pulled through the roofing before any global mechanism formed. This ultimate failure occurred at 1850, 2300 and 3000 N/f for roofing of medium spans (650 and 500 mm) and short span, respectively. Figure 24 shows a typical failed specimen with its global plastic mechanisms and the fracture at the central support.

**Figure 24. Ultimate Static Failure of Corrugated Roofing Fastened at Alternate Valleys**

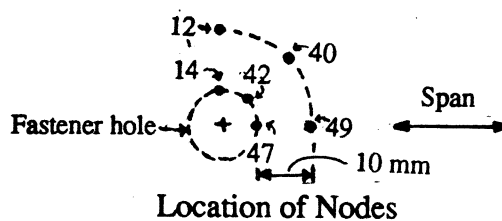
1. FEA = Finite Element Analysis
2. Expt. = Experiments on strain gauged roofing specimens
3. T, B = Stresses on Top, Bottom surfaces of roofing
4. PT, PB = Principal Stresses on Top, Bottom surfaces of roofing
5. von Mises equivalent stress from FEA is given inside brackets
6. Short span, Medium span and Long span refer to test spans of 250, 500 and 1000 mm, respectively
7. The figure below shows the locations of nodes 14, 12, 42, 40, 47 and 49.
