**Static Testing of Batten Connections
at University of Western Australia**

CTS Technical Report No 62

December, 2015

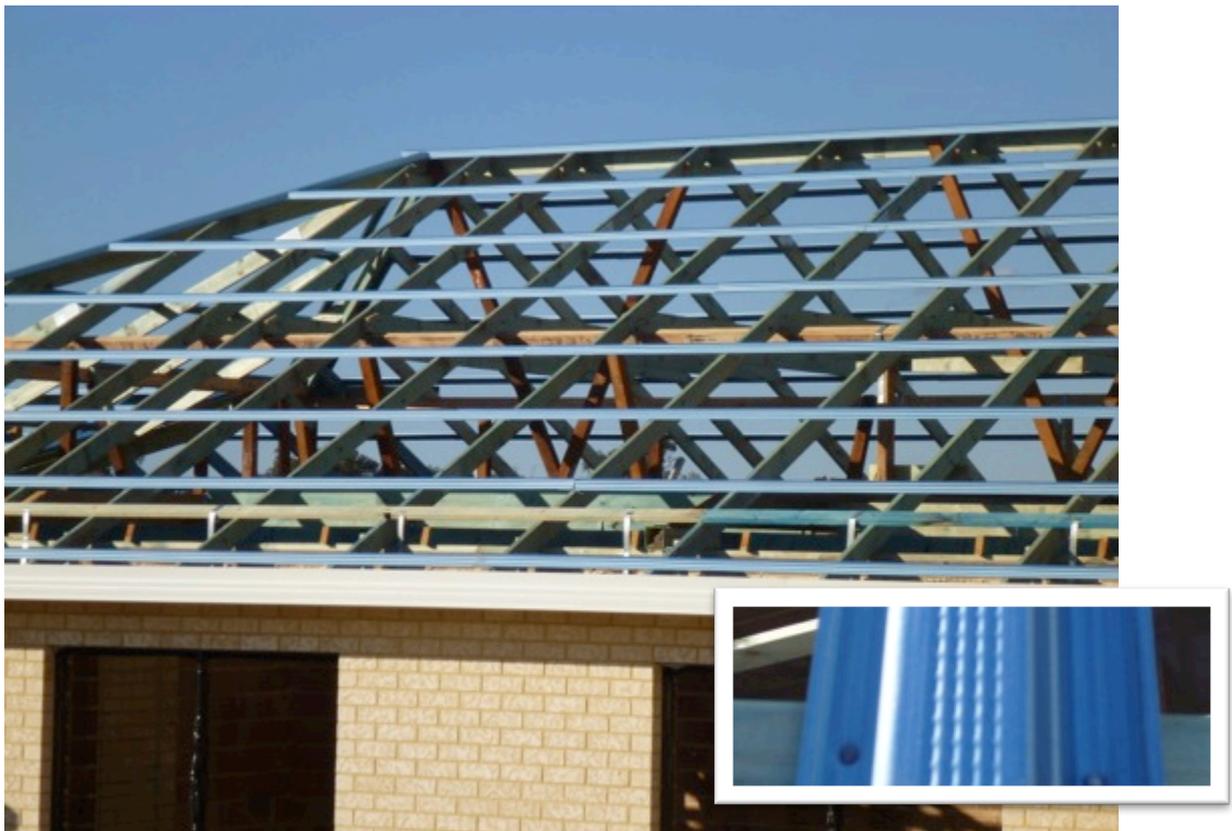
Figure 1.1 – Gun-driven nails used in metal battens (inset shows top view of connection).

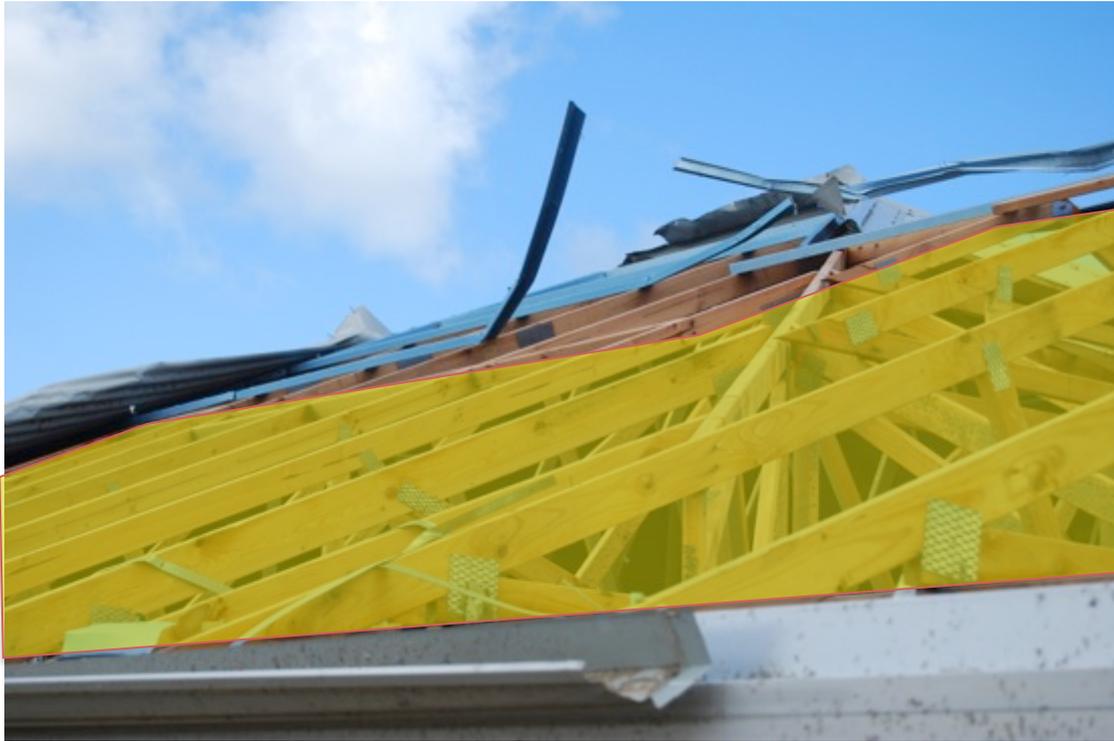
Figure 1.2 – Failure of gun-driven nails connections between metal battens and trusses. (Shading shows area of batten to truss failure.)

Failure of gun-driven nail connections between metal battens and softwood trusses were observed by Boughton and Falck (2008) and are illustrated in Figure 1.2. In this case, some of the nails withdrew from the trusses and in other cases, the battens

pulled over the nail heads near the edge of the roof, and progression of the failure tore roofing fasteners out of the battens near the ridge.

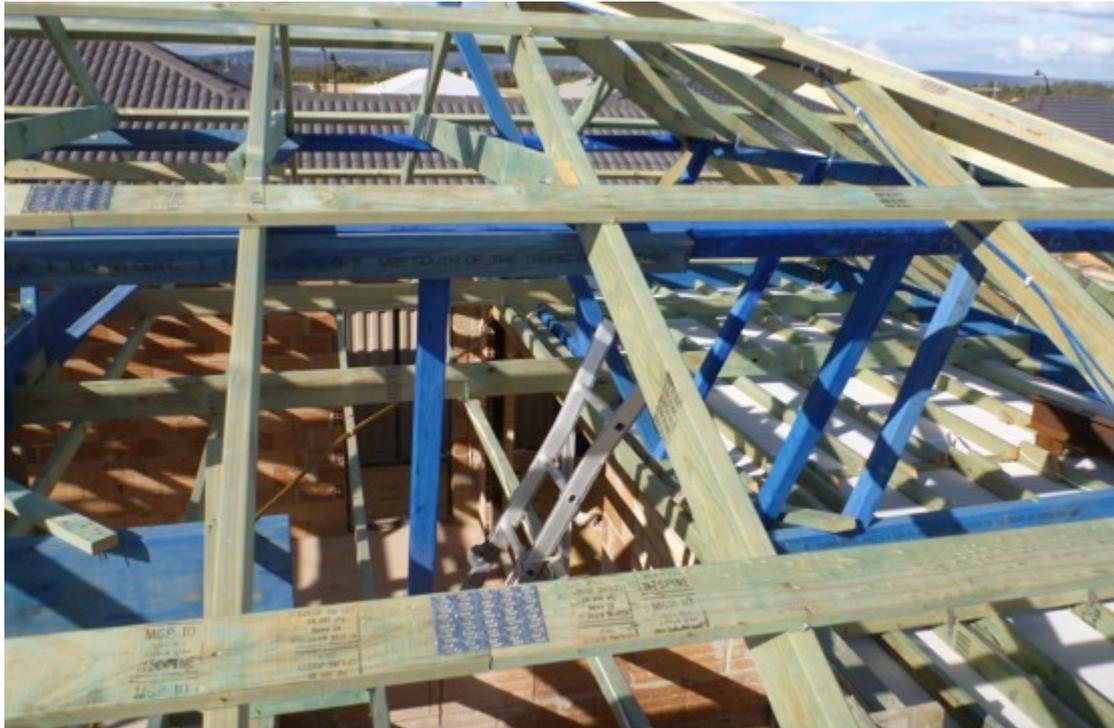
Figure 1.3 – connections between 35 mm thick battens and rafters.

Other roofs are constructed with timber battens. The 90 x 35 battens shown in Figure 1.3 can use connections selected directly from AS 1684.2 (Standards Australia 2010a), as the assumed batten depth in the Standard is 38 mm. However, the battens in Figure 1.4 are 45 mm deep so the connectors do not have the same depth of penetration into the rafter assumed in AS 1684.2. Hence the capacity of these connections cannot be directly obtained from AS 1684.2.

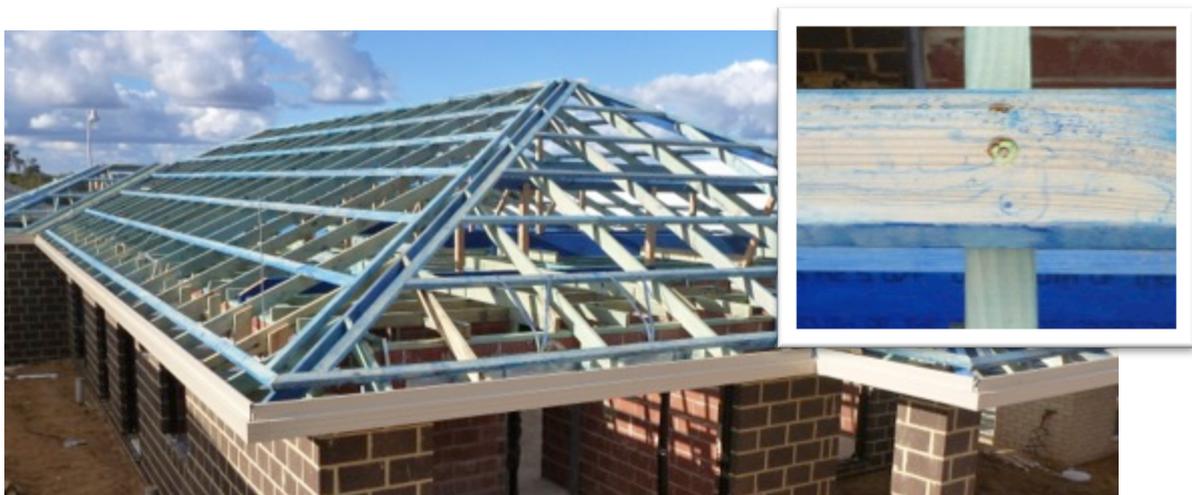
Figure 1.4 – connections between 45 mm thick battens and rafters. (Inset shows connection detail.)

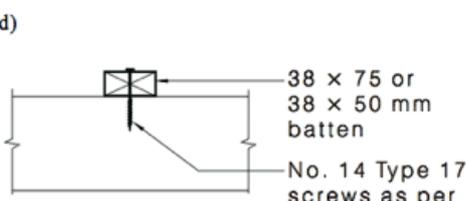
Figure 1.6 – Connection capacity for 35–38 mm thick battens from AS 1684.2 Table 9.25 (Reproduced with permission from SAI Global Ltd under Licence 1505-c035.)

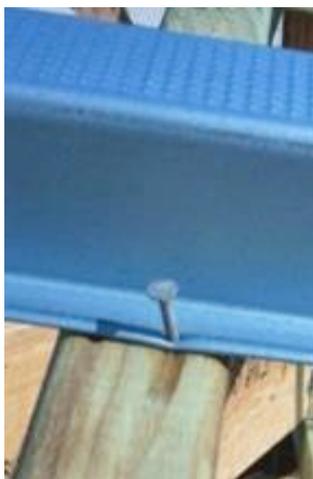
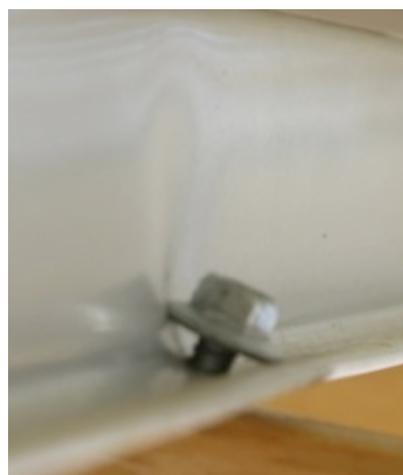
(a) Nail into top hat batten

(b) screw into top-hat batten

Figure 1.7 –Under-driven fasteners on building sites– (Photo (a) Greg Flowers, Building Commission of WA and (b) Lex Sommerville)

- Under-driven fasteners – there is some space between the underside of the fastener head and the surface of the batten. Figure 1.7(a) shows an under-driven nail into a top-hat batten and Figure 1.7(b) shows an under-driven screw into a top-hat batten.
- Correctly-driven fasteners – the underside of the fastener is just in contact with the surface of the batten.
- Over-driven fasteners – the fastener is driven further into the batten as shown in Figures 1.8(a), and Figure 1.8(b).

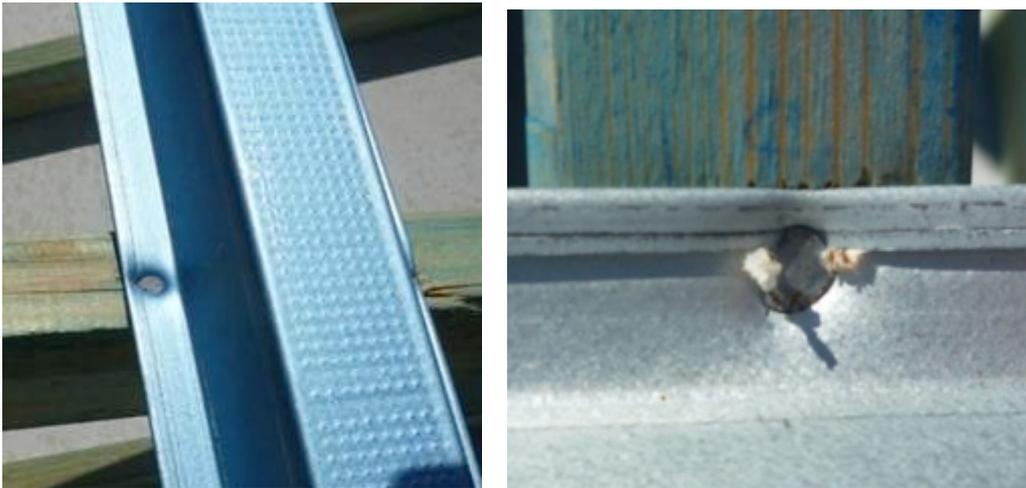
(a) deformed surface of batten (b) punched through a batten
Figure 1.8 – Over-driven fasteners – (Photos Greg Flowers, Building Commission of WA)

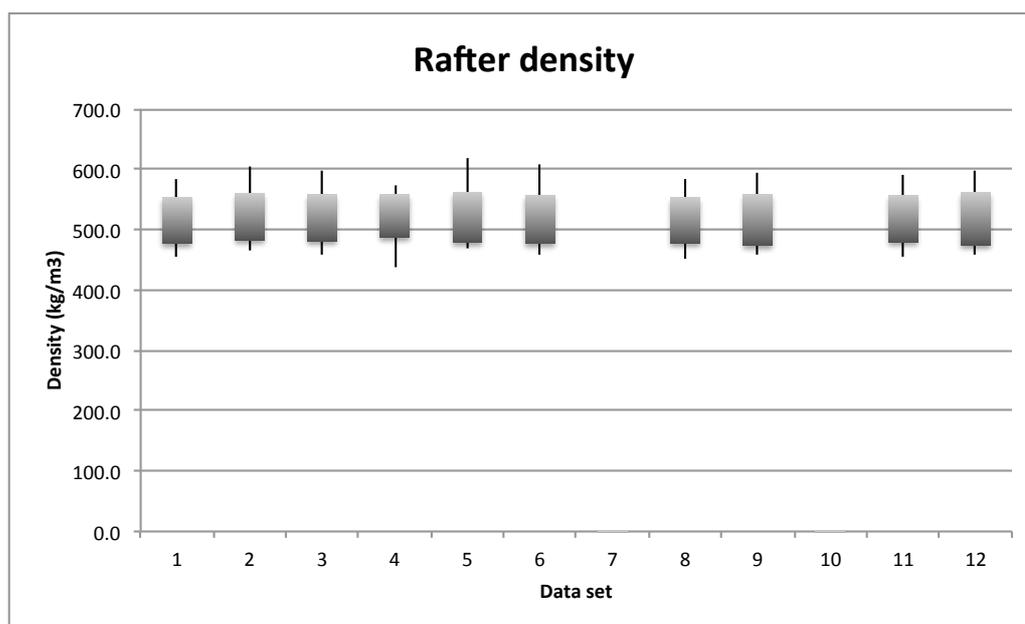
Figure 2.1 Density of rafters

- The range of density in each group given by the thin lines;
- One standard deviation either side of the mean, indicated by the boxes on the graph;
- Test groups 1 to 3 were for screws through top-hat battens;
- Groups 4 to 6 were for nails through top-hat battens;
- Groups 7 to 9 were for bugle head screws through 35 mm thick timber battens;
- Groups 10 to 12 were for bugle head screws through 45 mm thick timber battens.

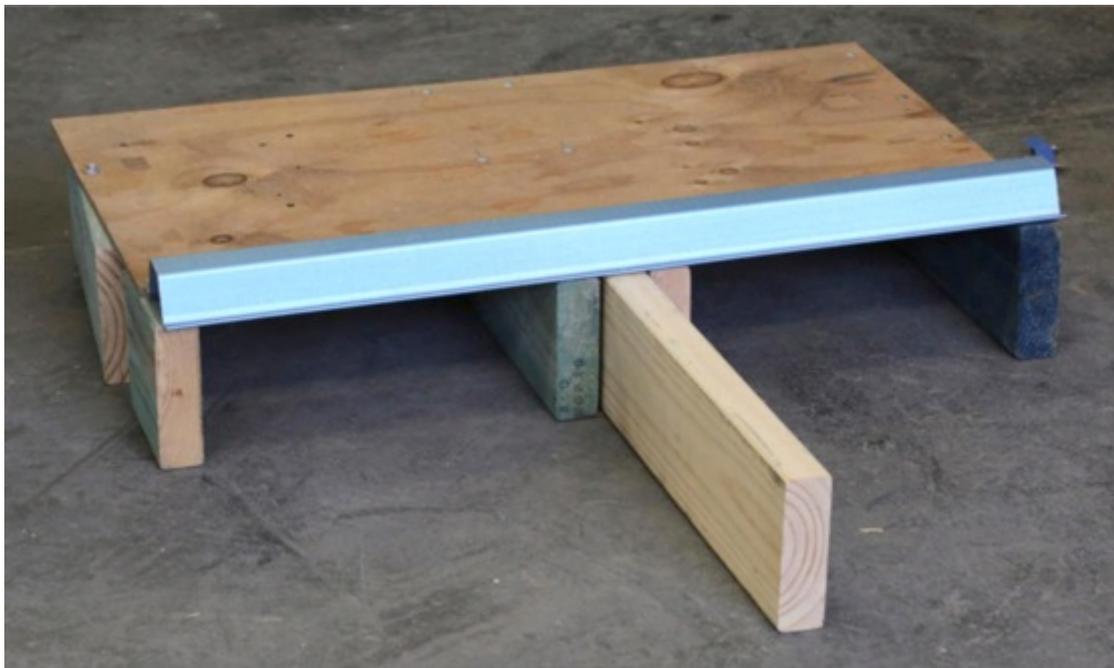
Figure 2.2 Connection assembly jig

A fabrication jig (Figure 2.2) was used to ensure all the test specimens were precisely and consistently nailed and screwed so that loads would be applied concentrically and connections would be free of moments or prising forces. The nails were installed using a compressed air nail gun tailored to the nails selected. The screws were installed using a battery powered electric drill.

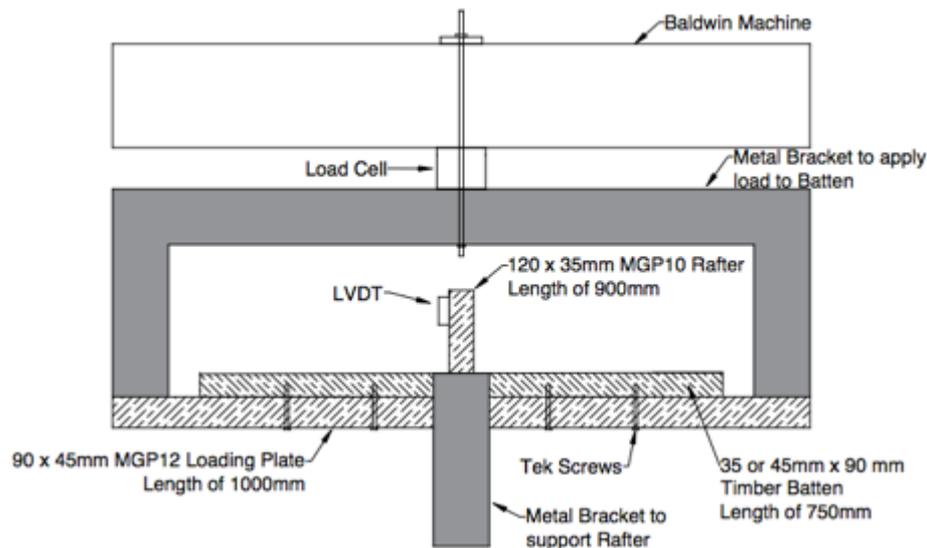
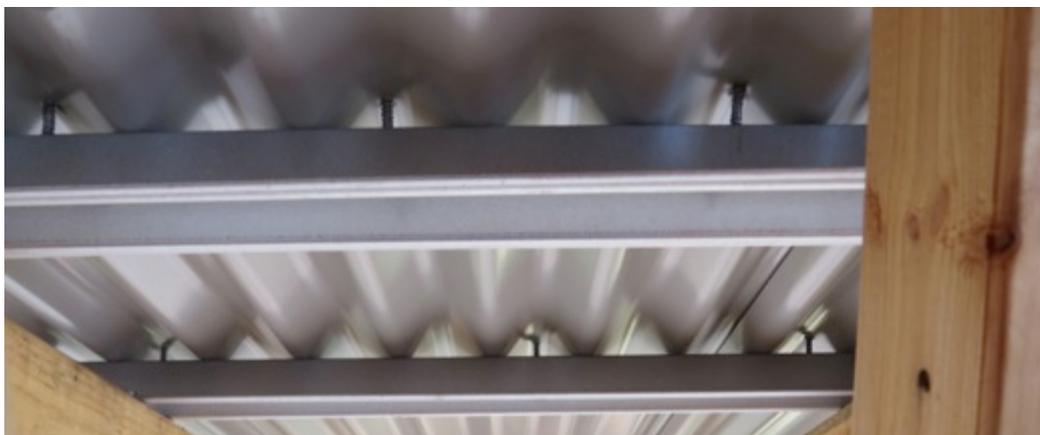
(a) Schematic diagram of test setup

(b) Connection to steel battens from roofing (Photo by Lex Sommerville)
Figure 2.3 Load transfer to battens

- A Universal test machine set to a loading rate estimated to produce time to failure between one and five minutes;
- A loading frame consisting of two U-shaped bearing elements that provided tension between the rafter and the batten as the UTM platens were moved closer together.
- A loading plate that distributed tension loads to five roofing screws that were used to apply the load to the batten in a realistic manner (see Figure 2.3).
- Load cell attached to the test machine to provide accurate force measurements;
- A laser displacement transducer was used to measure relative deflection between the batten and rafter. This provided a measurement of deflection of the connection.

These features are shown in Figures 2.3(a) and 2.4 for timber battens, but the top-hat battens were fastened in the same fashion.

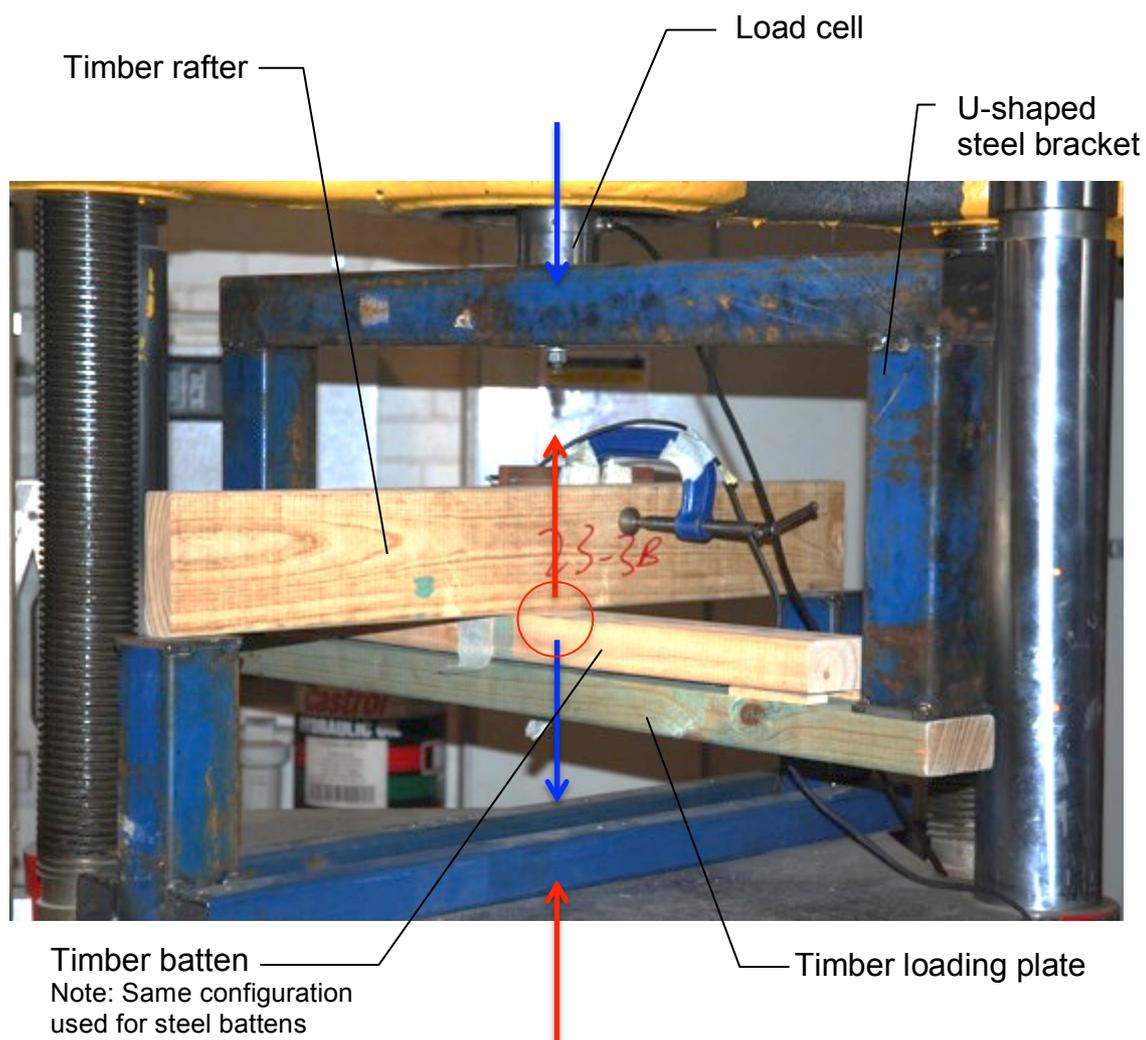
Figure 2.4 Photo of UWA Universal test machine (Note that the orientation of the batten and rafter is inverted compared with orientation in service.)

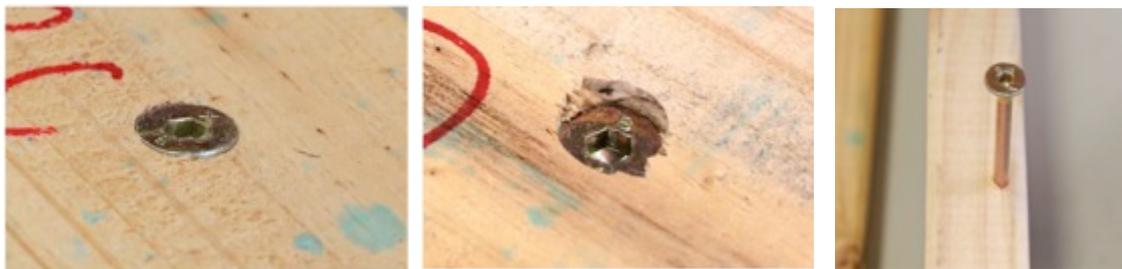
(a) Correctly driven

(b) Over-driven

- 10 specimens were correctly driven (the head of the screw was flush with the surface of the batten) – Figure 2.5(a);
- 10 specimens were over-driven (the head of the screw was below the surface of the batten) – Figure 2.5(b);
- 10 specimens had correctly driven screws installed close to the edge of the batten, and therefore, not in the centre of the rafter underneath – Figure 2.5(c).

It was observed that over-driving pulls the head of the screw into the batten as shown in Figure 2.5(b). This reduced the depth of the batten under the flange of the fastener,

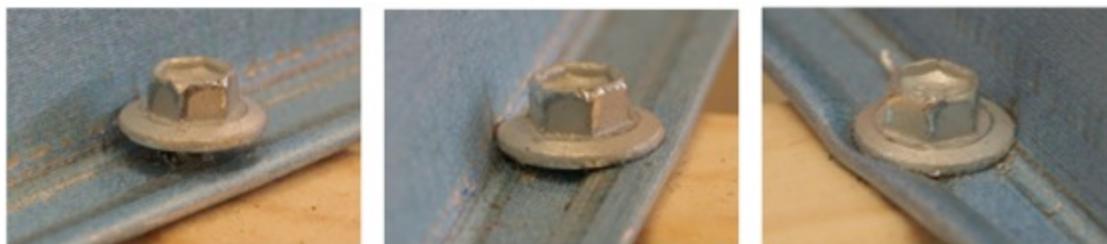
(a) Under-driven

(b) Correctly driven

All the screws were installed so they were centrally located in the rafter and the flange of the screw was a snug fit with the upstand of the batten in accordance with recommended Lysaght fixing details (Lysaght 2014), as shown in Figure 2.6(b).

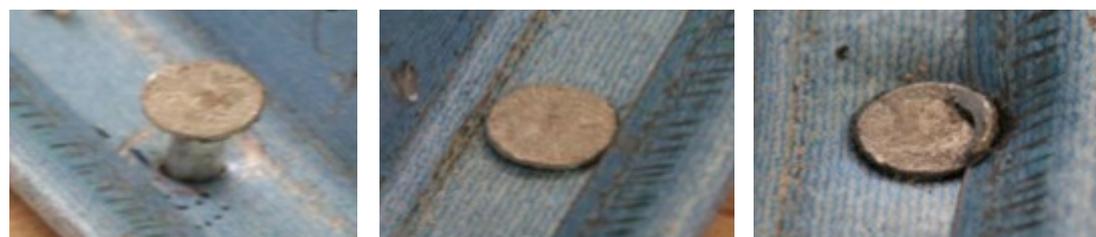
(a) Under-driven

(b) Correctly driven

The nails were installed as for the screw-fixed battens: 11 specimens under-driven, 18 specimens correctly driven, 21 specimens over-driven and as shown in Figure 2.7.

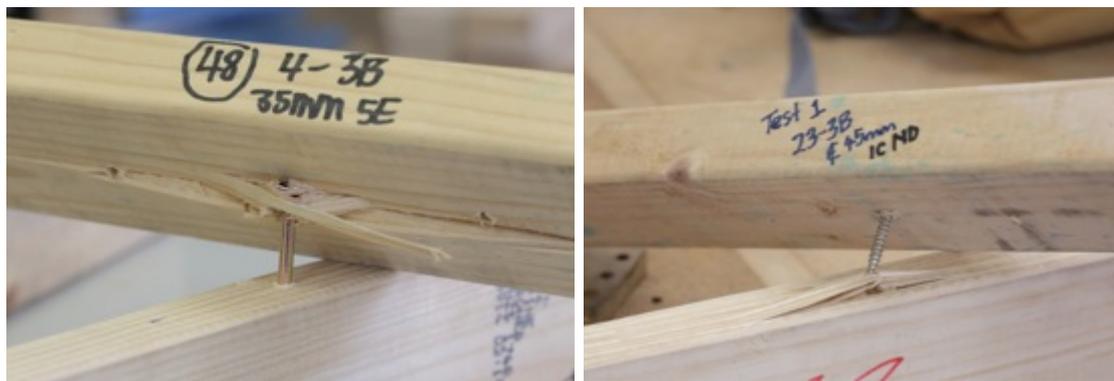
(a) Pull-through failure

(b) Withdrawal failure

Figure 3.1 Failure modes for screws through timber battens

In the 35 mm batten test program, some fasteners failed by pull through in the batten as shown in Figure 3.1(a) and others failed by withdrawal from the rafter as shown in Figure 3.1(b). In the 45 mm batten test program, all fasteners failed by withdrawal.

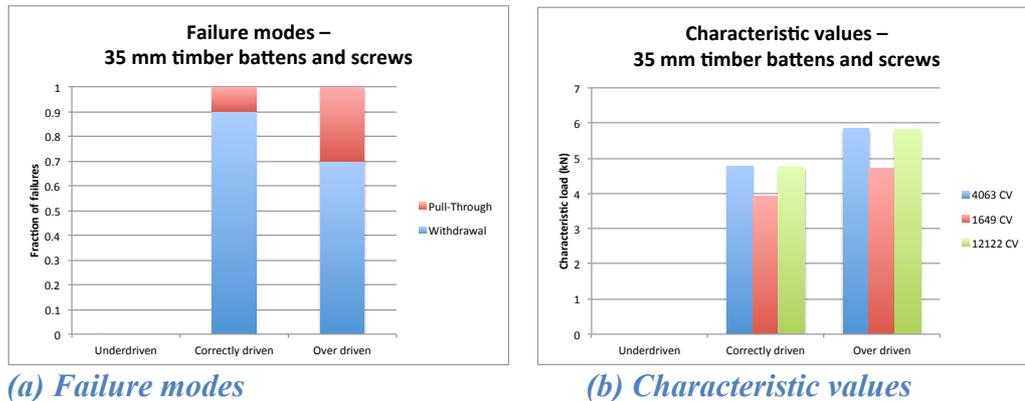
(a) Failure modes (b) Characteristic values
Figure 3.2 Results for screws through 35 mm thick timber battens

which makes a pull-through failure more likely. However, the failure strength was higher for over-driven screws. These trends can be seen in Figure 3.2.

Figure 3.2 (b) shows that the characteristic values determined by AS/NZS 4063.2 (Australian Standards 2010c) and ISO 12122.5 (International Standards Organisation 2015) were almost identical and the value determined using AS 1649 (Standards Australia 2001) was conservative. An average of the AS/NZS 4063.2 and the ISO 12122.5 values was used as a representative characteristic value. The correctly driven fasteners had a representative characteristic strength of 4.75 kN, while the over-driven fasteners had a characteristic strength of 5.83 kN.

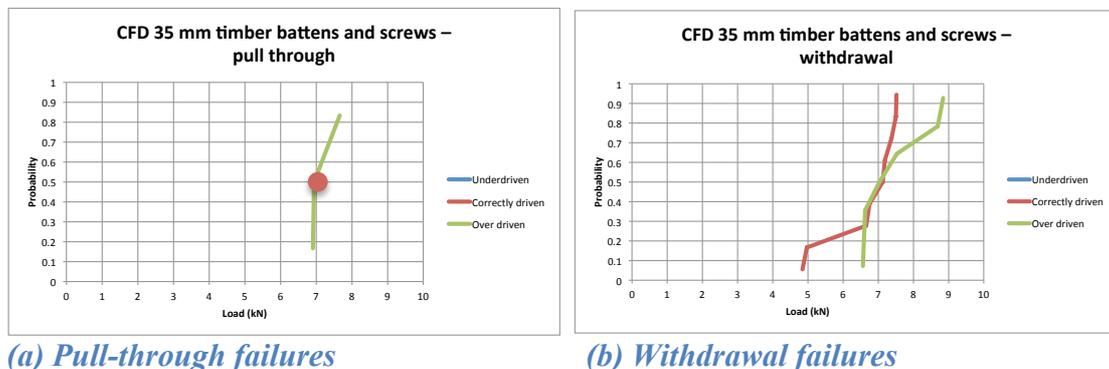
(a) Pull-through failures (b) Withdrawal failures
Figure 3.3 Cumulative frequency distribution for screws through 35 mm thick timber battens

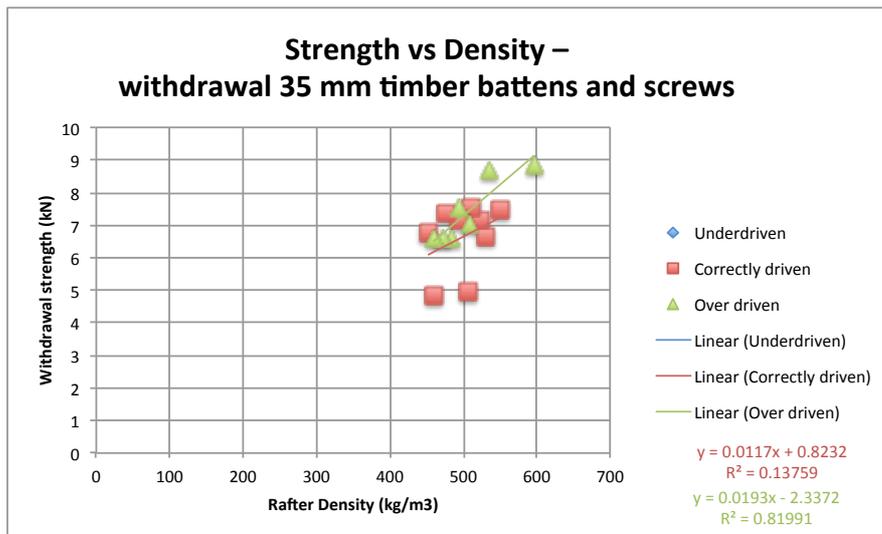
Figure 3.4 Strength vs rafter density for screws through 35 mm thick timber battens

Most of the failures were by withdrawal of the screws from the rafters; the withdrawal load could be related to the rafter density. Figure 3.4 shows that the two low values of two correctly driven specimens were significantly lower than the capacities of all others, and independent of the rafter density. Aside from those two points, the capacities of most other correctly driven and over-driven specimens are clustered together.

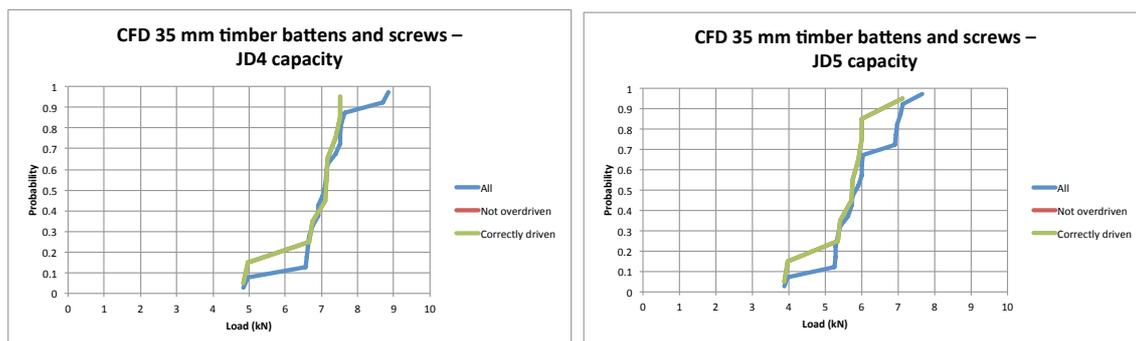
(a) JD4 timber rafters

(b) JD5 timber rafters

JD5 capacities were evaluated for correctly driven screws only and for all screws (whether correctly driven or over-driven). The cumulative frequency diagrams are shown in Figure 3.5 and the characteristic values in Table 3.2. The correctly driven screws had known depth of penetration that enabled the calculation of the resistance to withdrawal in N/mm total depth of embedment. This is shown in the last line of Table 3.2

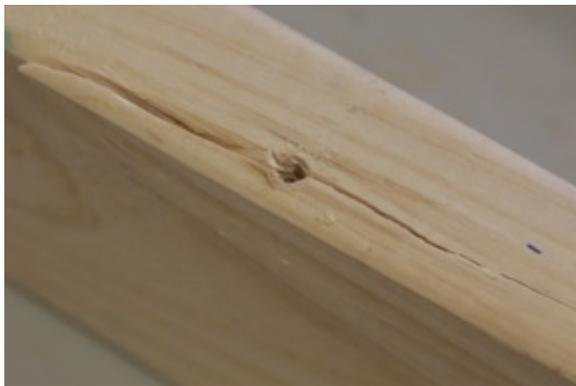
Figure 3.6 Splitting of rafter with inadequate edge distance

As indicated in Section 2.5.2, correctly installed batten to rafter connections cannot satisfy the rafter edge distance requirements in Table 4.8 in AS1720.1 (Standards Australia 2010b). 10 connections were prepared with correctly driven fasteners installed non-centrally in rafters as shown in Figure 3.6. A range of rafter edge distances was selected.

Failure modes were all by withdrawal from the rafter. In some cases, the withdrawal was accompanied by splitting of the rafter as shown in Figure 3.6.

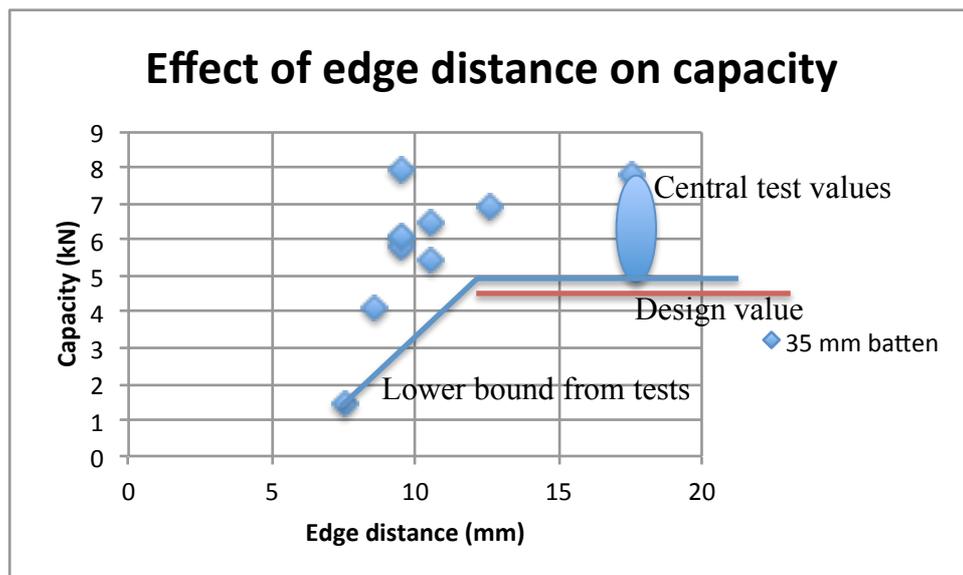
Figure 3.7 Effect of rafter edge distance on capacity of connections through 35 mm thick timber battens

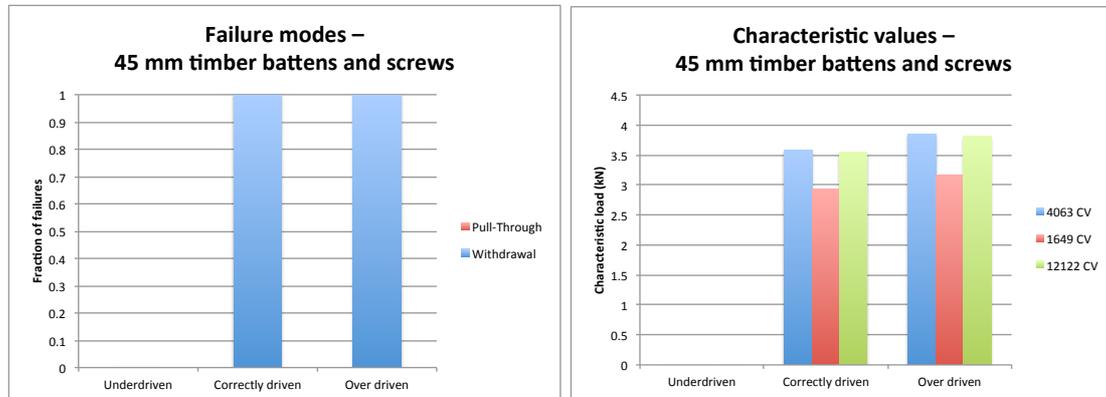
(a) Failure modes

(b) Characteristic values

These trends can be seen in Figure 3.8.

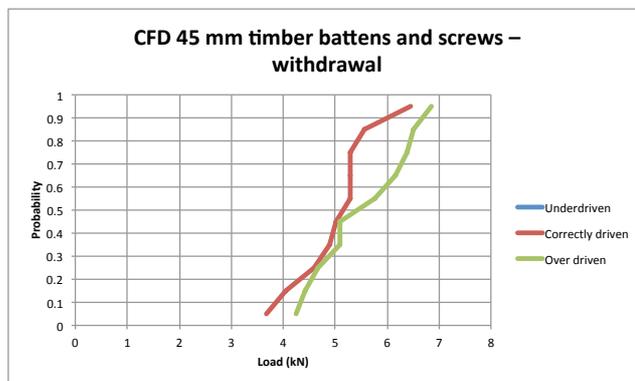
Figure 3.9 Cumulative frequency distribution of withdrawal failures for screws through 45 mm thick timber battens

Figure 3.9 shows that the capacity of screws through 45 mm thick battens at the 50%ile level is the same for all specimens at around 5.2 kN, regardless of how they were driven. This value divided by the depth of embedment gives 173 N/mm – almost identical to the 50%ile capacity of screws into 35 mm thick battens divided by its depth of embedment – 175 N/mm. The average of the characteristic values calculated using AS/NZS 4063.2 (Standards Australia 2010c) and ISO 12122.5 (International Standards Organisation 2015) was 3.56 kN for correctly driven fasteners, and 3.83 kN for the over-driven fasteners.

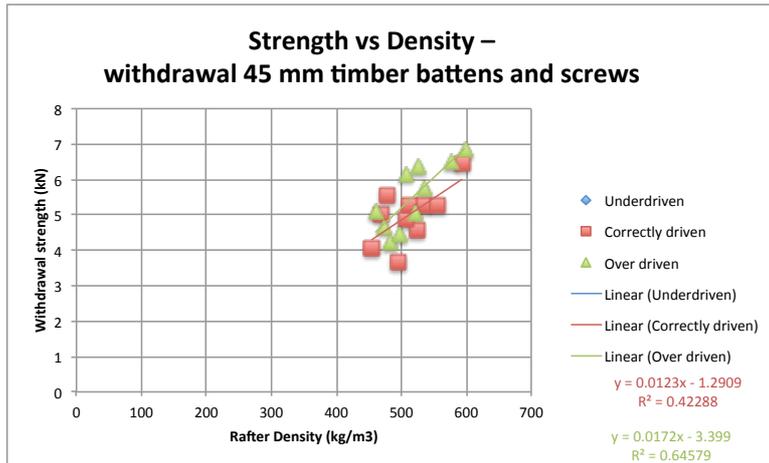
Figure 3.10 Strength vs rafter density for screws through 45 mm thick timber battens

All of the failures were by withdrawal of the screws from the rafters; the withdrawal load could be related to the rafter density. The capacities of correctly driven and over-driven specimens are clustered together, as shown in Figure 3.10.

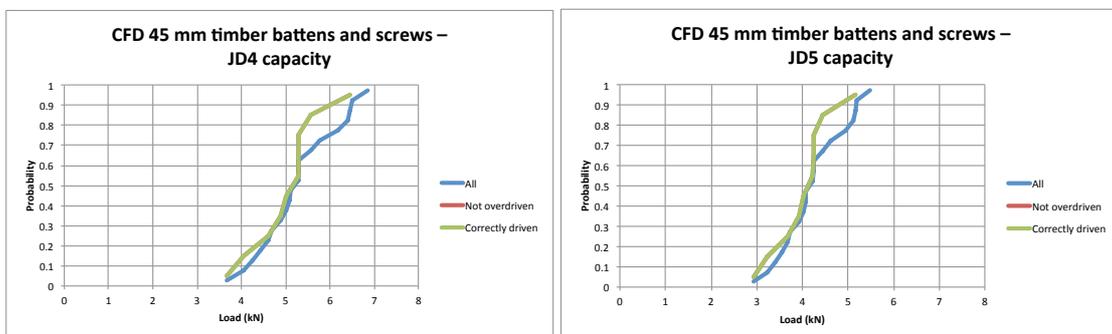
(a) JD4 timber rafters

(b) JD5 timber rafters

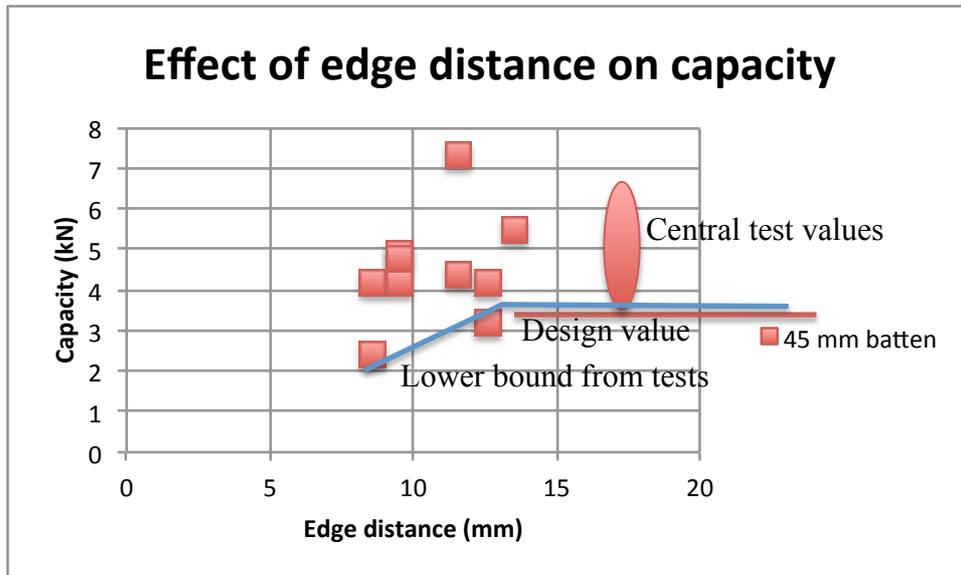
Figure 3.12 Effect of edge distance on strength of connections with 45 mm thick timber battens

Figure 3.12 shows the 10 test results from the rafter edge distance study as red squares and the results from the central test values as a red ellipse. The design value from Table 3.6 is shown as a red line, and the blue line reflects the lower lower bound of the combined data sets for correctly driven screws through 45 mm thick battens.

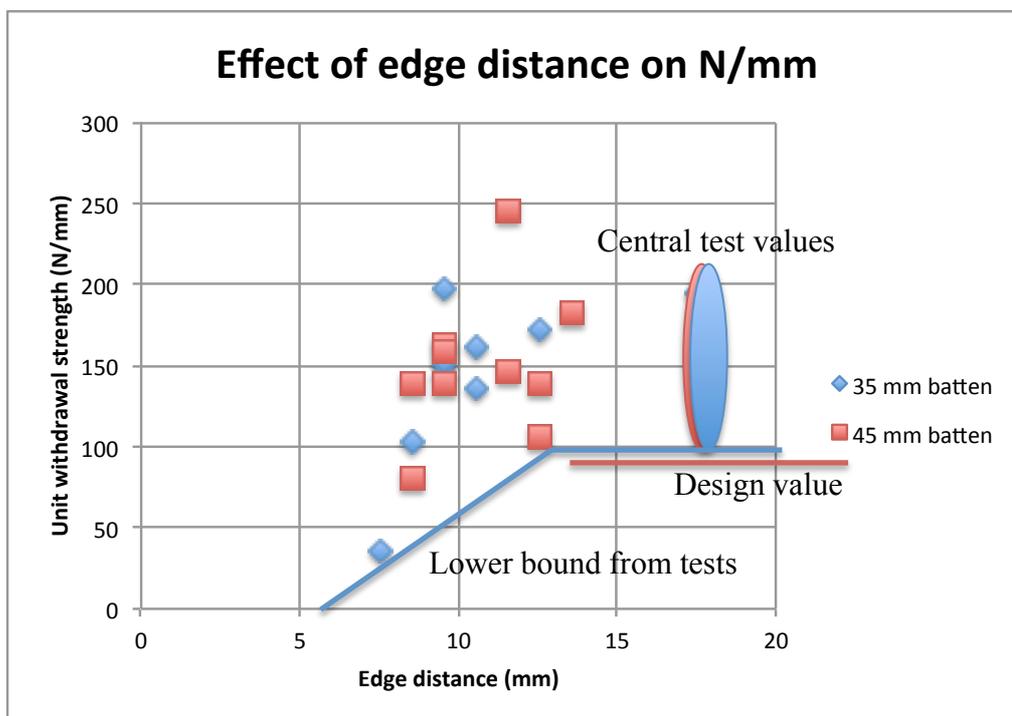
Figure 3.13 Effect of edge distance on unit withdrawal strength of connections with both 35 mm and 45 mm thick timber battens

Tables 3.3 and 3.6 gave very similar results for the unit withdrawal capacity per mm depth of embedment for the tests in 35 mm thick battens (penetration 40 mm) and the tests in 45 mm thick battens (penetration 30 mm). These unit strengths were 119 N/mm and 113 N/mm respectively. Edge distance studies on the two battens were combined and shown in Figure 3.13.

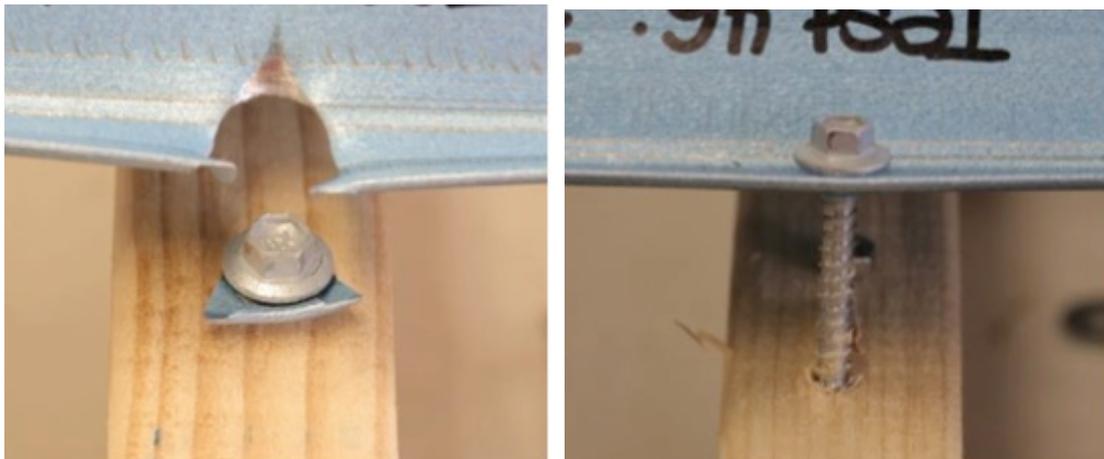
(a) Pull-through failure

(b) Withdrawal failure

Figure 4.1 Failure modes in screwed top-hat battens

Some fasteners failed by pull through in the batten as shown in Figure 4.1(a) and others failed by withdrawal from the rafter as shown in Figure 4.1(b).

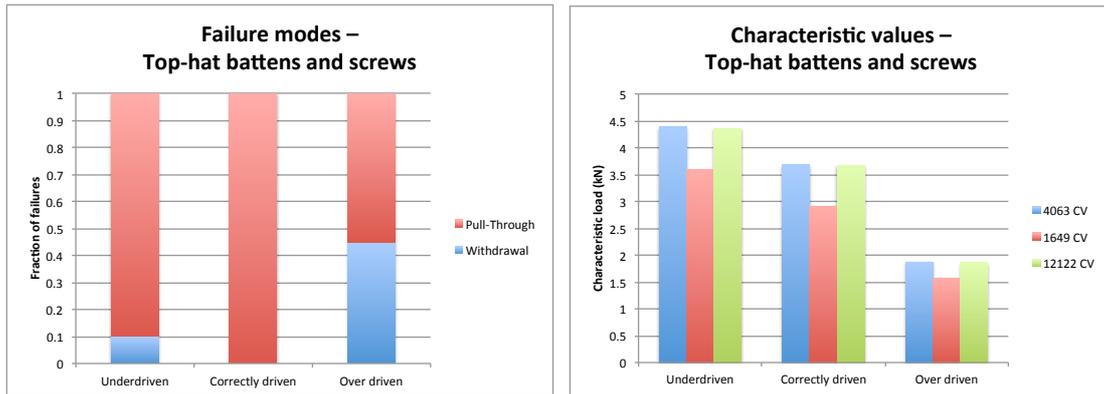
(a) Failure modes
 (b) Characteristic values
 Figure 4.2 Results for two Batten Zip® screws through top-hat battens

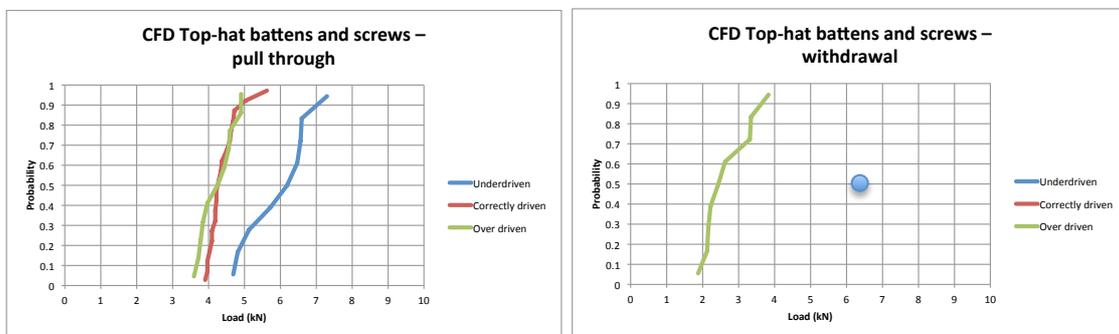
(a) Pull-through failures
 (b) Withdrawal failures
 Figure 4.3 Cumulative frequency distribution for two Batten Zip® screws through top-hat battens

- Most Batten Zip® screws that failed in withdrawal were over-driven;
- The strongest over-driven screws that failed in withdrawal had around the same capacity as the weakest of the over-driven screws that failed by pull-through;
- There was a significant difference between the capacity of the only under-driven screw that failed in withdrawal and the capacities of the over-driven screws that failed in withdrawal;
- The CFDs for the correctly driven and over-driven screws that failed by pull-through were similar. However, the CoV for the capacity of over-driven screws was much higher than the capacity of correctly driven screws because it was obtained from the total over-driven data shown in Figure 4.3(a) and (b).

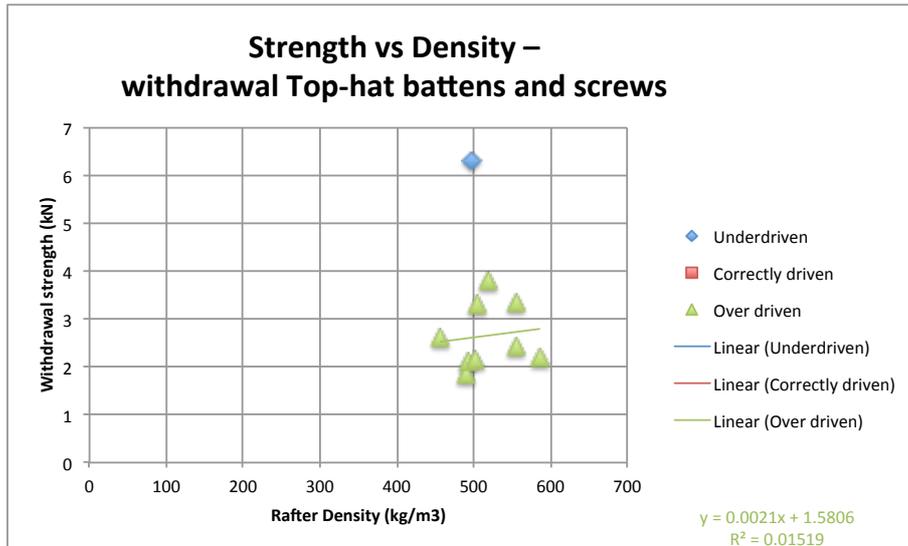
Figure 4.4 Strength vs rafter density for two Batten Zip® screws through top-hat battens

Figure 4.4 indicates that there is almost no relationship between rafter density and strength of the fasteners that failed in withdrawal. Most of the withdrawal failures were for over-driven screws where over-driving damaged the fibres. The low capacity probably reflects the extent of the fibre damage rather than the inherent strength of the rafter material.

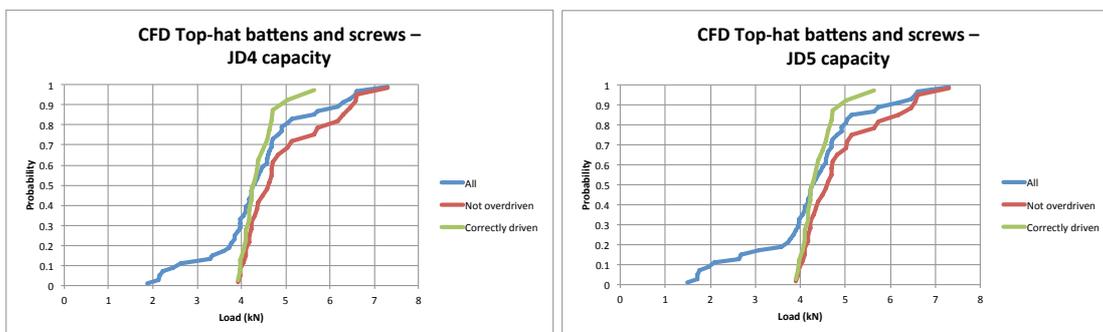
(a) JD4 timber rafters

The capacity of the screws in JD4 timber rafters was limited by pull-through of the metal batten flange so was identical to the capacity in JD5 rafters.

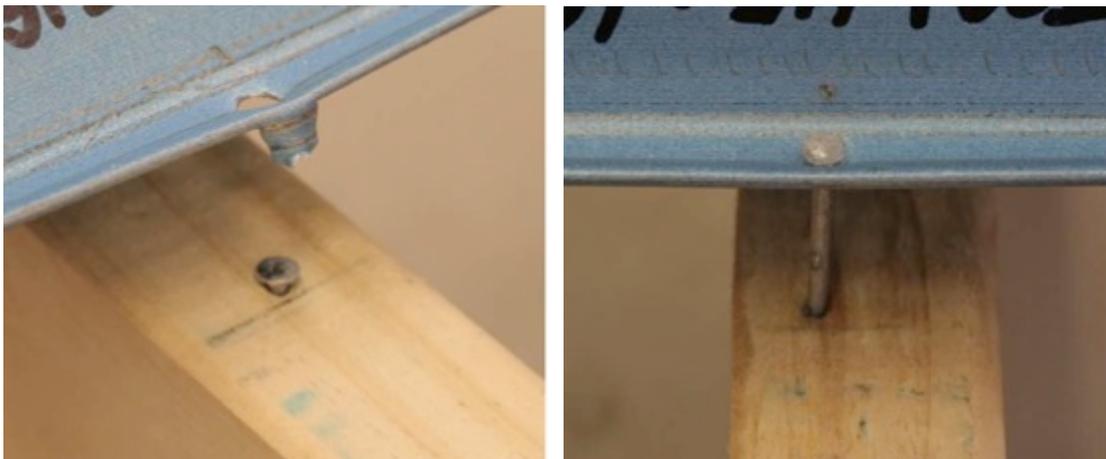
(a) Pull-through failure

Some fasteners failed by pull through in the batten as shown in Figure 4.6(a) and others failed by withdrawal from the rafter as shown in Figure 4.6(b).

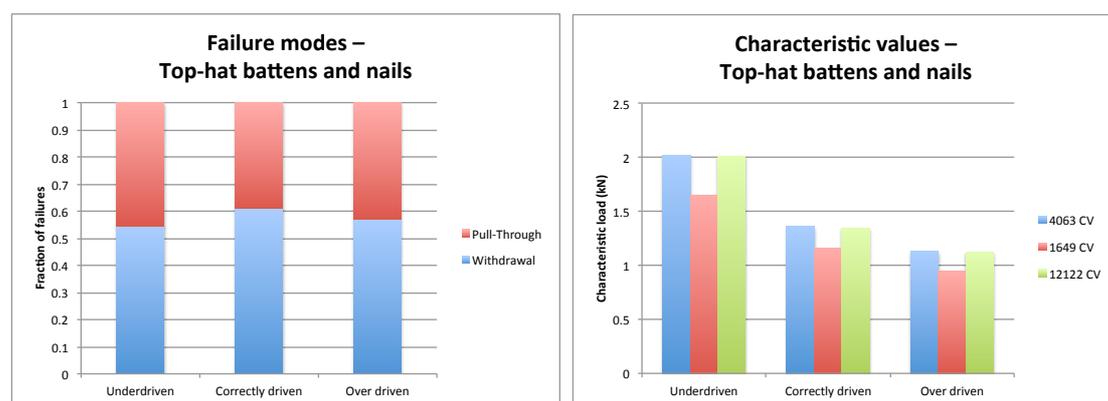
(a) Failure modes

These differences are illustrated in Figure 4.7(b).

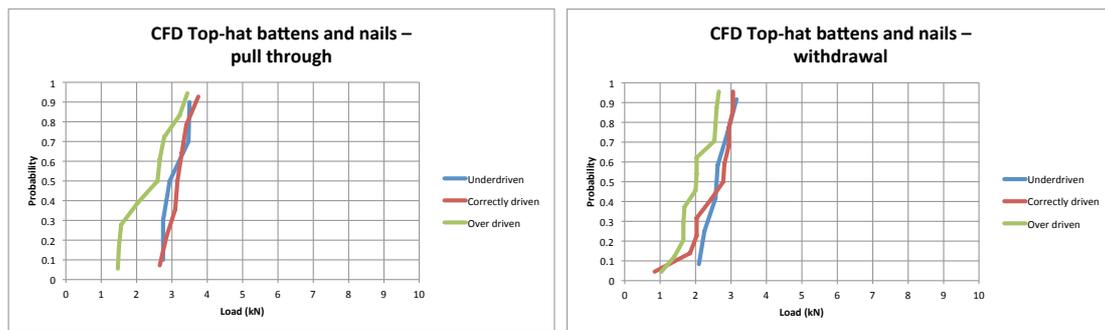
(a) Pull-through failures

- There was a significant difference between the capacity of the over-driven nails that failed by pull-through and the capacities of the correctly and under-driven nails that failed by pull-through;
- The CFDs for the correctly driven and under-driven nails that failed in withdrawal were similar, except at the lower tail of the distribution;
- In general, over-driven nails had the lowest capacity for both withdrawal and pull-through failures – CFDs for over-driven nails are to the left of the correctly and under-driven nails in Figure 4.8(a) and (b).

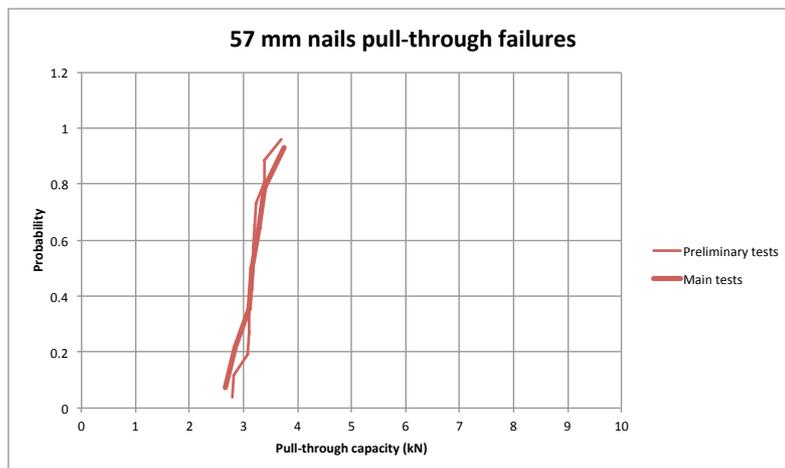
Figure 4.9 Comparison between preliminary and main test data for two correctly driven 57 mm nails through top-hat battens

Figure 4.9 shows the CFD for correctly driven fasteners that failed by pull-through in the main test program overlaid on the CFD for correctly driven 57 mm nails that failed by pull-through in the preliminary test program. The results are similar for both, which indicates that the preliminary tests were a valid representation of correctly driven nails in the main test program.

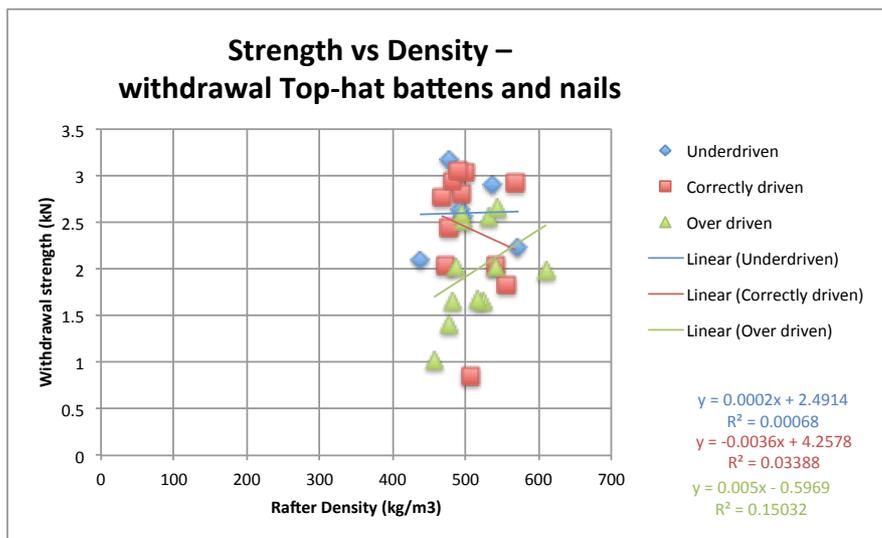
Figure 4.10 Strength vs rafter density for two 57 mm nails through top-hat battens

An estimate of the strength of the same connections into JD5 timber rafters was calculated by scaling withdrawal loads by 0.65 (the ratio of JD5 withdrawal strength to JD4 withdrawal strength for nails in AS1720.1 (Standards Australia 2010b)). The strength for any connections that failed by pull-through were not scaled as the mode of failure was independent of the density of the rafter; it was only affected by the properties of the top-hat batten. From the scaled individual test values, the JD5 characteristic values were found using the analysis techniques outlined in Section 2.6.2.

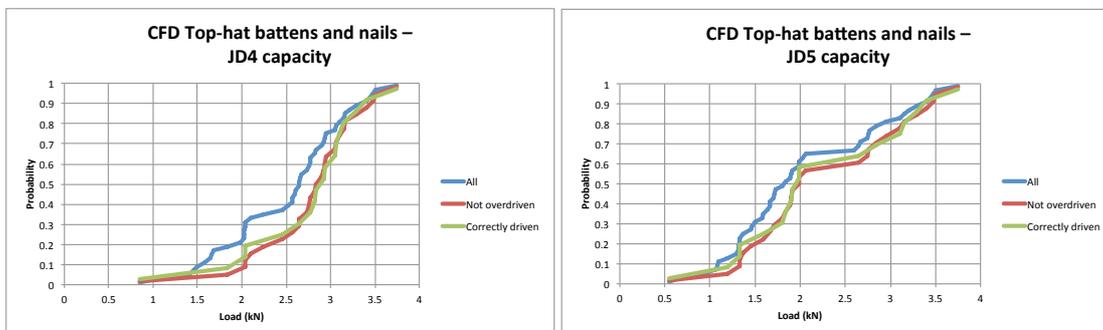
(a) JD4 timber rafters

The cumulative frequency diagrams for the capacity of two nails through top-hat battens into JD4 and JD5 rafters are shown in Figure 4.11 and the characteristic values in Table 4.5. The correctly driven nails had known depth of penetration that enabled the calculation of the resistance to withdrawal in N/mm depth of embedment. This is shown in the last line of Table 4.5. The value for JD5 timber rafters (7.0 N/mm) is significantly less than the values in Table 4.2 for Batten Zip® screws through top-hat battens (47.3 N/mm).
