INVESTIGATION of DAMAGE to STRUCTURES FOLLOWING CYCLONE CONNIE

TECHNICAL REPORT No. 30

May 1987

G.N. Boughton

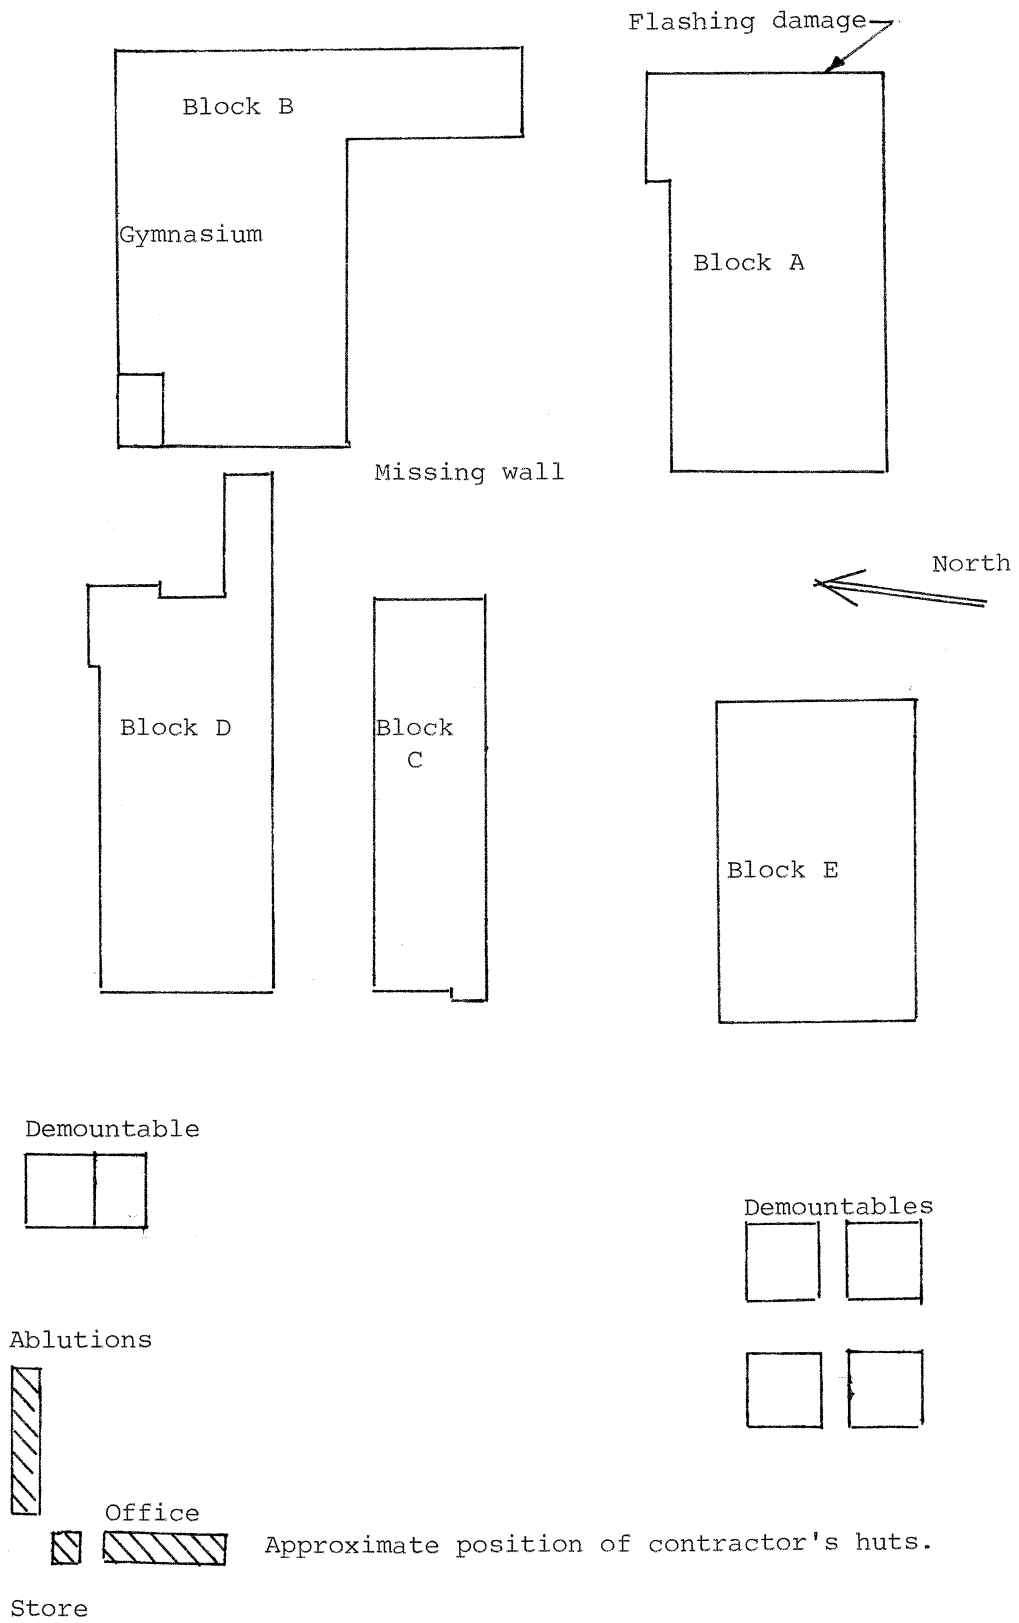
Figure 5. Hedland Senior High School - Site Plan

Conspicuous flashing damage to the main classroom block in this complex and loss of some louvres in the gymnasium/hall building meant that this group of buildings was included high in the media lists of damage. However, some other buildings on the site were studied in which no damage was observed in spite of dubious structural provisions to resist wind loads at the time. Figure 5 shows a site plan of the buildings in the Hedland Senior High School.

The school is located in South Hedland and wind speeds at that location were probably similar to those recorded at the nearby airport.

Examination of records of cyclone damage caused by past cyclones in the Port Hedland area (Bureau of Meteorology, 1987) has shown that roofing damage was caused to the Hedland Senior High School during cyclone Kerry in 1973 (with a maximum wind speed recorded at the airport of 36ms^{-1}), cyclone Trixie in 1975 (35ms^{-1}) and cyclone Joan in 1975 (58ms^{-1}). Specific details of the nature or the location of the damage were not available, but some repair work to damaged roofing over the manual arts wing was noted in an inspection of the roof.

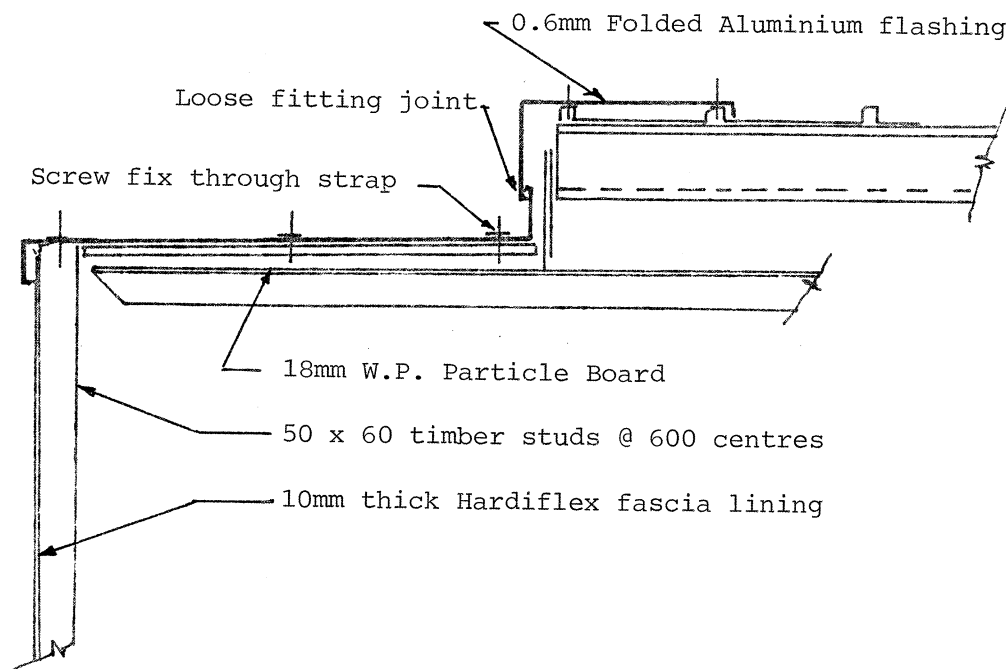
Figure 7. Detail of the flashing and attachment as designed

The flashing at that location was a two part aluminium sheet fixture secured by self tapping screws into timber products under the sheeting as shown in Figure 7. The lower piece was fixed over the top of the fascia panel and served as cladding for the eaves overhang. A second piece of aluminium flashing was screwed to the lower piece, passed over the roof sheeting and was fastened to it along the two ribs closest to the edge of the aluminium roofing as shown in Figure 7.

The detail shown in Figure 7 was taken from the design drawings, but a few minor differences between the detail as installed and that shown on the drawings may have contributed to the failure of the flashing.

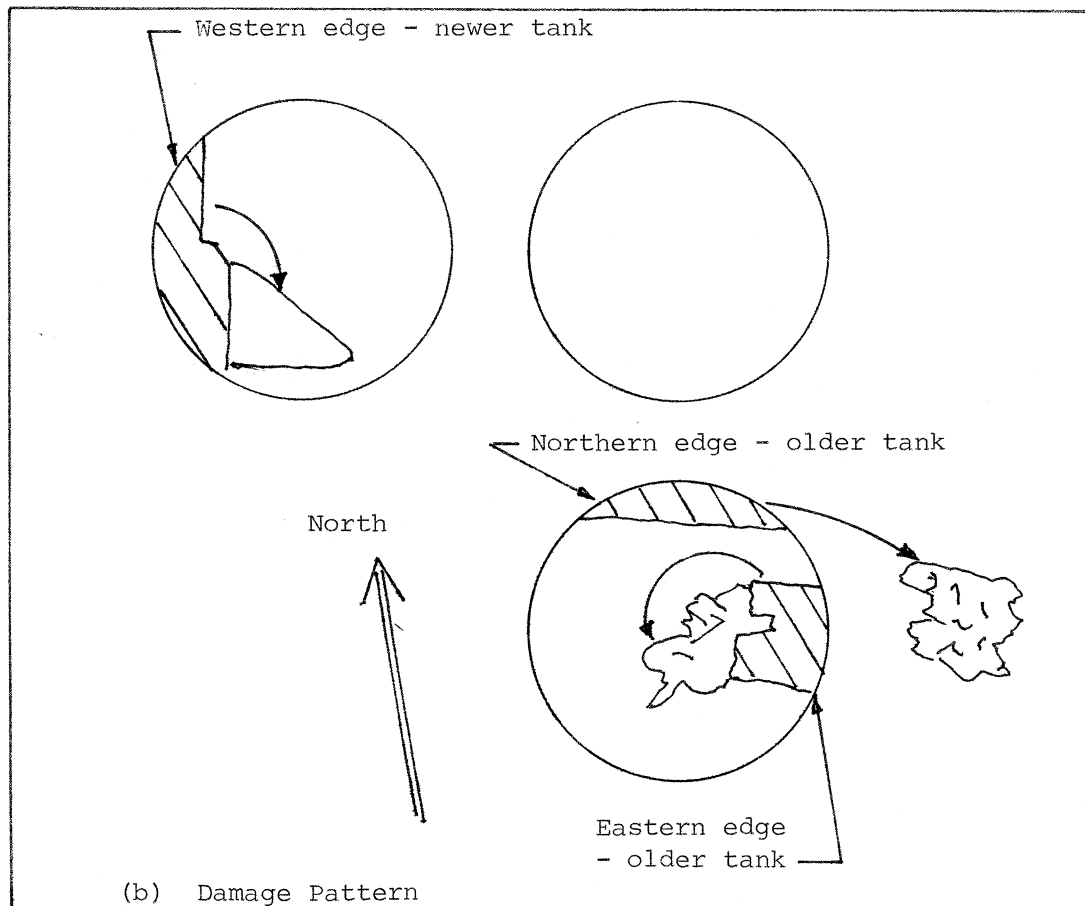
Figure 12. Site Plan and Damage Location
3 Mile water tanks.

The Water Authority of Western Australia has constructed three two million gallon ground level water tanks at the location called 'the Three Mile'. Roof damage was sustained by two of these tanks. The two damaged tanks were constructed six years apart, but used essentially similar designs. They were sited in an environment that had terrain category 2 approach terrain to the east and to the north-west. A site plan is shown in Figure 12.

Figure 12 includes a sketch showing the extent of the roof subjected to damage. The distribution of the debris from the two damaged areas indicated that the damage on the eastern edge of the tank was caused by winds primarily from the east, and that on the northern edge was caused by winds from the north-west.

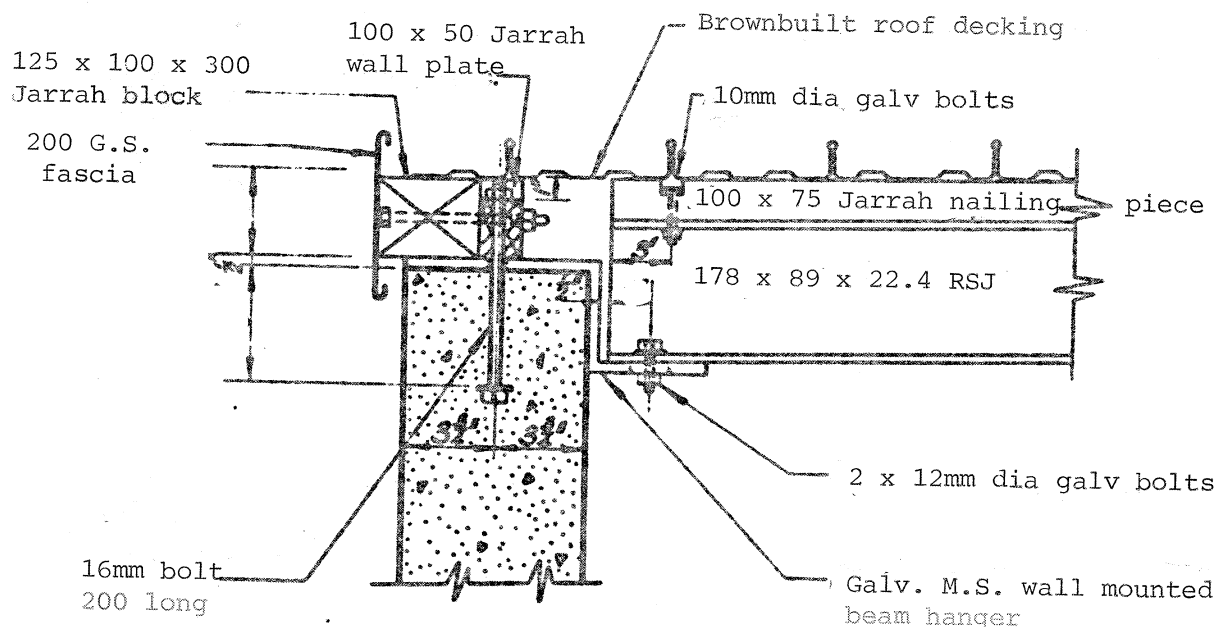
Figure 13. Detail of Roof Fixing - Tanks

The design drawings for the tanks called for all fixing clips and screws to be fastened to 100mm x 75mm jarrah nailing pieces. These timber nailing pieces, spaced at approximately 3.5m centres were bolted along the top of galvanised rolled steel joists (RSJ) as shown in the portion of the design drawing reproduced as Figure 13.

Figure 13 shows that the bolts that fastened the timber batten along the top of the RSJ were recessed at the top to allow for flush fitting of the roof sheeting. Also the bolts were specified as galvanised.

On the older tank, a Z shaped steel bracket was bolted to the underside of the purlin and rested on top of the concrete wall as shown in Figure 13. A bolt cast into the concrete wall secured both the wall plate and the Z shaped bracket.

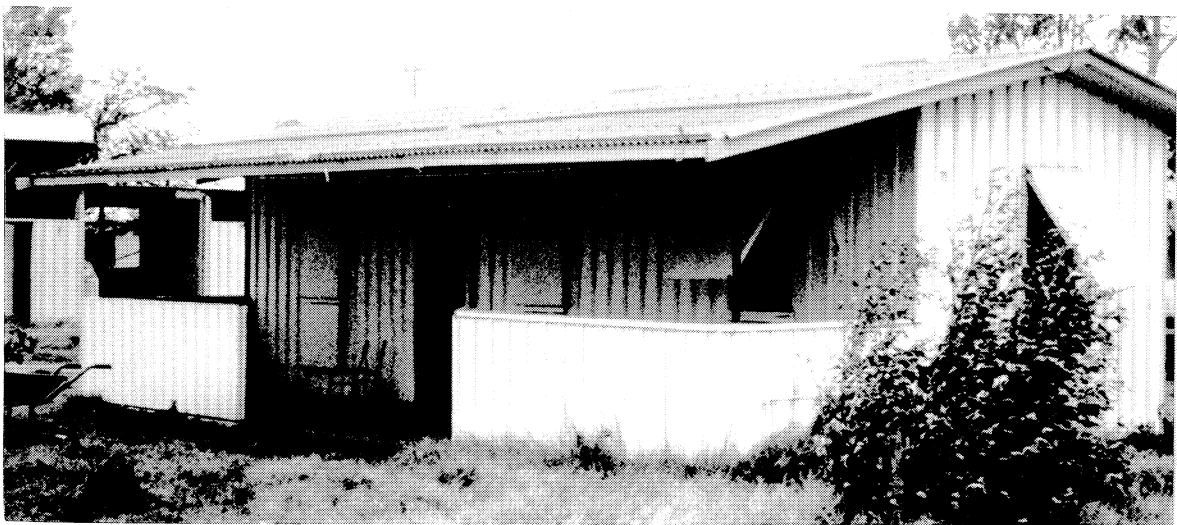
Figure 21. Housing At The 'Three Mile Camp'

The 'Three Mile Camp' was located within 1km of the tanks detailed in Section 3.2 and consists of a number of houses constructed with metal frames and light guage steel cladding. An example of the housing is illustrated in Figure 21.

The housing provides rudimentary shelter with minimal lining. The windows are fitted with storm shutters, two of which are shown open in Figure 21. The roof sheeting was fixed in accordance with current recommendations for cyclone areas and remained undamaged. An open verandah was provided on the north side of every house. The northern row of houses would have had terrain category 2 exposure to the open verandahs, and there was no sign of any damage to the cladding or structure.

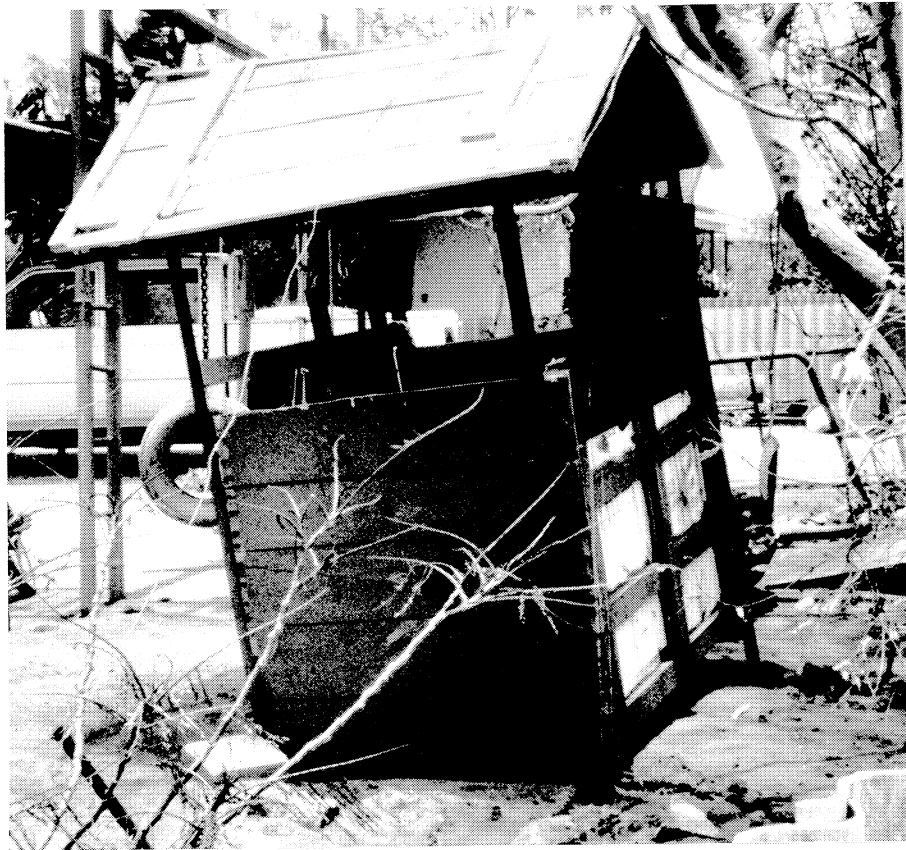
Figure 29. Child's Cubby House

This structure, made of a light gauge angle steel frame with pine packing case roof and walls, had a terrain category 1 exposure to winds from the north and north-west. It had been tied down by a loose 3mm galvanised wire over the top of the roof into a star picket on either side. It is illustrated in Figure 29, and apart from a slight racking deformation, is still quite serviceable!
