## Tropical Cyclone Damien Damage to buildings in the Pilbara Region of WA

### CTS Technical Report No 65

## **Tropical Cyclone Damien Damage to buildings in the Pilbara Region of Western Australia**

This edition: 28 February 2020

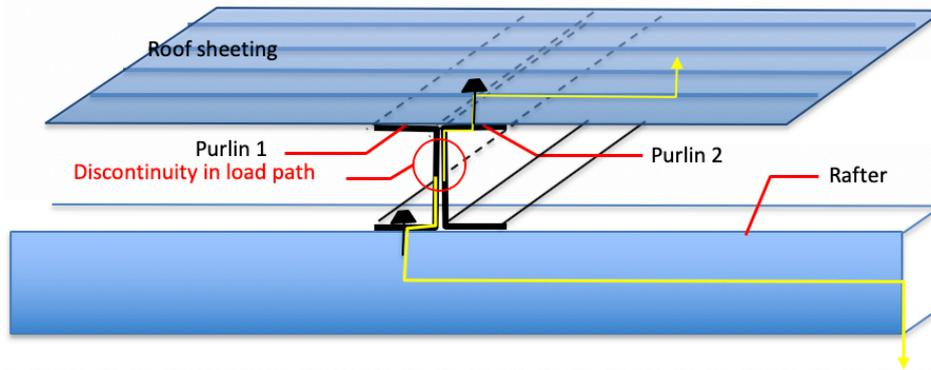
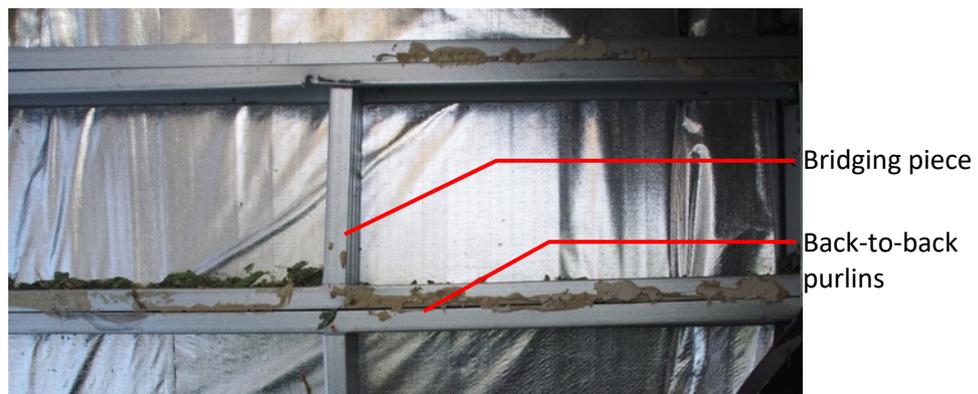
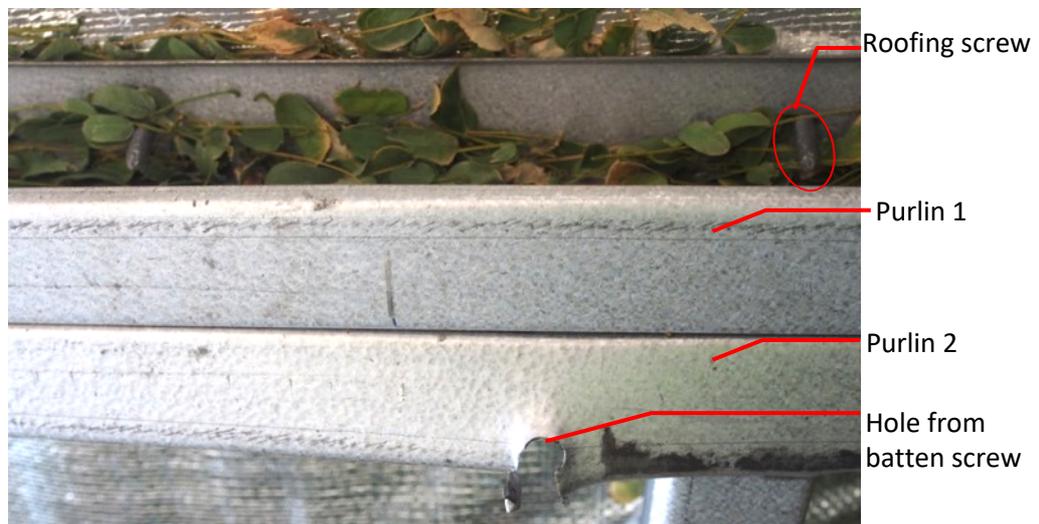
**Figure 4.5 Load path through back-to-back purlins**

One of the inspected buildings that failed during TC Damien included non-standard structural system and a discontinuity was noted in the tie-down chain. Figure 4.4 shows the disconnected purlins after failure, and Figure 4.5 includes photos and a diagram of the back-to-back purlins used in a part of a roof that failed.

(a) Diagram of back-to-back purlins

(b) Roof section showing back-to-back purlins

(c) Detail of back-to-back purlins`

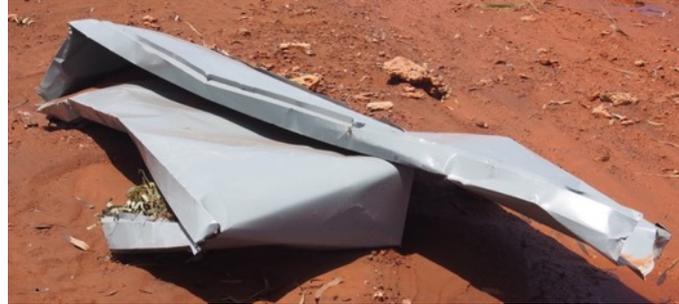
(b) Detached parapet flashing

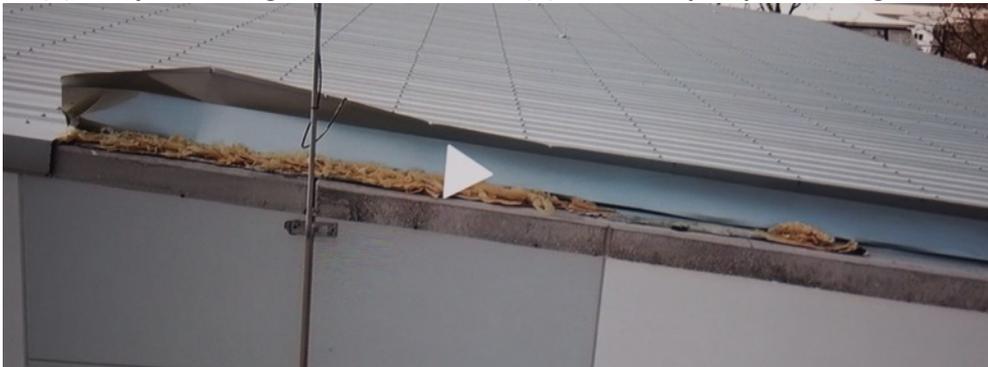
(c) Lifted barge flashing on a commercial building

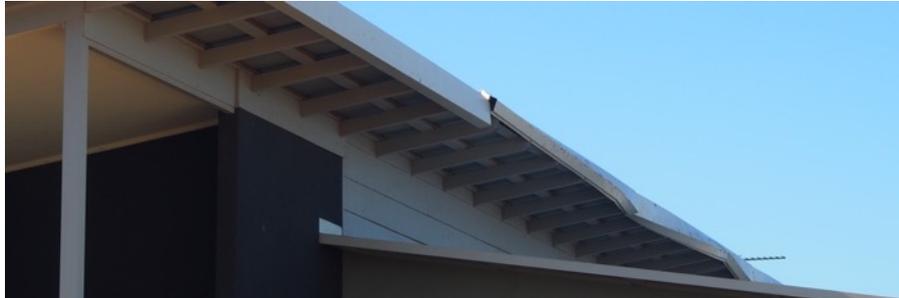
(d) Lifted barge flashing on a contemporary house

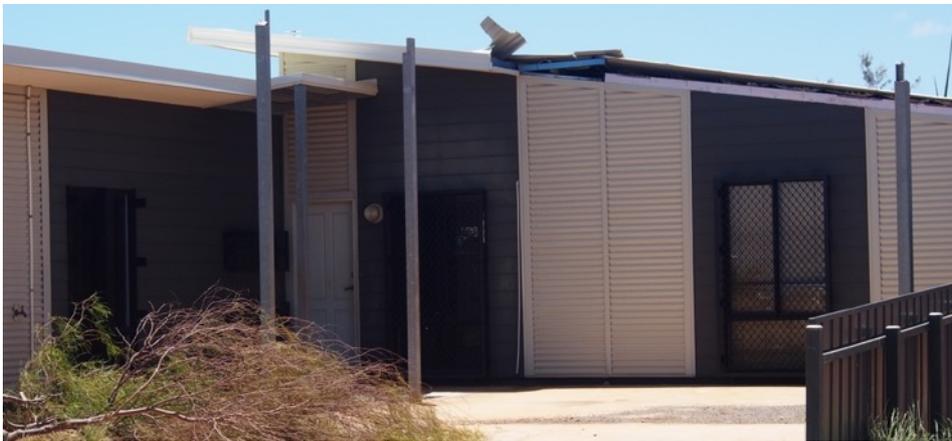
Some carports lost their roofs completely as shown in Figure 4.11. The structural connection from the roof to the columns had been via a bracket screwed into the SHS column and into the underside of the carport beams as shown in Figure 4.11(b).

(a) Loss of carport roof in uplift

In the example shown in Figure 4.11, the carport roof was a continuation of the main house roof and the failure had not propagated into the house, though the loss of the carport roof gave a pathway for water ingress into the main house. Figure 4.12 shows a house from a similar construction period with similar construction details in the carport.

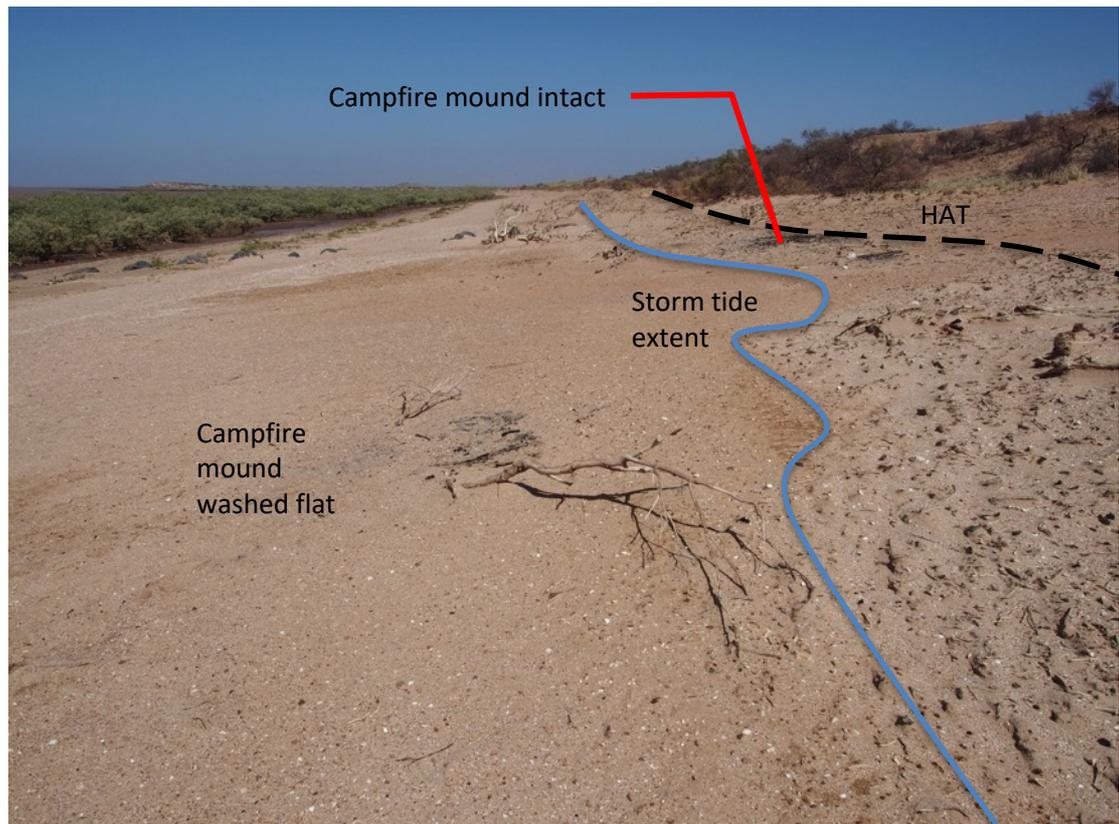
Figure 6.2 shows a photo of the foreshore at Searipple lookout at Karratha in Nickol Bay. The dashed line shows the approximate position of the Highest Astronomical Tide (HAT) and the blue line shows the inferred storm tide position, which includes the effect of wave run-up. The two campfire mounds near the HAT line were not affected by sea water, but the one in the foreground had been washed by moving sea water. The highest storm tide corresponded with winds from the east at this location.

**Figure 6.2 Foreshore at Searipple lookout, Karratha**

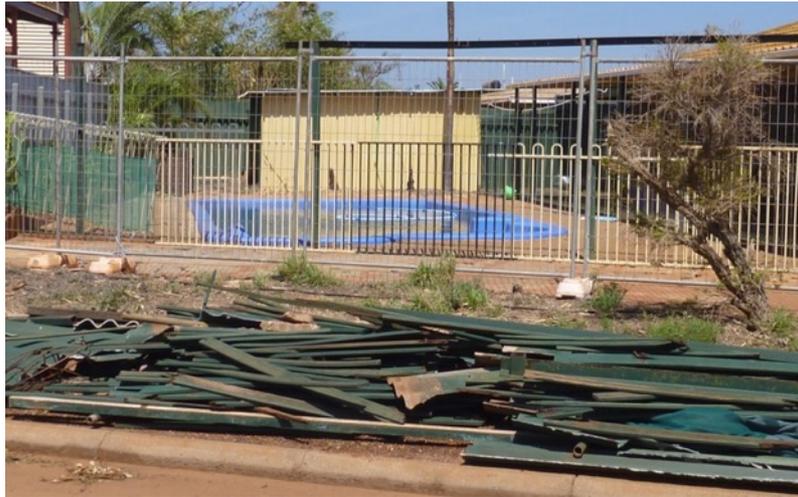
In other cases, the loss of a fence created a safety issue around pools. Figure 7.3 shows an example (a temporary fence needed to be erected quickly after the event).

Figure 7.3 Temporary fence around pool

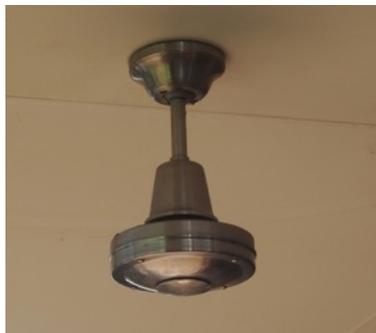
The owner of one of the houses inspected by the team, had removed the fan blades from an outdoor ceiling fan during preparation for the cyclone. This fan is shown after the event in Figure 7.10. It remained undamaged throughout and can be returned to service by reattaching the fan blades.

**Figure 7.10** Blades removed from ceiling fan in preparation for TC Damien

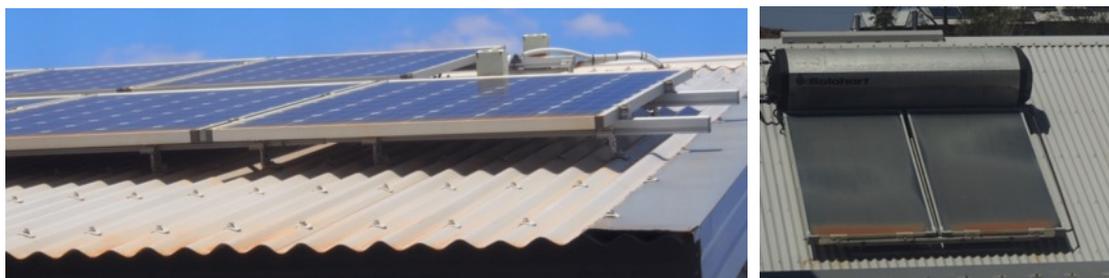
There were many buildings that had either solar hot water systems or solar photovoltaic systems installed on roofs that had no wind damage to either the solar panels or the roof. Figure 7.11 shows roofs in an exposed location with no damage to either the roof or the solar panels. The investigators found no examples where the mounting brackets between roofs and solar hot water or photovoltaic panels failed.

**Figure 7.11** Securely attached roof top solar panels

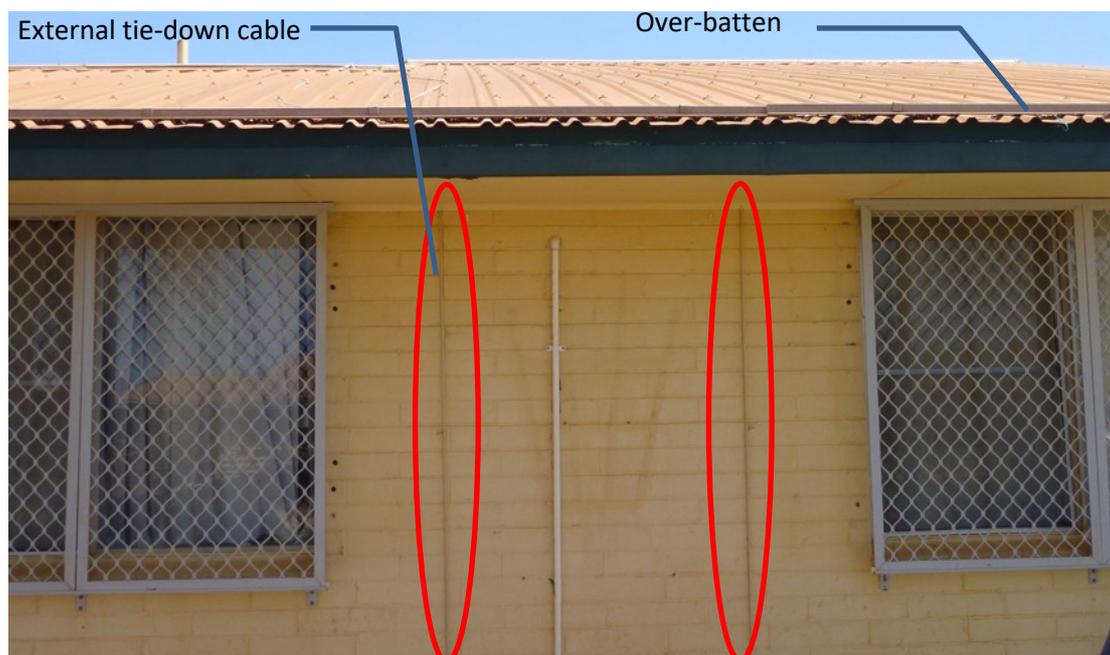
**Figure 9.1 House with external tie-down cables and over-battens**

- An external tie-down system that uses overbattens and tie-down cables outside the walls as shown in Figure 9.1;
- Tie-down cables outside the walls that are connected into trusses within the roof system;
- Additional tie-down elements within the wall framing.
