Tropical Cyclone George
Wind penetration inland

Report: TR53
February 2009

Cyclone Testing Station
School of Engineering
James Cook University
Queensland, 4811

TECHNICAL REPORT NO. 53

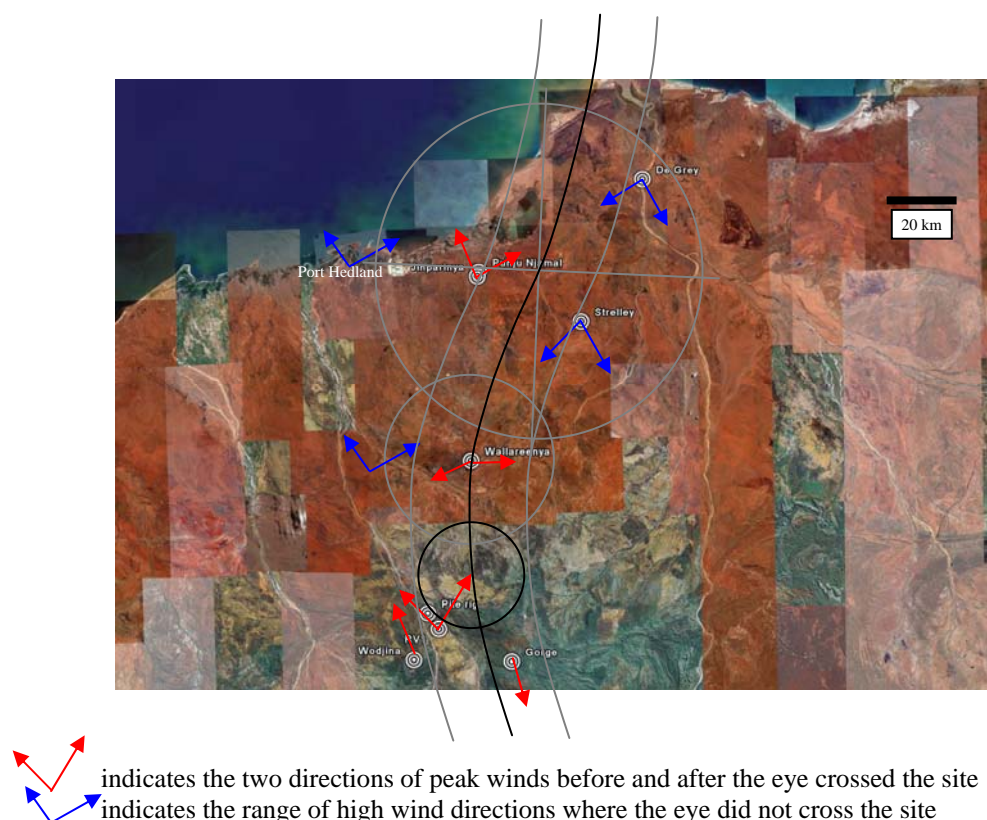
Figure 2.1: Estimated Track of Tropical Cyclone George after landfall.

The resulting track (Figure 2.1) shows the centre of the eye at ground level passing near to Jinparinya settlement and Wallareenya station. The eye also passed over FMG Rail Camp 1, and the Wodjina camp and mine.

Likewise, a gorge to the east of Rail Camp 1 (RV1) shown on Figure 2.1 showed vegetation damage caused by winds that were close to North-North-Westerly winds only. This would have placed it on the eastern edge of the eye.

The Mount Newman Rail access road runs Southward from Port Hedland and passes quite close to the FMG Rail Camp 1. The estimation of the track in Figure 2.1 shows that the eye wall intersects that road approximately 40 km South of South Hedland (around 50 km from the coast line).

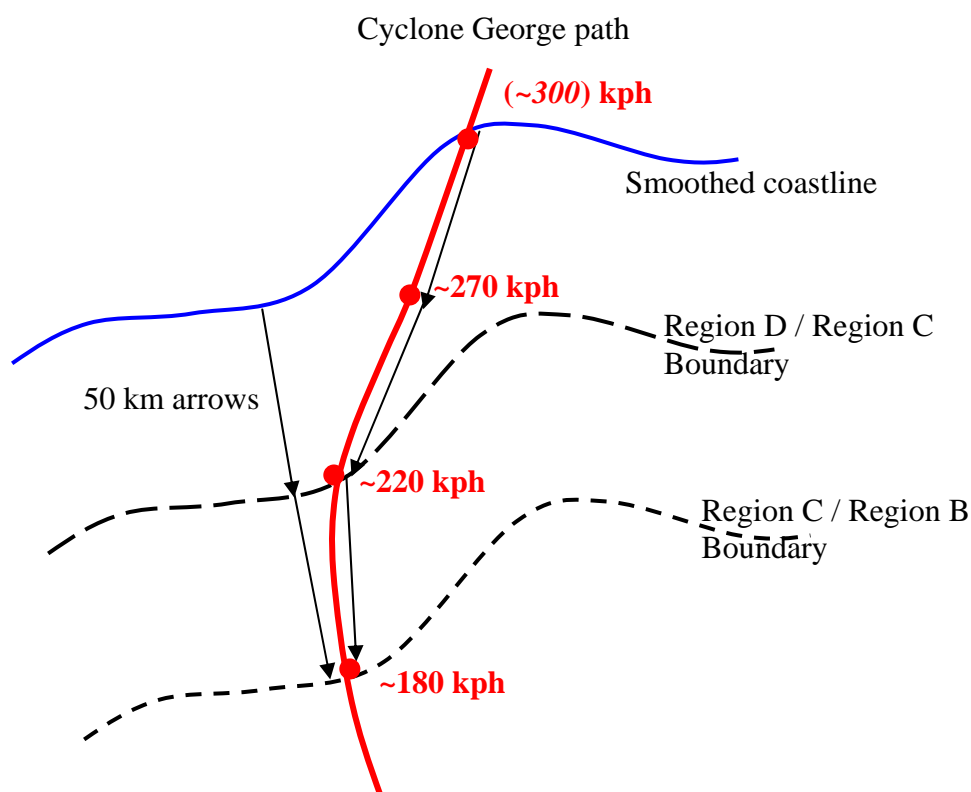
Figure 4.1 Estimated peak wind speeds after overland travel

The two analyses are illustrated in Figure 4.1. The wind speed estimates are at about 50 km intervals along the path of the cyclone, but the design wind speed at each location is given by the direct distance from the smoothed coast line. The first two points are in wind region D, even though the path of the cyclone has covered 100 km overland by the time it reaches the region D / region C boundary.

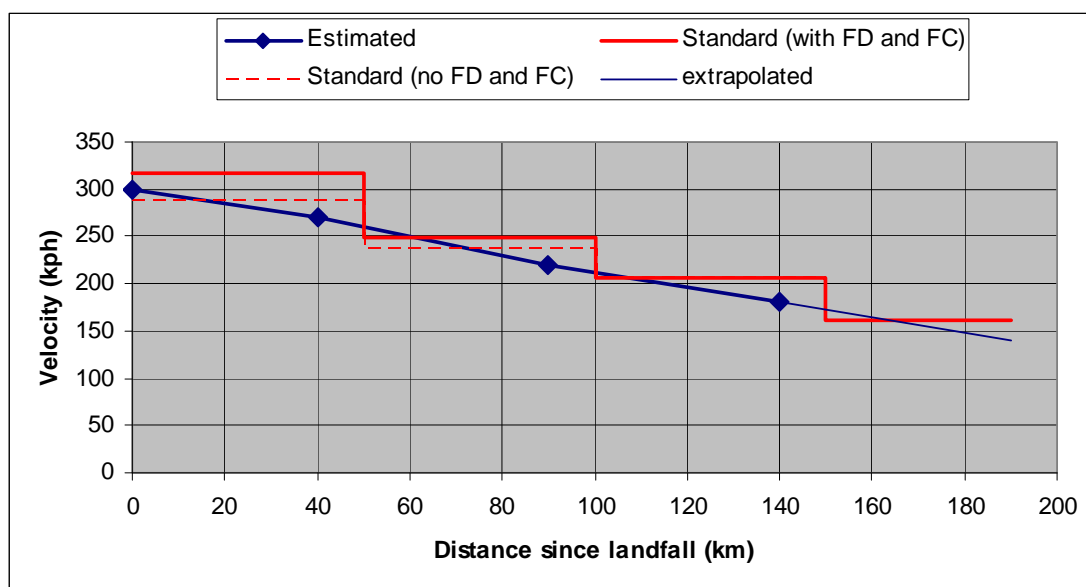
Figure 4.2 Design wind speeds plotted against estimated wind speeds with distance after landfall

For the hypothetical case of a cyclone with the same characteristics as Cyclone George but crossing the coast at right angles, then the estimated wind speed could be compared with the design wind speeds as shown in Figure 4.2. The blue line represents the wind speeds and distance from landfall indicated in Table 4.2, and the red lines the design wind speeds for this scenario. The full red line is the design wind

Figure 4.2 shows that the current design wind speeds are a little conservative for nearly all distances from the coast. (There are only very small excursions of the blue line below the full red line near the region boundaries.) However, the dotted red line shows a significant portion below the estimated wind speeds within the first 100 km of overland travel.

It appears that the code models of cyclone penetration of wind speed (including the F_D and F_C factors) after landfall would have led to appropriate predictions of wind speed for this event. This confirmed that the F_D and F_C factors are a necessary feature of the design wind velocity.
