ASBESTOS MATERIALS REPORT AND REGISTER

St Mark's College,
James Cook University
DOUGLAS QLD 4811

Inspection Date: 23/11/2016 9:00:00 AM

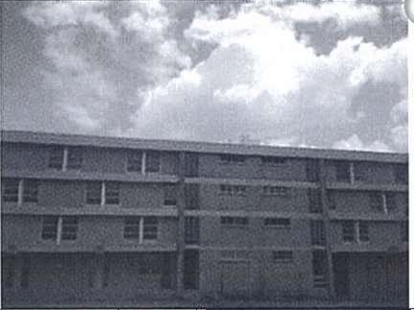
McGregor Wing	GL	External - West stairwell	Asbestos cement sheeting to ceiling to awning and fascia panels.	NF	G	L	E3206	CH

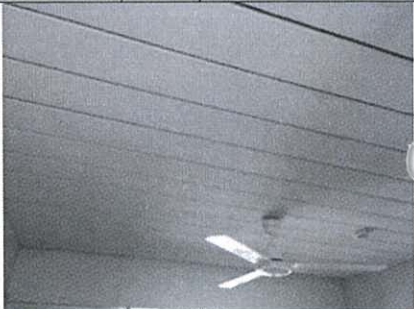
Clark Wing	GL	Room 1	Asbestos cement sheeting to walls above window and door.	NF	G	L	E3185	CH	
26/11/2016			No change in the condition of this item.		G	L

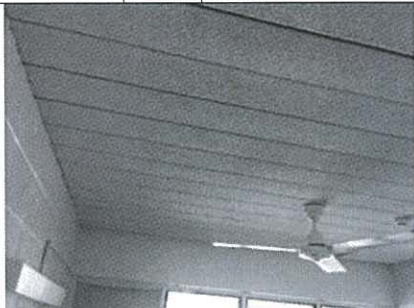
Clark Wing	GL	Room 2	Asbestos spray material to metal ceiling.	NF	G	L	E3187	CH

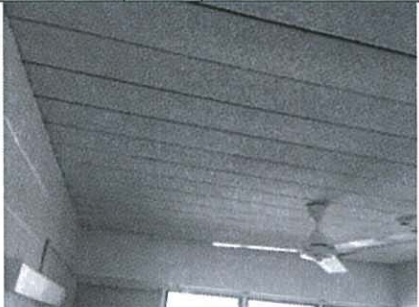
Clark Wing	GL	Room 2	Asbestos cement sheeting to walls above window and door.	NF	G	L	E3185	CH	
26/11/2016			No change in the condition of this item.		G	L

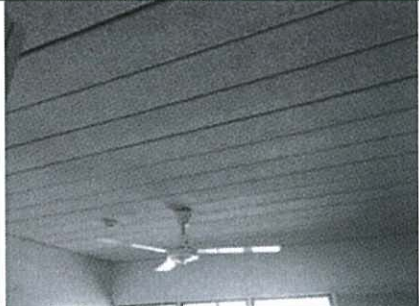
Clark Wing	GL	Hot water room	Asbestos spray material to metal ceiling.	NF	G	L	E3187	CH

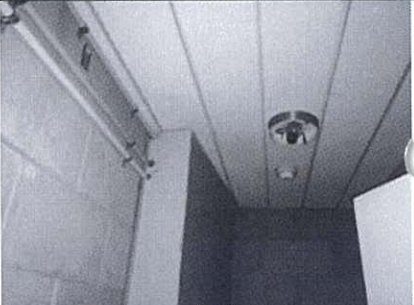
Clark Wing	GL	Room 3	Asbestos spray material to metal ceiling.	NF	G	L	E3187	CH

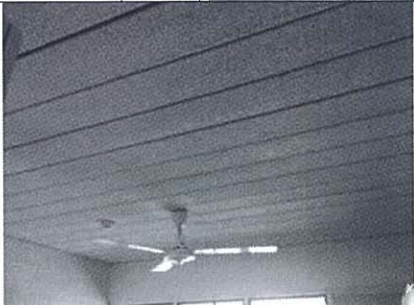
Clark Wing	GL	Room 3	Asbestos cement sheeting to walls above window and door.	NF	G	L	E3185	CH

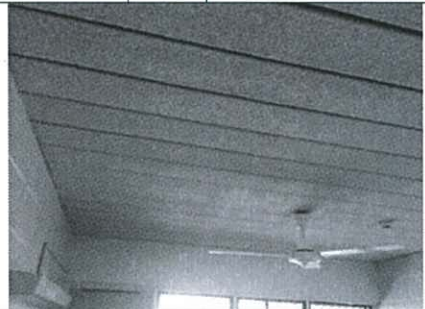
Clark Wing	GL	Room 4	Asbestos cement sheeting to walls above window and door.	NF	G	L	E3185	CH

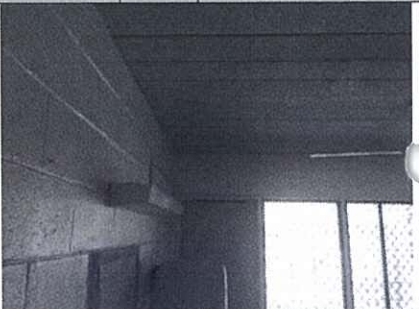
Clark Wing	GL	Room 5	Asbestos spray material to metal ceiling.	NF	G	L	E3187	CH

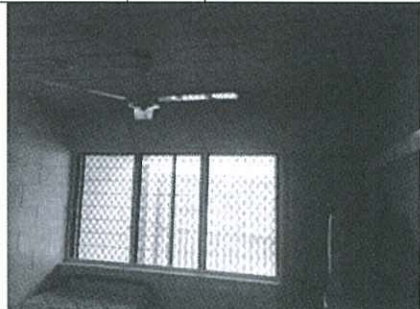
Clark Wing	GL	Room 6	Asbestos cement sheeting to walls above window and door.	NF	G	L	E3185	CH

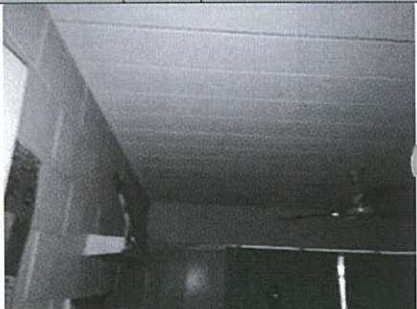
Clark Wing	GL	Room 7	Asbestos spray material to metal ceiling.	NF	G	L	E3187	CH

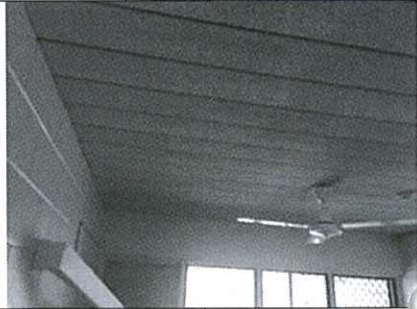
Clark Wing	GL	Room 7	Asbestos cement sheeting to walls above window and door.	NF	G	L	E3185	CH

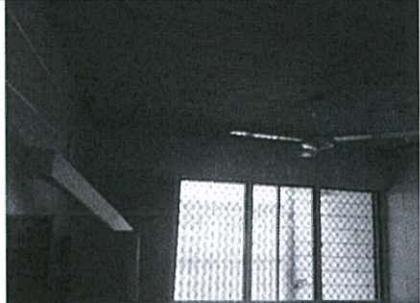
Clark Wing	GL	Room 8	Asbestos spray material to metal ceiling.	NF	G	L	E3187	CH

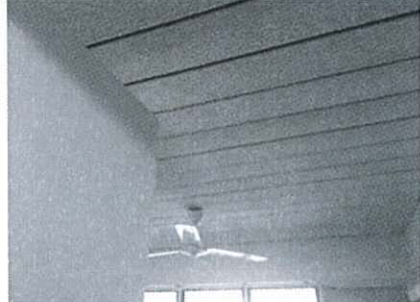
Clark Wing	GL	Room 8	Asbestos cement sheeting to walls above window and door.	NF	G	L	E3185	CH	
26/11/2016			No change in the condition of this item.		G	L

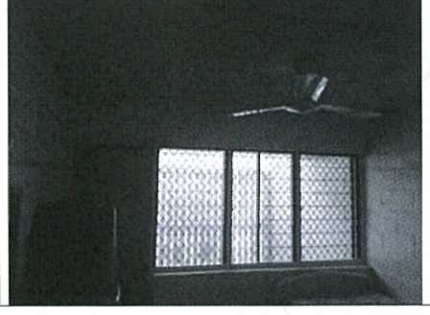
Clark Wing	GL	Room 21	Asbestos cement sheeting to walls above window and door.	NF	G	L	E3185	CH	
26/11/2016			No change in the condition of this item.		G	L			
Clark Wing	GL	Room 22	Asbestos spray material to metal ceiling.	NF	G	L	E3187	CH

26/11/2016			No change in the condition of this item.		G	L

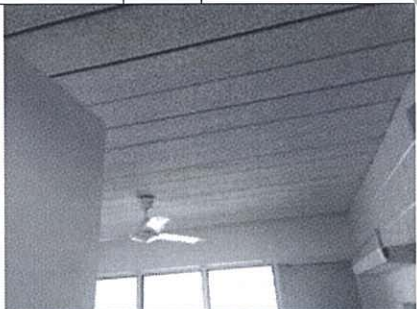
Building	Floor Level	Room	Asbestos in Room	Type	Condition	Priority	Sample No.	Result	Previous Photo
Clark Wing	GL	Room 22	Asbestos cement sheeting to walls above window and door.	NF	G	L	E3185	CH	
26/11/2016		No change in the condition of this item.			G	L			
Clark Wing	GL	Bathroom Room 22	Asbestos cement sheeting to ceiling.	NF	G	L	E3186	CH	
26/11/2016		No change in the condition of this item.			G	L

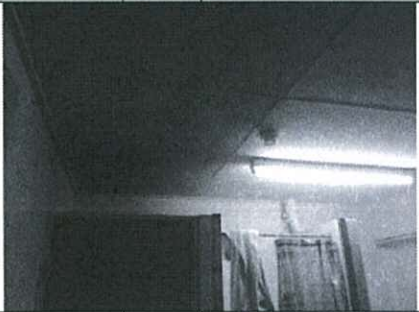
Building	Floor Level	Room	Asbestos in Room	Type	Condition	Priority	Sample No.	Result	Previous Photo
26/11/2016			No change in the condition of this item.		G	L

Clark Wing	GL	Bathrooms	Asbestos cement sheeting to front of partition walls.	NF	G	L	S5748	CH

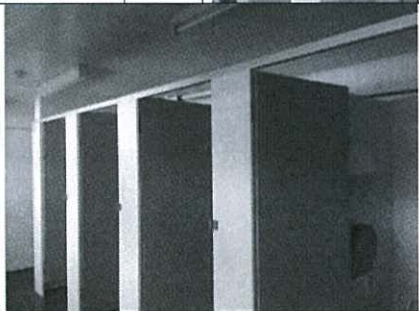
26/11/2016			No change in the condition of this item.		G	L

Clark Wing	GL	Bathrooms	Asbestos cement sheeting to wall behind mirror.	NF	G	L	S5742	CH

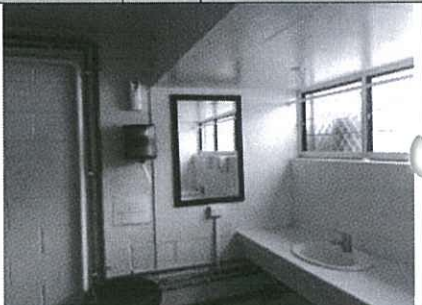
Building	Floor Level	Room	Asbestos in Room	Type	Condition	Priority	Sample No.	Result	Previous Photo
26/11/2016			No change in the condition of this item.		G	L

Clark Wing	GL	Bathrooms	Asbestos cement sheeting to front of partition walls.	NF	G	L	S5742	CH

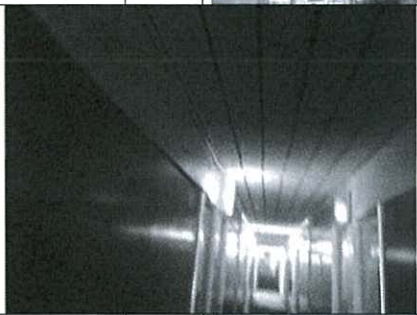
Clark Wing	GL	Hallway	Asbestos cement sheeting to walls above each unit from Unit 4 to Unit 22 internal and external.	NF	G	L	E3186	CH

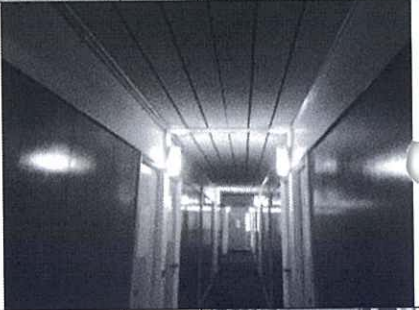
Building	Floor Level	Room	Asbestos In Room	Type	Condition	Priority	Sample No.	Result	Previous Photo
26/11/2016			No change in the condition of this item.		G	L

Clark Wing	1st	East Balcony	Assumed Asbestos cement sheeting to ceiling and walls over balcony.	NF	G N	L	E3185	CH

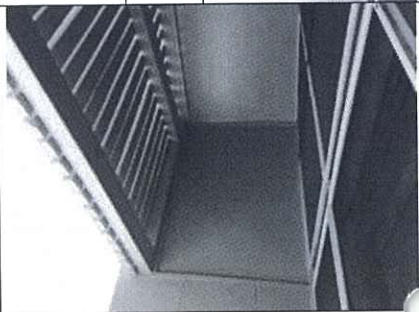
26/11/2016			No change in the condition of this item.		G N	L

Clark Wing	1st	Bathrooms	Asbestos cement sheeting to front of partition walls.	NF	G	L	S5742	CH

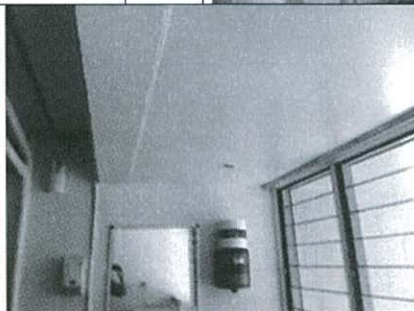
Building	Floor Level	Room	Asbestos in Room	Type	Condition	Priority	Sample No.	Result	Previous Photo
Clark Wing	1st	Room 23	Asbestos spray material to metal ceiling.	NF	G	L	E3184	CH

26/11/2016		No change in the condition of this item.			G	L

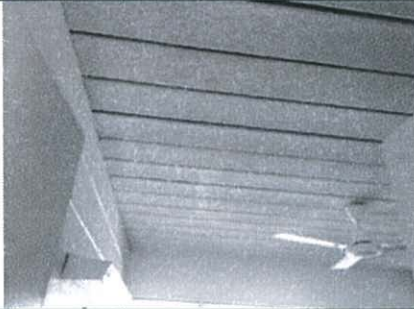
Clark Wing	GL	Room 24	Asbestos cement sheeting to walls above window and door.	NF	G	L	E3185	CH	
27/11/2014			No change in the condition of this item.		G	L

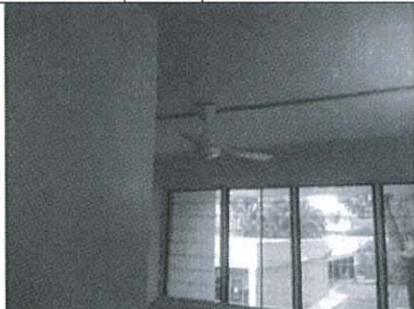
Clark Wing	1st	Room 25	Asbestos spray material to metal ceiling.	NF	G	L	E3184	CH

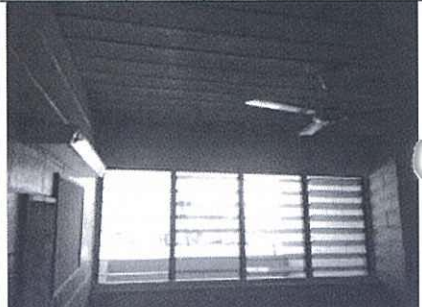
Clark Wing	GL	Room 25	Asbestos cement sheeting to walls above window and door.	NF	G	L	E3185	CH	
26/11/2016			No change in the condition of this item.		G	L			
Clark Wing	1st	Room 26	Asbestos spray material to metal ceiling.	NF	G	L	E3184	CH

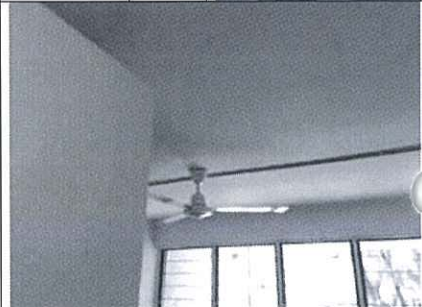
Building	Floor Level	Room	Asbestos In Room	Type	Condition	Priority	Sample No.	Result	Previous Photo
Clark Wing	GL	Room 26	Asbestos cement sheeting to walls above window and door.	NF	G	L	E3185	CH	
26/11/2016		No change in the condition of this item.			G	L			
Clark Wing	1st	Room 27	Asbestos spray material to metal ceiling.	NF	G	L	E3184	CH

26/11/2016		No change in the condition of this item.			G	L

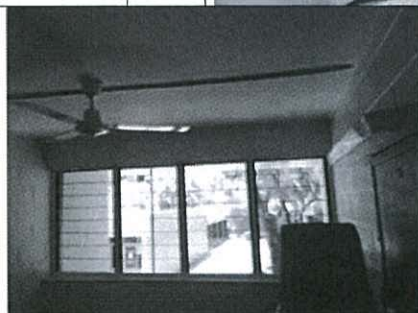
Clark Wing	GL	Room 27	Asbestos cement sheeting to walls above window and door.	NF	G	L	E3185	CH	
26/11/2016		No change in the condition of this item.			G	L			
Clark Wing	1st	Room 28	Asbestos cement sheeting to ceiling.	NF	G	L	E3185	CH

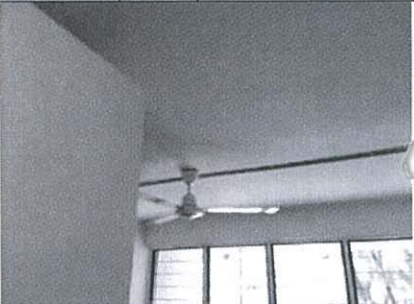
Building	Floor Level	Room	Asbestos In Room	Type	Condition	Priority	Sample No.	Result	Previous Photo
26/11/2016			No change in the condition of this item.		G	L

Clark Wing	1st	Room 28	Asbestos cement sheeting to walls above window and door.	NF	G	L	E3185	CH

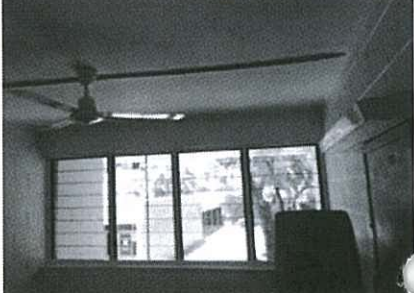
Building	Floor Level	Room	Asbestos in Room	Type	Condition	Priority	Sample No.	Result	Previous Photo
Clark Wing	1st	Room 29	Asbestos spray material to metal ceiling.	NF	G	L	E3184	CH

25/11/2016		No change in the condition of this item.			G	L

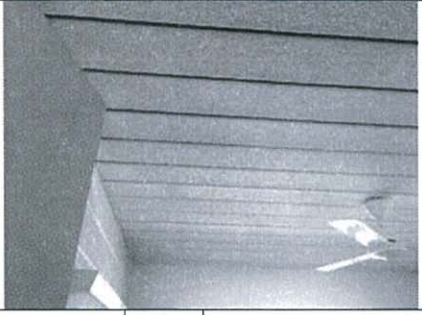
Clark Wing	1st	Room 29	Asbestos cement sheeting to walls above window and door.	NF	G	L	E3185	CH	
26/11/2016		No change in the condition of this item.			G	L

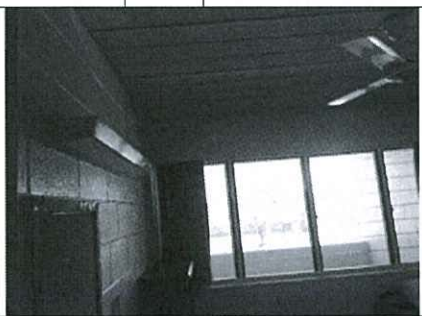
Building	Floor Level	Room	Asbestos in Room	Type	Condition	Priority	Sample No.	Result	Previous Photo
Clark Wing	1st	Room 30	Asbestos cement sheeting to ceiling.	NF	G	L	E3185	CH

26/11/2016		No change in the condition of this item.			G	L

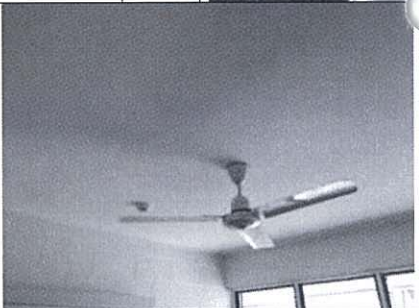
Clark Wing	1st	Room 30	Asbestos cement sheeting to walls above window and door.	NF	G	L	E3185	CH

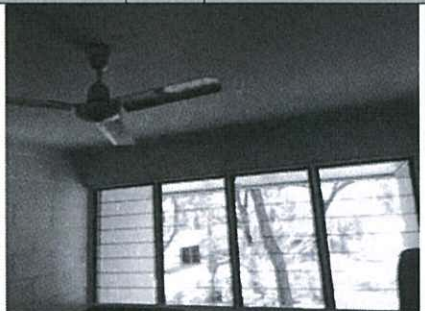
Building	Floor Level	Room	Asbestos in Room	Type	Condition	Priority	Sample No.	Result	Previous Photo
26/11/2016			No change in the condition of this item.		G	L

Clark Wing	1st	Room 31	Asbestos spray material to metal ceiling.	NF	G	L	E3184	CH

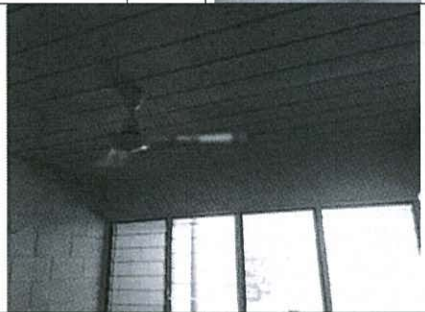
26/11/2016			No change in the condition of this item.		G	L

Clark Wing	1st	Room 31	Asbestos cement sheeting to walls above window and door.	NF	G	L	E3185	CH

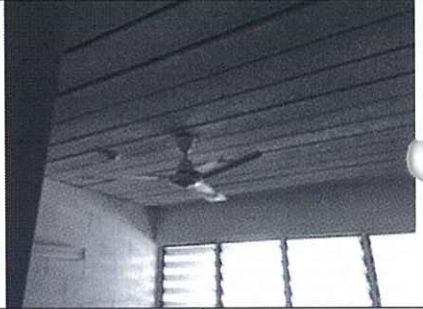
Clark Wing	1st	Room 32	Asbestos cement sheeting to ceiling.	NF	G	L	E3185	CH	No Photo Available
26/11/2016			No change in the condition of this item.		G	L

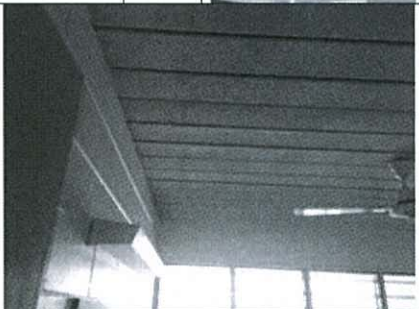
26/11/2016			No change in the condition of this item.		G	L

Clark Wing	1st	Room 33	Asbestos cement sheeting to walls above window and door.	NF	G	L	E3185	CH

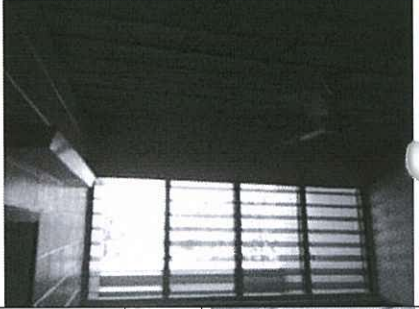
Building	Floor Level	Room	Asbestos In Room	Type	Condition	Priority	Sample No.	Result	Previous Photo
26/11/2016			No change in the condition of this item.		G	L

Clark Wing	1st	Common room	Asbestos cement sheeting to ceiling.	NF	G	L	E3185	CH

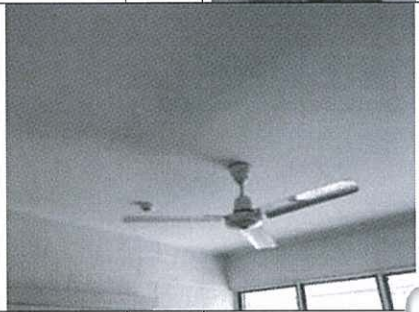
26/11/2016			No change in the condition of this item.		G	L

Clark Wing	1st	Common Room	Asbestos cement sheeting to walls above window and door.	NF	G	L	E3185	CH

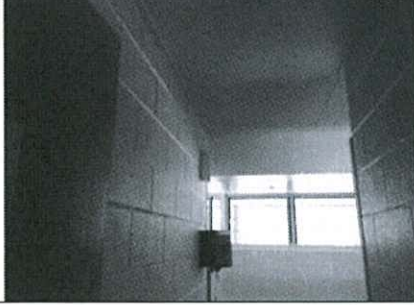
Building	Floor Level	Room	Asbestos in Room	Type	Condition	Priority	Sample No.	Result	Previous Photo
Clark Wing	1st	Room 34	Asbestos cement sheeting to ceiling.	NF	G	L	E3185	CH

26/11/2016		No change in the condition of this item.			G	L

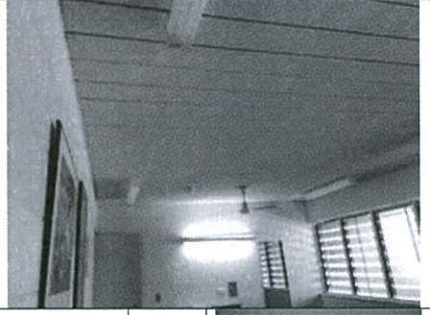
Clark Wing	1st	Room 36	Asbestos cement sheeting to ceiling.	NF	G	L	E3185	CH

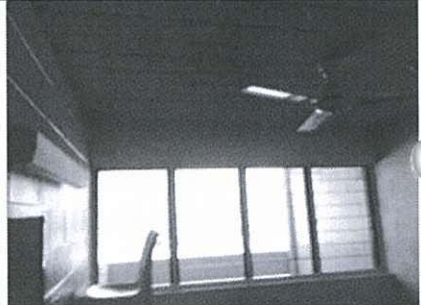
Building	Floor Level	Room	Asbestos in Room	Type	Condition	Priority	Sample No.	Result	Previous Photo
26/11/2016			No change in the condition of this item.		G	L

Clark Wing	1st	Room 36	Asbestos cement sheeting to walls above window and door.	NF	G	L	E3185	CH

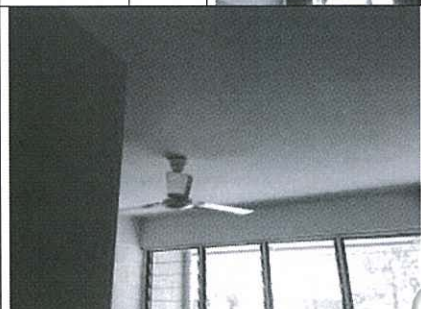
26/11/2016			No change in the condition of this item.		G	L

Clark Wing	1st	Room 37	Asbestos cement sheeting to walls above window and door.	NF	G	L	E3185	CH

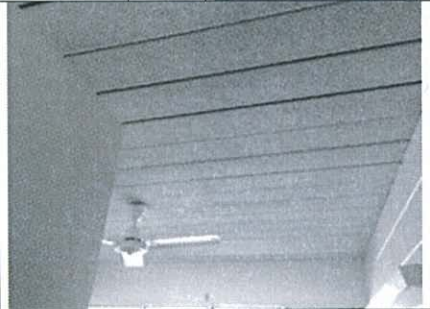
Building	Floor Level	Room	Asbestos In Room	Type	Condition	Priority	Sample No.	Result	Previous Photo
Clark Wing	1st	Room 38	Asbestos cement sheeting to ceiling.	NF	G	L	E3185	CH

26/11/2016		No change in the condition of this item.			G	L

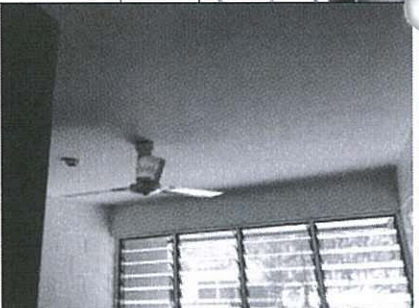
Clark Wing	1st	Room 38	Asbestos cement sheeting to walls above window and door.	NF	G	L	E3185	CH

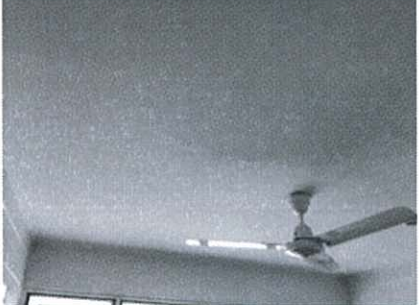
Building	Floor Level	Room	Asbestos in Room	Type	Condition	Priority	Sample No.	Result	Previous Photo
26/11/2016			No change in the condition of this item.		G	L

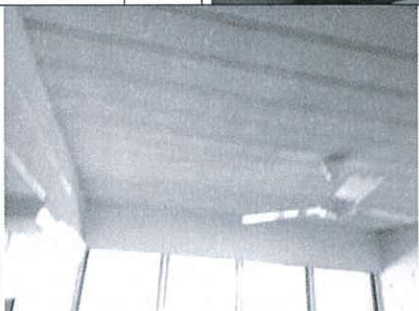
Clark Wing	1st	Room 39	Asbestos spray material to metal ceiling.	NF	G	L	E3184	CH

26/11/2016			No change in the condition of this item.		G	L

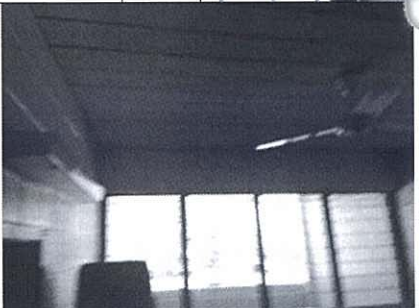
Building	Floor Level	Room	Asbestos in Room	Type	Condition	Priority	Sample No.	Result	Previous Photo
Clark Wing	1st	Room 39	Asbestos cement sheeting to walls above window and door.	NF	G	L	E3185	CH

26/11/2016		No change in the condition of this item.			G	L

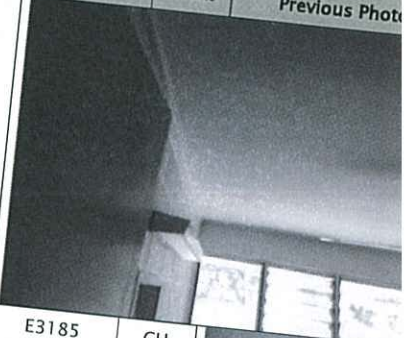
Clark Wing	1st	Room 40	Asbestos cement sheeting to ceiling.	NF	G	L	E3185	CH

Building	Floor Level	Room	Asbestos In Room	Type	Condition	Priority	Sample No.	Result	Previous Photo
26/11/2016			No change in the condition of this item.		G	L

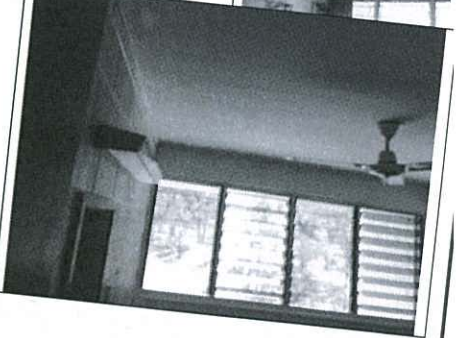
Clark Wing	1st	Room 40	Asbestos cement sheeting to walls above window and door.	NF	G	L	E3185	CH

26/11/2016			No change in the condition of this item.		G	L

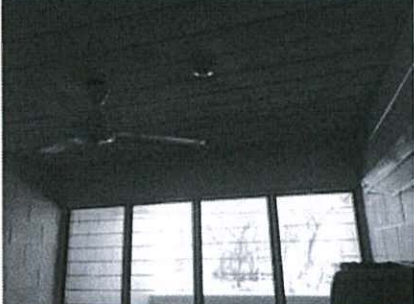
Clark Wing	1st	Room 41	Asbestos cement sheeting to walls above window and door.	NF	G	L	E3185	CH

Building	Floor Level	Room	Asbestos in Room	Type	Condition	Priority	Sample No.	Result	Previous Photo
26/11/2016			No change in the condition of this item.		G	L

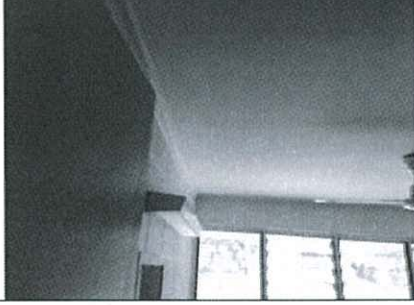
Clark Wing	1st	Room 42	Asbestos cement sheeting to ceiling.	NF	G	L	E3185	CH

26/11/2016			No change in the condition of this item.		G	L

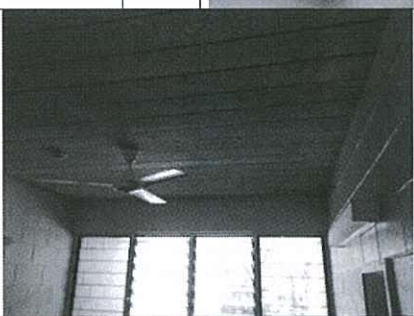
26/11/2016		No change in the condition of this item.			G	L			
Clark Wing	1st	Room 43	Asbestos spray material to metal ceiling.	NF	G	L	E3184	CH

26/11/2016		No change in the condition of this item.			G	L

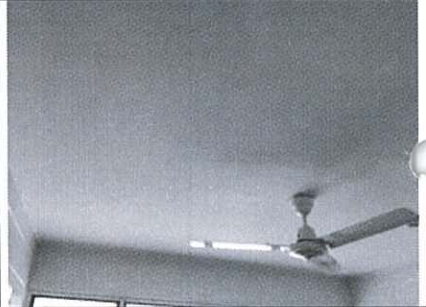
26/11/2016	No change in the condition of this item.				G	L			
Clark Wing	1st	Room 45 – rear room	Asbestos cement sheeting to ceiling.	NF	G	L	E3185	CH

Building	Floor Level	Room	Asbestos In Room	Type	Condition	Priority	Sample No.	Result	Previous Photo
26/11/2016			No change in the condition of this item.		G	L

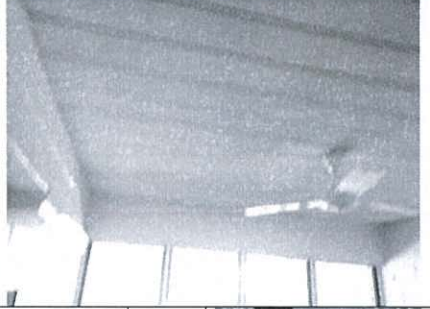
26/11/2016			No change in the condition of this item.		G	L			
Clark Wing	1st	Room 45	Asbestos spray material to metal ceiling.	NF	G	L	E3184	CH

Building	Floor Level	Room	Asbestos in Room	Type	Condition	Priority	Sample No.	Result	Previous Photo
26/11/2016			No change in the condition of this item.		G	L

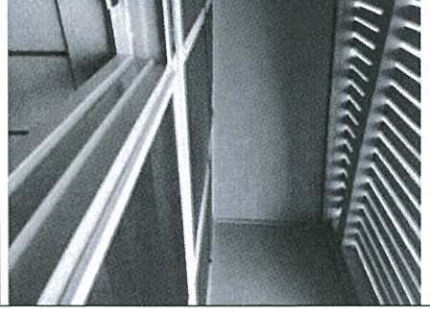
Clark Wing	1st	Balcony – West elevation	Asbestos cement sheeting to ceiling and walls panels.	NF	G	L	E3185	CH

26/11/2016			No change in the condition of this item.		G	L

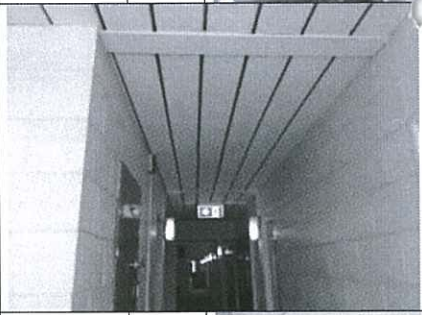
Building	Floor Level	Room	Asbestos in Room	Type	Condition	Priority	Sample No.	Result	Previous Photo
Clark Wing	1st	Hallway	Asbestos spray material to metal ceiling (east and west sections).	NF	G	L	E3184	CH

26/11/2016		No change in the condition of this item.			G	L

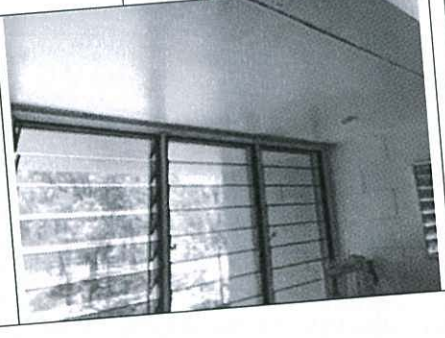
Clark Wing	1st	Bathroom	Asbestos cement sheeting to ceiling.	NF	G	L	E3185	CH

26/11/2016			No change in the condition of this item.		G	L

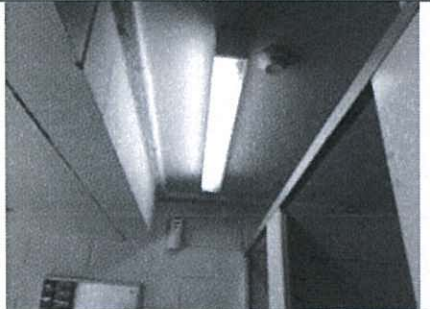
Clark Wing	1st	Bathroom	Asbestos cement sheeting to ceiling.	NF	G	L	E3185	CH

Building	Floor Level	Room	Asbestos in Room	Type	Condition	Priority	Sample No.	Result	Previous Photo
26/11/2016			No change in the condition of this item.		G	L

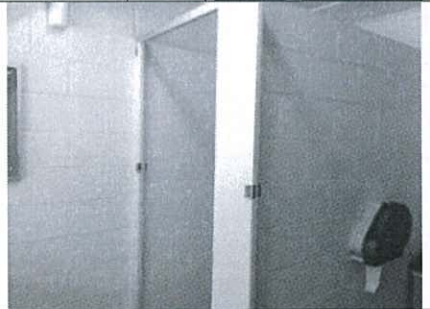
Clark Wing	1st	Bathroom	Asbestos cement partition to walls.	NF	G	L	E3185	CH

26/11/2016			No change in the condition of this item.		G	L

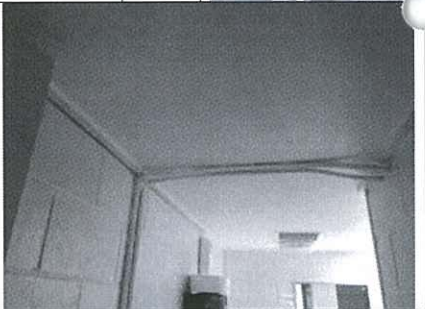
Building	Floor Level	Room	Asbestos In Room	Type	Condition	Priority	Sample No.	Result	Previous Photo
Clark Wing	2nd	Bathroom	Asbestos cement sheeting to ceiling.	NF	G	L	E3210	CH

26/11/2016		No change in the condition of this item.			G	L

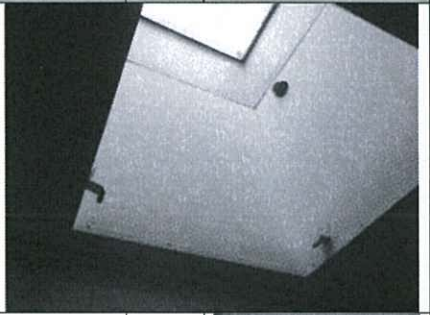
Clark Wing	2nd	Middle Bathroom	Asbestos cement sheeting to ceiling and walls of skylight.	NF	G	L	E3210	CH

Building	Floor Level	Room	Asbestos in Room	Type	Condition	Priority	Sample No.	Result	Previous Photo
26/11/2016			No change in the condition of this item.		G	L

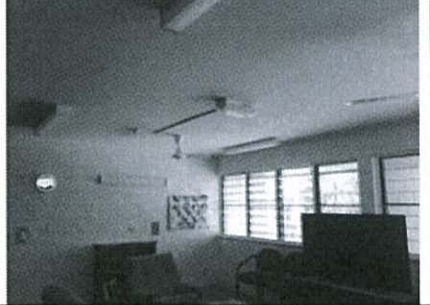
Clark Wing	2nd	Common room	Asbestos cement sheeting to ceiling.	NF	G	L	E3210	CH

26/11/2016			No change in the condition of this item.		G	L

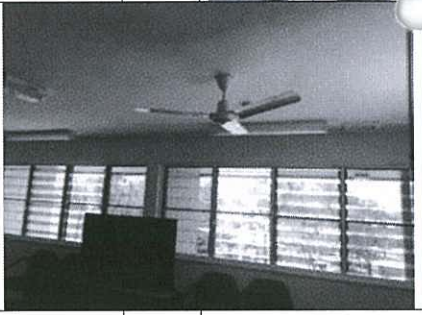
Building	Floor Level	Room	Asbestos in Room	Type	Condition	Priority	Sample No.	Result	Previous Photo
Clark Wing	2nd	Common room	Asbestos cement sheeting to walls above window and door.	NF	G	L	E3210	CH

26/11/2016		No change in the condition of this item.			G	L

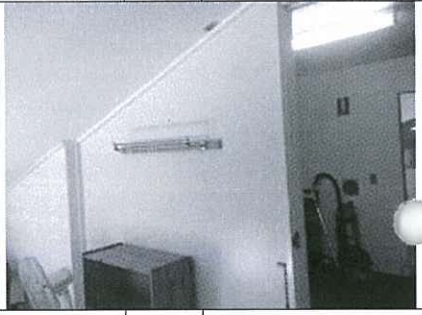
Clark Wing	2nd	Room 58	Asbestos cement sheeting to non masonry walls.	NF	G	L	E3210	CH	
26/11/2016		No change in the condition of this item.			G	L

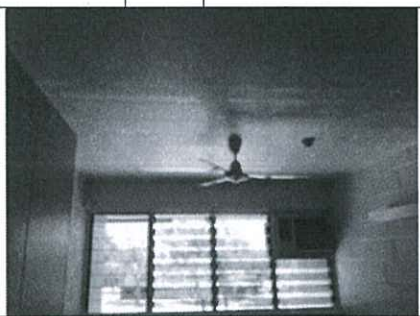
Clark Wing	2nd	Room 58	Asbestos cement sheeting to walls	NF	G	L	E3210	CH

Building	Floor Level	Room	Asbestos in Room	Type	Condition	Priority	Sample No.	Result	Previous Photo
			above window and door.						
26/11/2016			No change in the condition of this item.		G	L

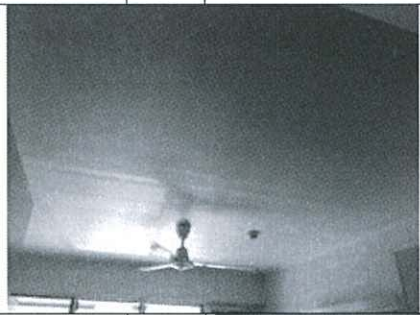
Clark Wing	2nd	Room 58	Asbestos cement sheeting to ceiling.	NF	G	L	E3210	CH	
26/11/2016			No change in the condition of this item.		G	L

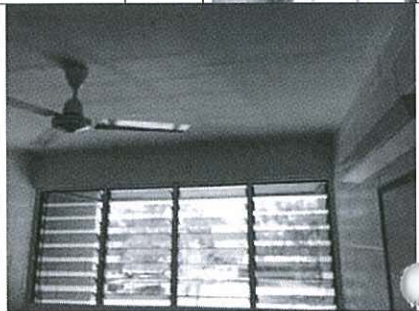
Clark Wing	2nd	Room 46	Asbestos cement sheeting to walls above window and door.	NF	G	L	E3210	CH

26/11/2016			No change in the condition of this item.		G	L

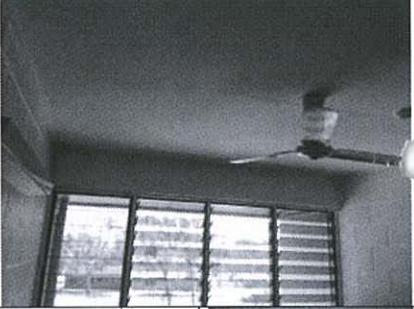
Clark Wing	2nd	Room 47	Asbestos cement sheeting to walls above window and door.	NF	G	L	E3210	CH

Building	Floor Level	Room	Asbestos in Room	Type	Condition	Priority	Sample No.	Result	Previous Photo
26/11/2016			No change in the condition of this item.		G	L

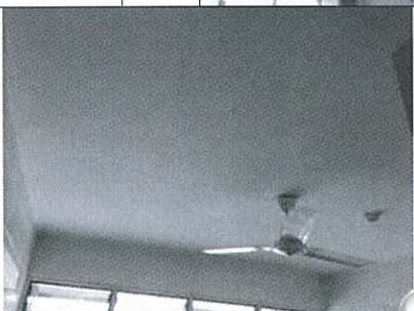
Clark Wing	2nd	Room 48	Asbestos cement sheeting to ceiling.	NF	G	L	E3210	CH

26/11/2016			No change in the condition of this item.		G	L

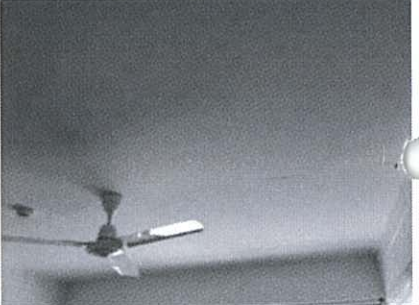
Clark Wing	2nd	Room 49	Asbestos cement sheeting to ceiling.	NF	G	L	E3210	CH

Building	Floor Level	Room	Asbestos in Room	Type	Condition	Priority	Sample No.	Result	Previous Photo
26/11/2016			No change in the condition of this item.		G	L

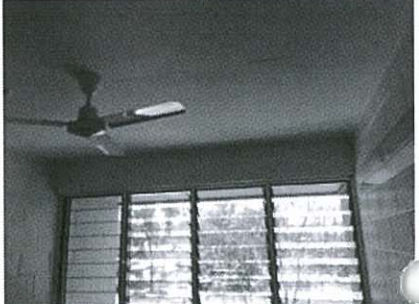
Clark Wing	2nd	Room 49	Asbestos cement sheeting to walls above window and door.	NF	G	L	E3210	CH

26/11/2016			No change in the condition of this item.		G	L

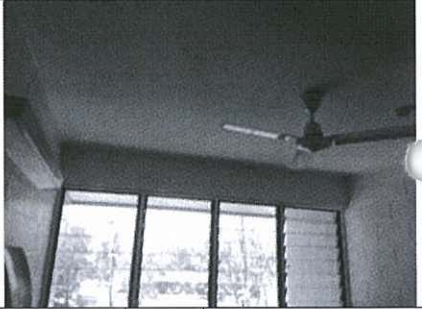
Clark Wing	2nd	Room 50	Asbestos cement sheeting to walls above window and door.	NF	G	L	E3210	CH

Building	Floor Level	Room	Asbestos In Room	Type	Condition	Priority	Sample No.	Result	Previous Photo
26/11/2016		No change in the condition of this item.			G	L

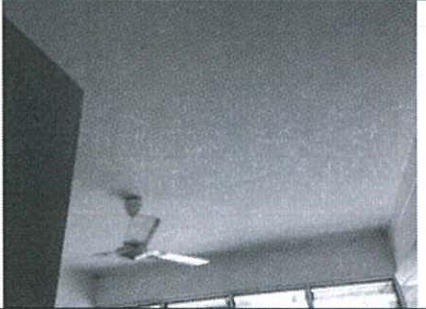
26/11/2016		No change in the condition of this item.			G	L			
Clark Wing	2nd	Room 51	Asbestos cement sheeting to ceiling.	NF	G	L	E3210	CH

Building	Floor Level	Room	Asbestos In Room	Type	Condition	Priority	Sample No.	Result	Previous Photo
26/11/2016			No change in the condition of this item.		G	L

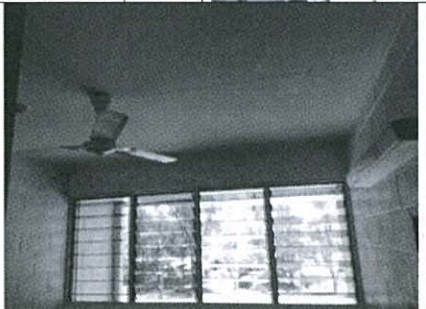
Clark Wing	2nd	Room 51	Asbestos cement sheeting to walls above window and door.	NF	G	L	E3210	CH

26/11/2016			No change in the condition of this item.		G	L

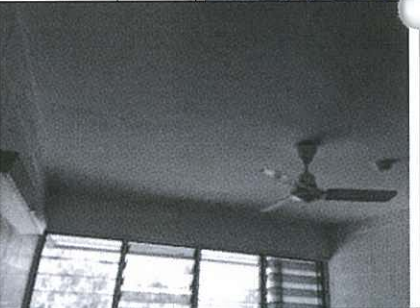
Building	Floor Level	Room	Asbestos In Room	Type	Condition	Priority	Sample No.	Result	Previous Photo
Clark Wing	2nd	Room 52	Asbestos cement sheeting to ceiling.	NF	G	L	E3210	CH

26/11/2016		No change in the condition of this item.			G	L

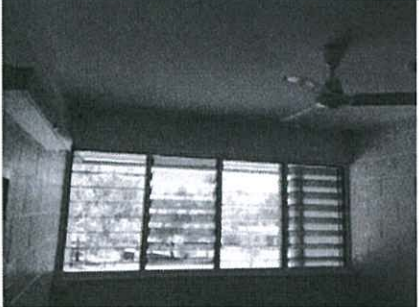
Clark Wing	2nd	Room 52	Asbestos cement sheeting to walls above window and door.	NF	G	L	E3210	CH

Building	Floor Level	Room	Asbestos in Room	Type	Condition	Priority	Sample No.	Result	Previous Photo
26/11/2016			No change in the condition of this item.		G	L

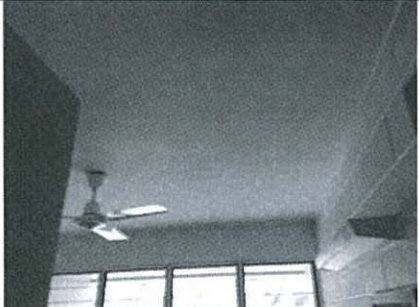
26/11/2016			No change in the condition of this item.		G	L

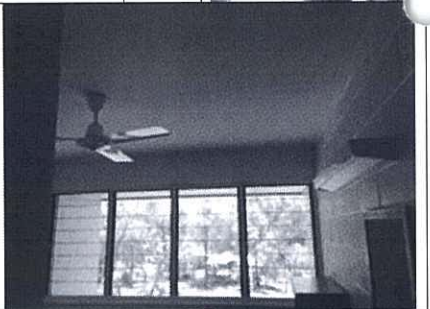
Building	Floor Level	Room	Asbestos In Room	Type	Condition	Priority	Sample No.	Result	Previous Photo
Clark Wing	2nd	Room 53	Asbestos cement sheeting to walls above window and door.	NF	G	L	E3210	CH

26/11/2016		No change in the condition of this item.			G	L

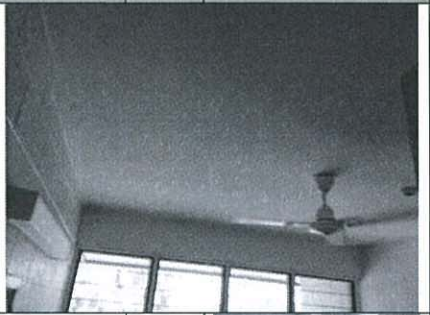
Clark Wing	2nd	Room 54	Asbestos cement sheeting to ceiling.	NF	G	L	E3210	CH

Building	Floor Level	Room	Asbestos in Room	Type	Condition	Priority	Sample No.	Result	Previous Photo
26/11/2016			No change in the condition of this item.		G	L

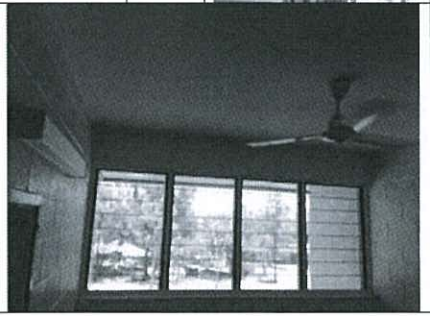
Clark Wing	2nd	Room 54	Asbestos cement sheeting to walls above window and door.	NF	G	L	E3210	CH

26/11/2016			No change in the condition of this item.		G	L

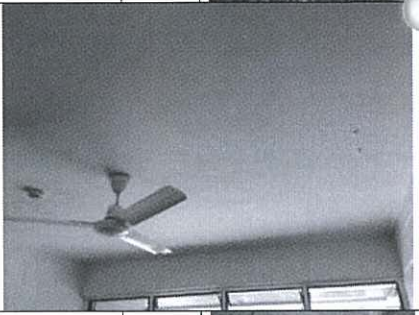
Building	Floor Level	Room	Asbestos in Room	Type	Condition	Priority	Sample No.	Result	Previous Photo
Clark Wing	2nd	Room 55	Asbestos cement sheeting to ceiling.	NF	G	L	E3210	CH

26/11/2016		No change in the condition of this item.			G	L

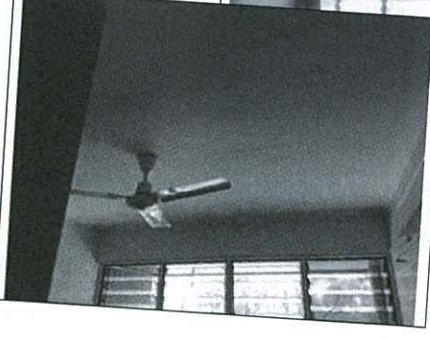
Clark Wing	2nd	Room 56	Asbestos cement sheeting to ceiling.	NF	G	L	E3210	CH

26/11/2016			No change in the condition of this item.		G	L

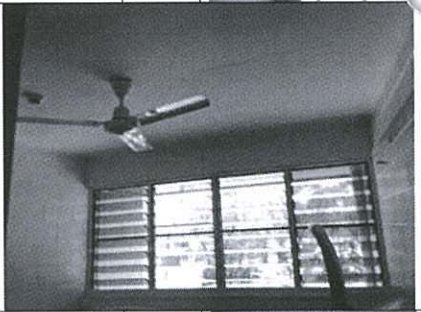
Building	Floor Level	Room	Asbestos in Room	Type	Condition	Priority	Sample No.	Result	Previous Photo
Clark Wing	2nd	Room 56	Asbestos cement sheeting to walls above window and door.	NF	G	L	E3210	CH

26/11/2016		No change in the condition of this item.			G	L

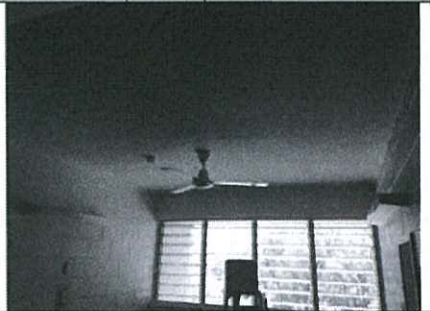
Clark Wing	2nd	Room 57	Asbestos cement sheeting to ceiling throughout.	NF	G	L	E3210	CH

Building	Floor Level	Room	Asbestos in Room	Type	Condition	Priority	Sample No.	Result	Previous Photo
26/11/2016			No change in the condition of this item.		G	L

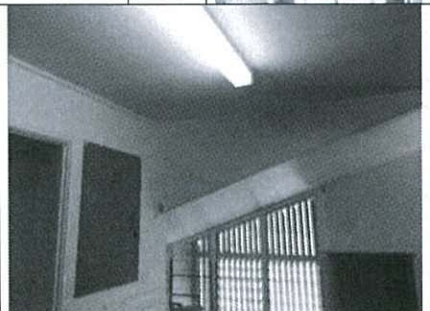
Clark Wing	2nd	Room 57	Asbestos cement sheeting to walls above window and door and non masonry walls throughout.	NF	G	L	E3210	CH

26/11/2016			No change in the condition of this item.		G	L

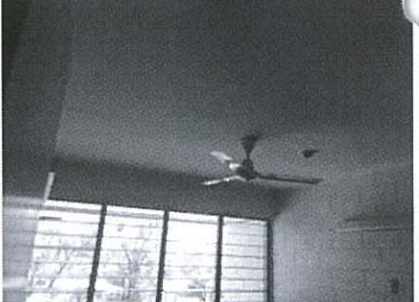
Building	Floor Level	Room	Asbestos In Room	Type	Condition	Priority	Sample No.	Result	Previous Photo
Clark Wing	2nd	Room 57 common area	Asbestos cement sheeting to wall above and beside windows	NF	G	L	E3210	CH

26/11/2016		No change in the condition of this item.			G	L

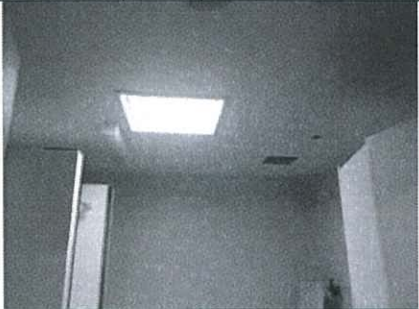
Clark Wing	2nd	Room 57 bathroom	Asbestos cement sheeting to ceiling.	NF	G	L	E3210	CH

Building	Floor Level	Room	Asbestos in Room	Type	Condition	Priority	Sample No.	Result	Previous Photo
26/11/2016			No change in the condition of this item.		G	L

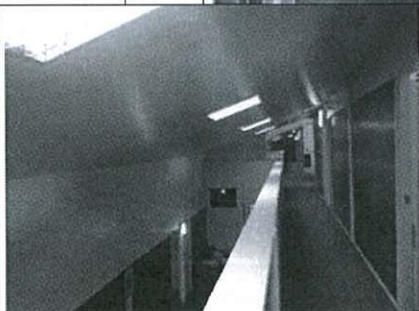
Clark Wing	2nd	Hallway	Asbestos cement sheeting to walls above panels.	NF	G	L	E3210	CH

26/11/2016			No change in the condition of this item.		G	L

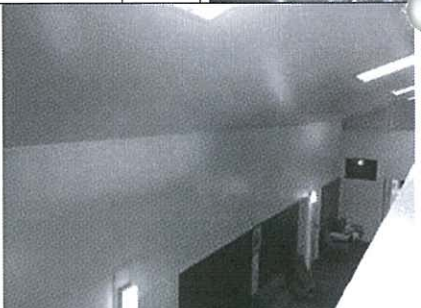
Building	Floor Level	Room	Asbestos In Room	Type	Condition	Priority	Sample No.	Result	Previous Photo
Clark Wing	2nd	Hallway	Asbestos cement sheeting to ceiling.	NF	G	L	E3210	CH

26/11/2016		No change in the condition of this item.			G	L
