Tropical Cyclone Damien Damage to buildings in the Pilbara Region of WA

CTS Technical Report No 65

Tropical Cyclone Damien Damage to buildings in the Pilbara Region of Western Australia

This edition: 28 February 2020

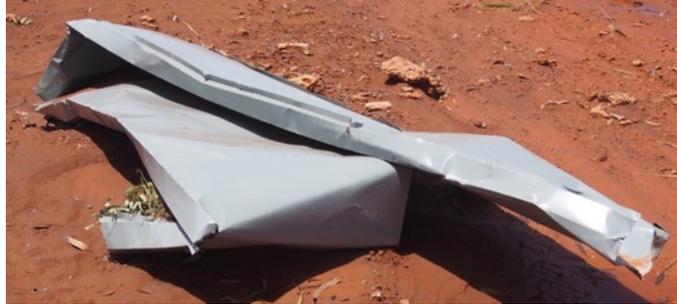
(b) Detached parapet flashing

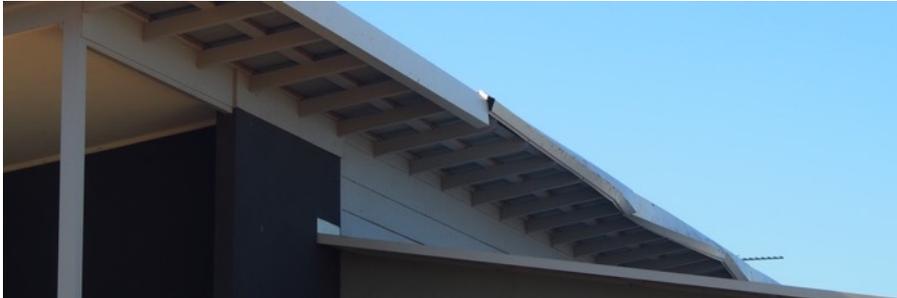
(d) Lifted barge flashing on a contemporary house
