2024 Severe storms in Bunbury, WA Damage to Houses

CTS Technical Report No 68

TECHNICAL REPORT NO. 68

2024 Severe Storms in Bunbury, WA

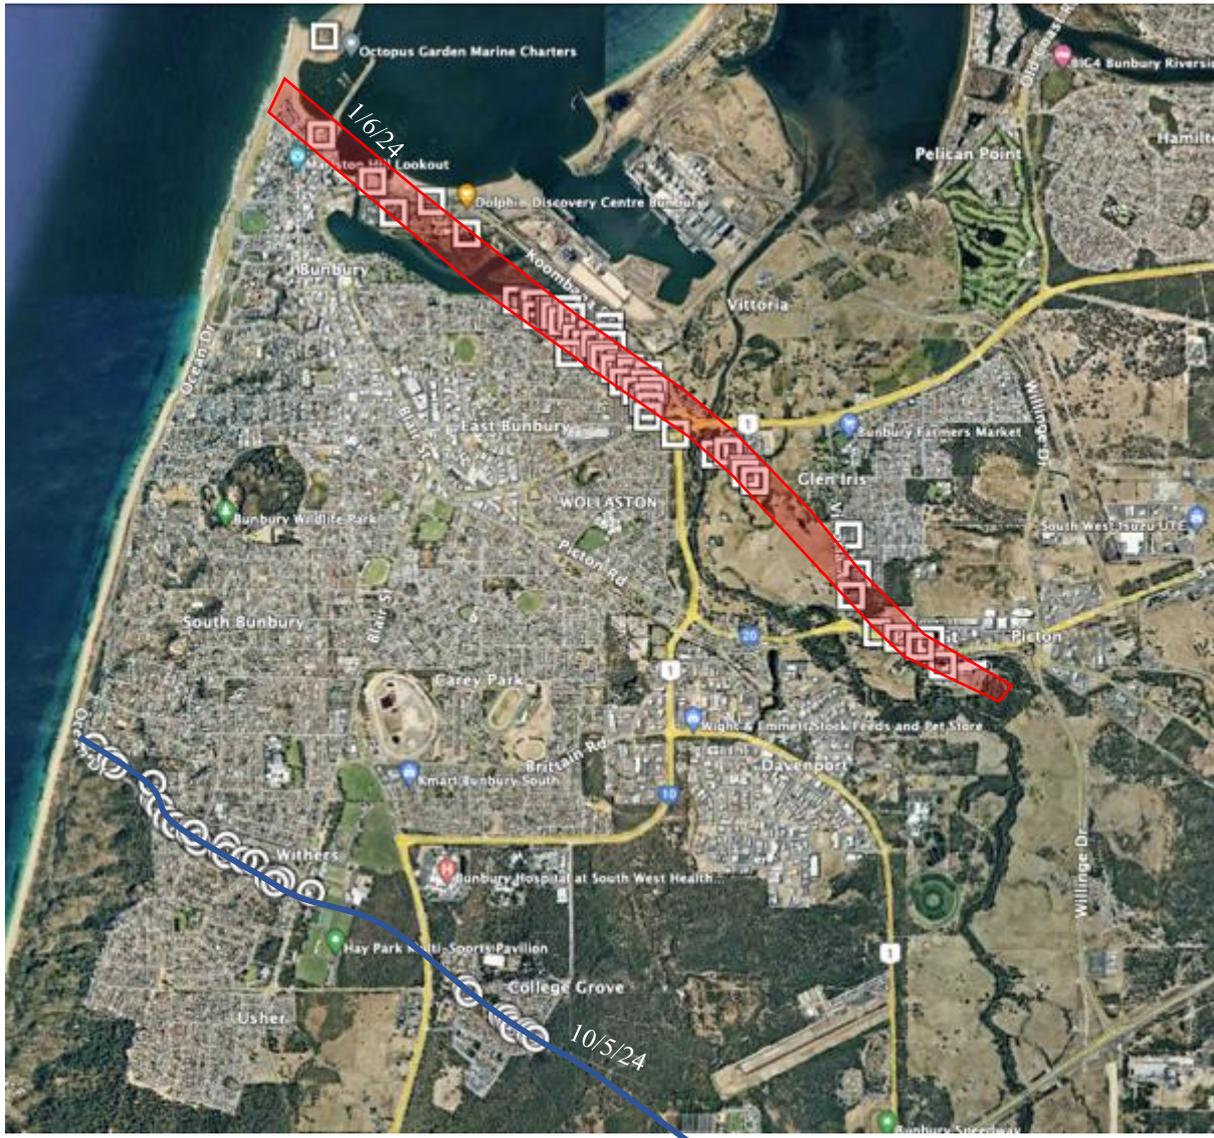
Figure 1-3 Buildings extensively damaged in the two 2024 Bunbury storm events showing their paths

- The locations of extensively damaged buildings in the 10/5/2024 tornado are shown with circles, with the path of the tornado shown in blue. The path of damage was estimated to be around 40 to 60 m wide. The level of damage was consistent along the path.
- Buildings with at least moderate damage in the 1/6/2024 downburst are shown with squares and the damaged area highlighted in red. The path of the damage was estimated to be between 300 and 500 m wide.

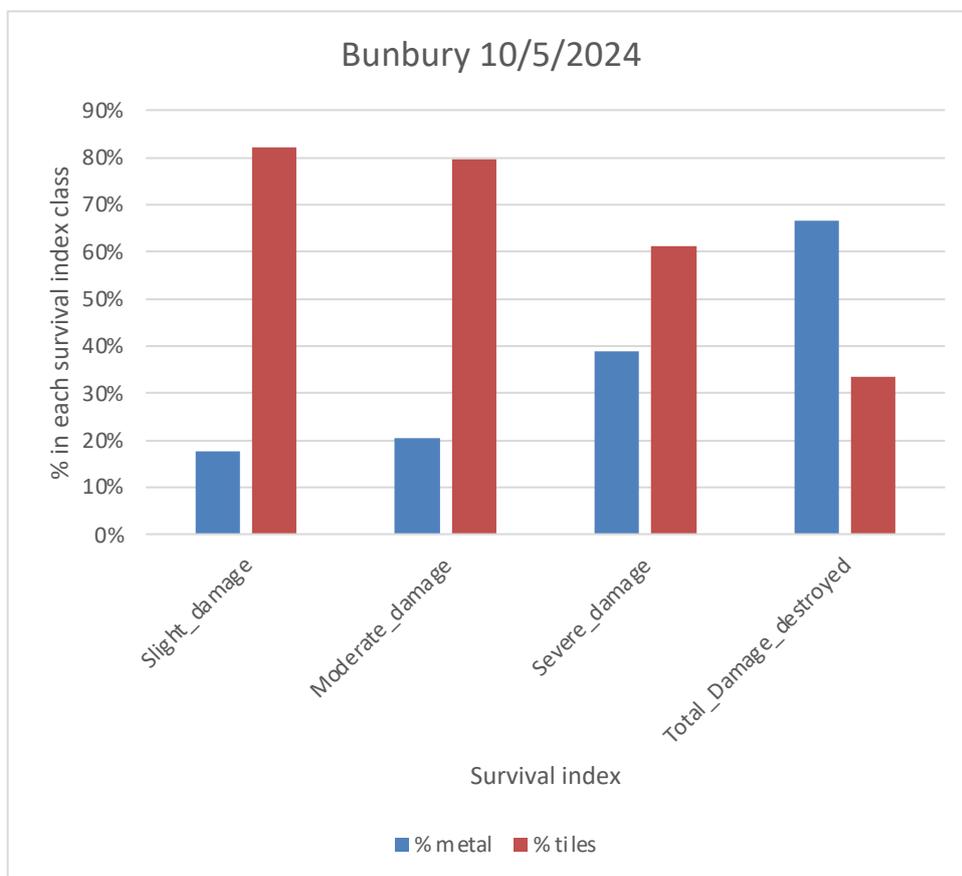
Figure 4-2 Percentage of roofs that were damaged and either metal or tile.

Around 10% of the houses in the affected area had metal roofs (estimated from Google Earth imagery). The percentage of damaged roofs that were metal increased with the damage level, as shown in Figure 4-2. This indicates that lightweight roofs were more susceptible to total loss, and tile roofs were more susceptible to loss of individual tiles or small areas of roof tiles.

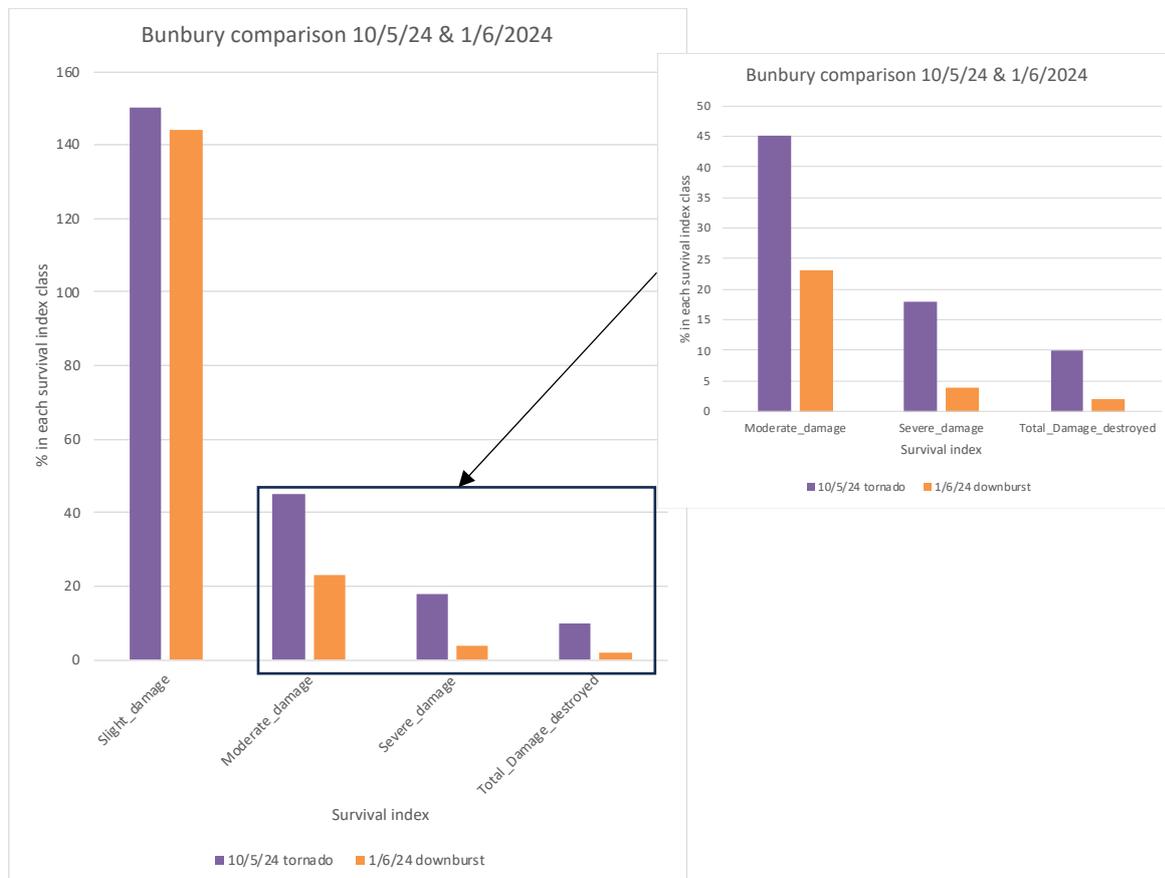
Figure 4-3 Comparison of Damage Assessment results for the 10/5/24 tornado and the 1/6/24 downburst.

Comparing the results in Table 1 for the 10/5/2024 tornado with the results in Table 2 for the 1/6/2024 downburst, it can be seen that there are significantly more houses with severe and total damage in the tornado compared with the downburst. The area impacted in the downburst is significantly larger as shown in Figure 1-3. The smaller number of buildings damaged is a function of the lower wind speed in the downburst compared with the tornado. The wind speeds in the downburst were estimated at 75% of the wind speeds in the tornado which means the wind loads in the downburst were around 50% of the wind loads in the tornado.

The comparison of the numbers of buildings at each damage level are shown in Figure 4-3. The inset shows a magnification of the more severe levels of damage. While there is little difference at the slight damage level, there is a more significant difference at the higher levels of damage.
