## Cyclone Ingrid

Cyclone Ingrid was classified as an extremely destructive Category 5 cyclone, prior to crossing the coast at Croker Island. The CTS investigation focussed on the small community of Minjilang, located on Croker Island. The CTS team also inspected structures at Coburg Peninsula.

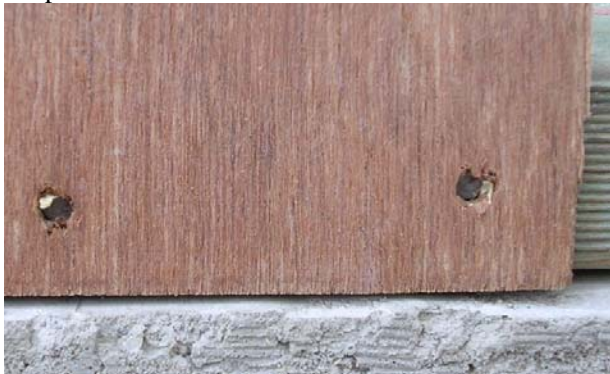
Panel bracing works through diaphragm action, in that the bracing forces are transferred between the house frame and the panel via the nails. In resisting the wind loads, if some thickness of panel has been lost from crushing from overdriving, the panel ruptures with the nails bursting through the edge. Overdriving or not leaving enough edge distance will cause premature failure of the panel as there is not enough 'meat' left in the panel.

The bracing capacities contained within AS1684 and product design guides are all derived from tests where

the fixings are installed as per the manufacturer's specifications (eg not overdriven).

An apparent fix for not overdriving using a nail gun involves setting the gun's depth adjustment (or for some guns buying and using the add-on depth adjustment fitting).

Please refer to the manufacturer's product data sheets for information on edge distances and correct fixing. **Remember a house is only as strong as its weakest link. Don't let it be you.**

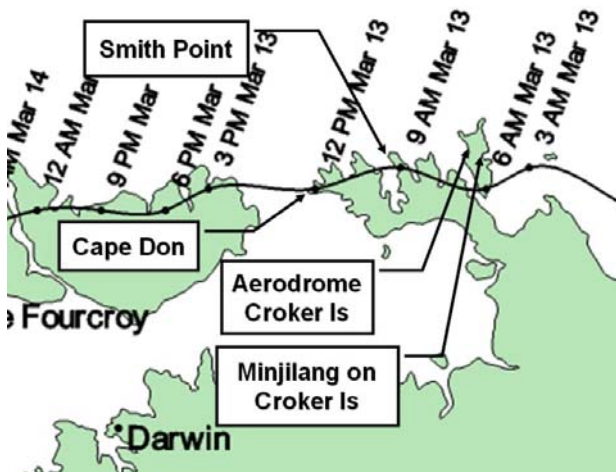
*Track of Cyclone Ingrid (from Bureau of Meteorology)*

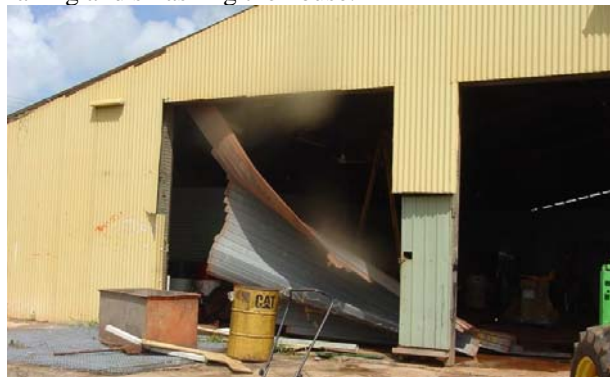
Even though observed damage levels were far lower than that from Cyclone Tracy, wind driven debris still posed a threat.

Roller door failures were noted. Along with damage to houses from attachments such as large awnings failing and smashing the house.
