Tropical Cyclone Seroja – Damage to buildings in the Mid-West Coastal Region of WA

CTS Technical Report No 66

**Tropical Cyclone Seroja
Damage to buildings in the
Mid-West Coastal Region of Western Australia**

Initial Release 28 May 2021
Revision released 3 June 2021

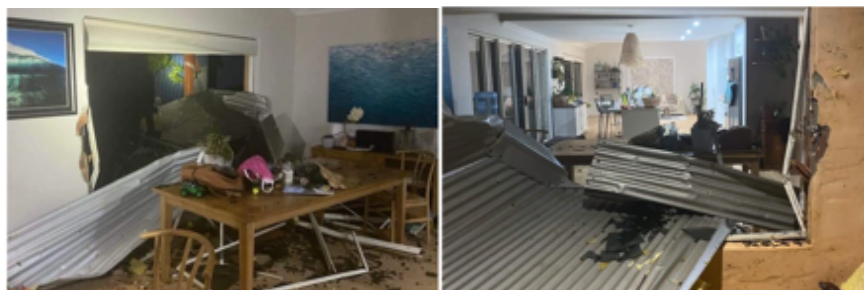
Figure 4-3 Examples of wind-borne debris

The wind-borne debris in this event included whole roofs, portions of roofs, verandas, and tree branches, similar to debris generated during cyclones in Wind Regions C and D. Parts of roof structures with sheeting attached were blown hundreds of metres. Some timber roofing elements speared into the ground or other houses. Figure 4-4 shows some of the damage caused to homes by wind-borne debris during TC Seroja. Many people were at risk of serious injury during this event.

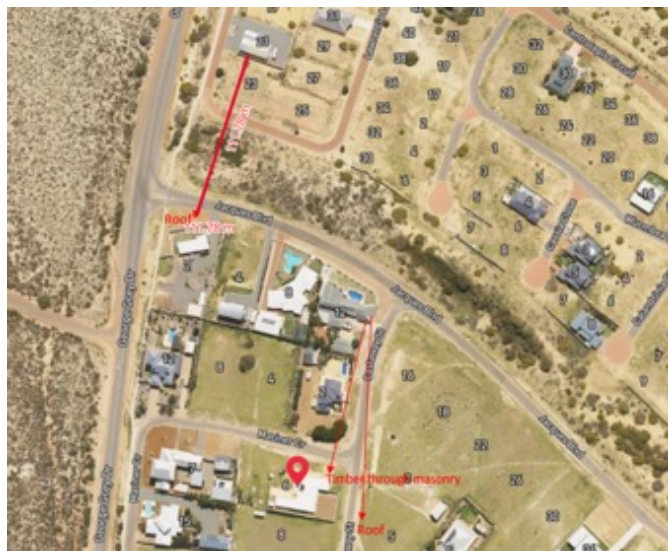
Figure 4-5 Debris trajectories

The trajectories of some of the larger items of debris were tracked (see Figure 4-5). Some debris was blown over two hundred metres, similar to observations during damage investigations in Wind Regions C and D.

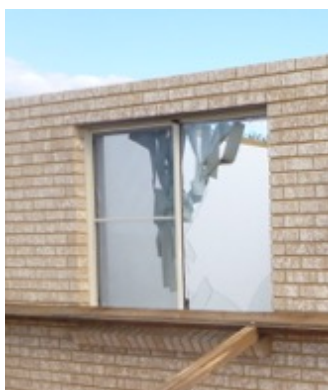
Figure 4-6 Broken window

Wind pressure or wind-borne debris broke windows or doors on the windward side of all the houses that the investigation team inspected where the whole roof was lost – Figure 4-6 shows an example. Also see Figure 4-7, Figure 4-22, Figure 4-25, Figure 4-28, Figure 4-31.

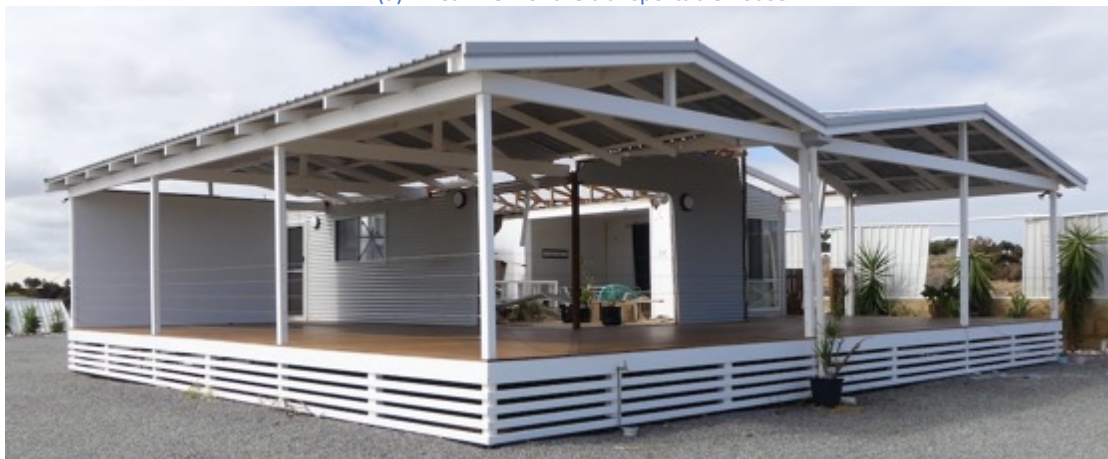
(b) Front view of transportable house showing verandas

Figure 4-11(a) shows a transportable house that had been positioned on site, refurbished, and surrounded by a veranda. The house lost its roof, but the verandas remained intact. The verandas (Figure 4-11(b)) had been specifically designed for the site, but the wind design of the original transportable house was unknown. Although the building had been refurbished and the quality of the finishes was high, it appeared that the structural details in the roof were the original ones and may not have been appropriate for the wind classification for the site.

Figure 4-11 Loss of house roof though large verandas remained

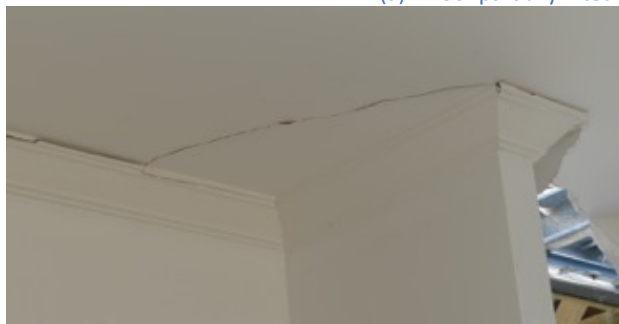
There were signs that the roofs of several houses had partially lifted off walls. An example is shown in Figure 4-12(a) and (b). These cases indicate that although the ultimate strength of the connections was sufficient, there was excessive deformation in the connections. In the house shown in Figure 4-12, the tiedown straps were angled to the outside of the building (highlighted by the red ellipse in Figure 4-12(c)), and they had cracked the outside upper courses of the external leaf when they straightened under uplift loads.

(b) Roof partially lifted off internal walls

Figure 4-12 Signs that the roof had lifted from the wall though not completely detached

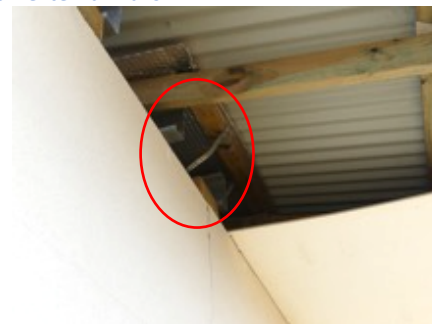
(c) Tie-down straps

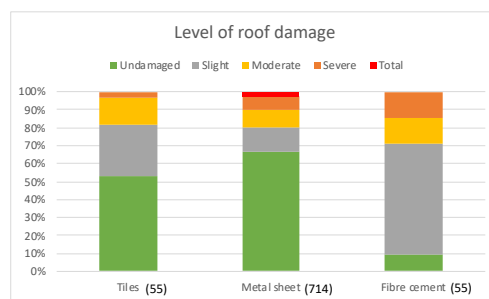
Figure 4-17 Comparison of damage to tile and sheet roofs

- No tile roofs had 'total damage', but many had 'slight' and 'moderate' levels of damage (44%).
- More metal sheet roofs were classified as 'undamaged' (66%) than tile roofs (53%).
- More metal sheet roofs were evaluated as 'severe' and 'total damage' (10%) than tile roofs (4%).
- Nearly all of the fibre cement roofs in Kalbarri suffered some damage, with around 30% 'moderate' or 'severe' (also refer to Section 5.4).

The damage to tile roofs was mainly the loss of individual tiles with the level of damage related to the area of tiles that were missing from the roof. There were no cases where all the tiles were blown off the roof. However, several entire metal sheet roofs failed at the wall connections. In most cases, the 'Total damage' and 'Severe damage' classifications represented the loss of the entire roof structure above the walls, as illustrated in Figure 4-7 and Figure 4-8. In other cases, the damage was the complete loss of the roofing with battens attached, as shown in Figure 5-2. There were many cases of metal sheet roofs with no damage or relatively minor damage. The 'Slight' damage to metal sheet roofs represented debris impact to the roof or damage at the edge of roofs.

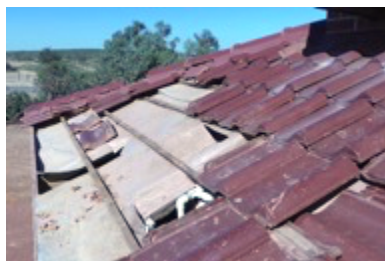
The tile battens were fixed to the rafters with 50 mm nails (AS 2050 specifies 65 mm nails). Some rafters were hardwood, and others softwood. The nails held in the hardwood rafters, but not the softwood rafters. The shorter nails had adequate withdrawal capacity in the hardwood rafters that have a higher joint strength group (likely JD2) but inadequate capacity for the softwood rafters with a lower joint strength group (JD5). The detachment of the tile battens was only observed on one house. In most cases where tile roofs were damaged, the tile battens remained fixed to the rafters, and individual tiles came off.

Only some of the tiles were nailed to the battens. Figure 4-21(a) shows an area of the roof where the tiles were sporadically fixed, and the tiles had separated from the battens. In other parts of the roof, each tile along a batten was nailed, and the battens lifted off the rafters, as shown in Figure 4-21(b). Note that just behind the white fascia in the lower quarter of the photo, all the tile battens are missing. This is also an area that has softwood rafters.

(a) Tile battens still attached to hardwood rafters

Figure 4-21 Tile batten to rafter connections

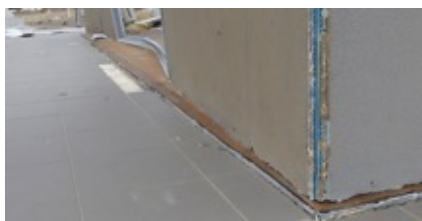
(a) Deflection at floor level

Walls on framed structures also showed signs of damage under the combined actions of external pressures and tensions induced by tie-downs. Figure 4-25(a) shows a steel-framed house, and Figure 4-25(b) shows a timber-framed house in which the windward walls had deflected inwards.

In Figure 4-25(a), the movement is obvious at the floor line. An inward deflection of around 150 mm was noted beside the large sliding door. The whole room had also moved upwards by 50 to 100 mm. These movements indicate that the connection between the wall and the floor was inadequate.

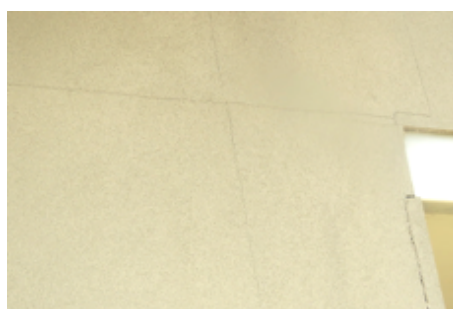
Figure 4-26 Movement cracks at panel joints

Several houses in the southern subdivisions of Kalbarri (Kalbarri C) had rendered magnesium oxide cladding. In several cases, the flexing of the house exposed the joints between the panels, as illustrated in Figure 4-26.

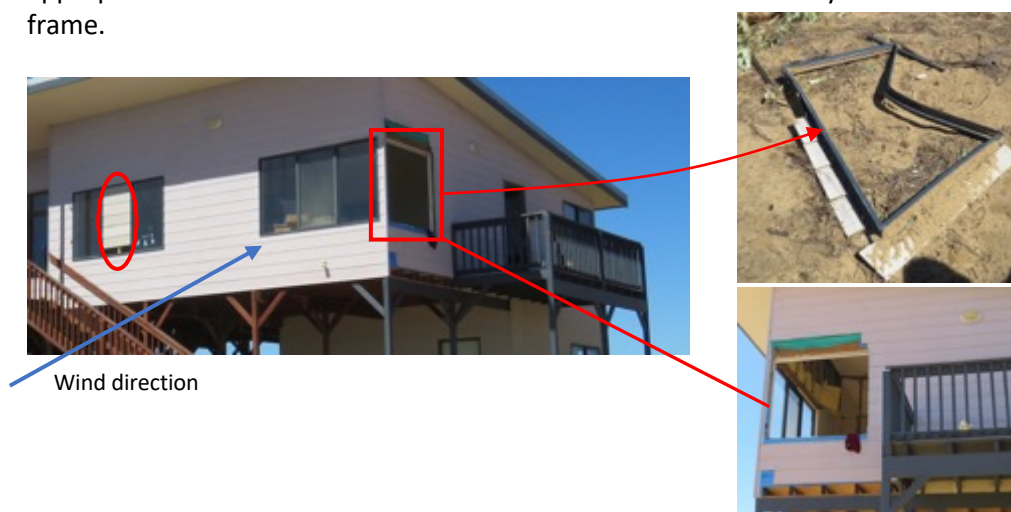
Figure 4-28 Loss of complete side window after a windward wall window broke

Figure 4-28 shows an elevated house in which a windward wall window broke (highlighted by an ellipse). The occupants had opened doors on the sidewalls of the house, so the increase in pressure was vented. However, a complete window and frame on a side wall were sucked out and landed around 50 metres away. It appeared that the window may not have been appropriate for the site Wind classification and had been incorrectly installed into the timber frame.

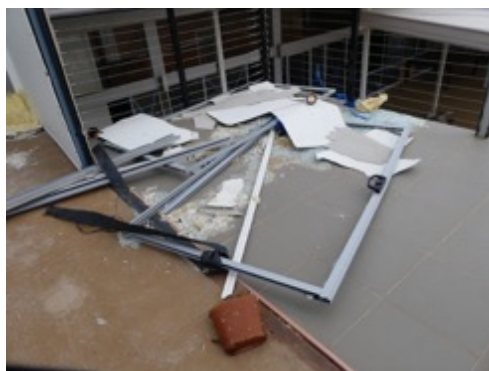
Figure 4-29 Detachment of glass sliding door frame under wind loads

The glass sliding doors shown in Figure 4-29 flexed under wind loads and distorted the sashes. Eventually, this led to the loss of both the sliding and fixed panels, and the increase in internal pressure led to the loss of the roof.

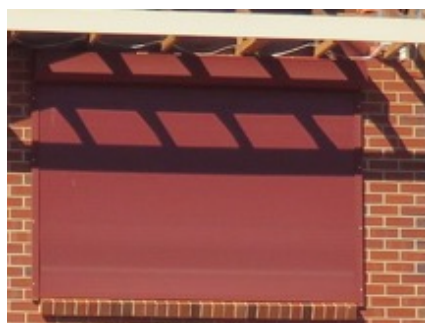
(b) Roller shutter

Wind-borne debris or wind pressure (Figure 4-30(a)) broke many windows in contemporary and older houses. The consequences of wind-borne debris are discussed in Section 4.1.1. Although they had not been debris-rated, some metal roller shutters on a house protected windows from some wind-borne debris – there were dents in the roller shutters from roof tiles that had detached from the roof above (Figure 4-30(b)).

Figure 4-30 Broken glass from wind-borne debris and protection by roller shutters

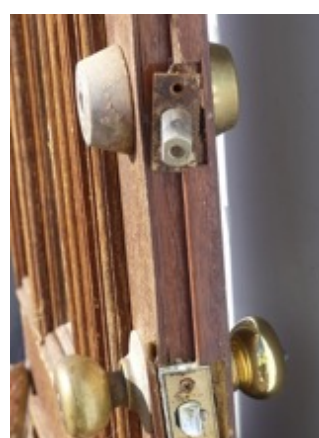
(b) Door latch failure

Figure 4-31(b) shows an example of a door latch that failed on a double entrance door, allowing full internal pressure into the house, causing failure of the roof. After the roof failed, the walls collapsed. The damage is also shown in Figure 4-8.

Figure 4-31 Failure of the front door

Entrance doors and entrance door hardware are not wind rated. Unless wind performance limits and appropriate detailing are applied to entrance doors, and their fittings, doors that fail under wind pressure can produce a dominant opening, leading to internal pressure.

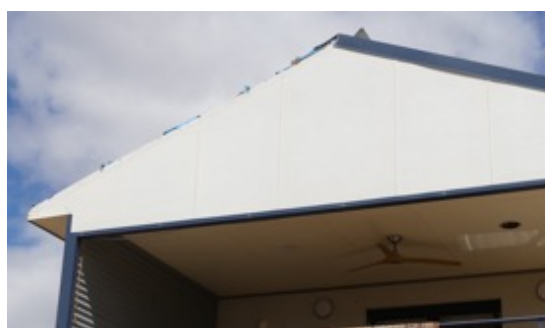
(b) Fasteners installed too far apart

The flashings shown in Figure 4-35(b) to (d) had details that would not have complied with the current version of AS 1562.1. However, the failure shown in Figure 4-35(a) indicates that even if the right number of screws are installed at the correct spacing, failures can still occur if the fasteners are positioned too close to the edge of the flashing.

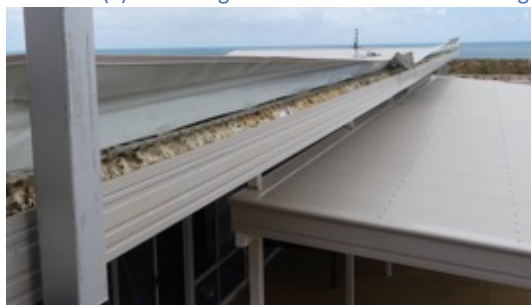
(c) Flashings fastened with pop rivets

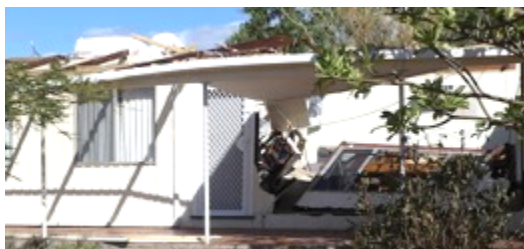
Figure 5-2 Broken windows leading to failure of the roof structure in an older house

The role of wind forces and wind-borne debris that breaks doors and windows, leading to roof damage to contemporary houses, as discussed in Section 4.1 also applies to older homes. An example is shown in Figure 5-2. Deterioration of structural elements and connections that don't comply with current standards also contributed to roof damage in older houses.

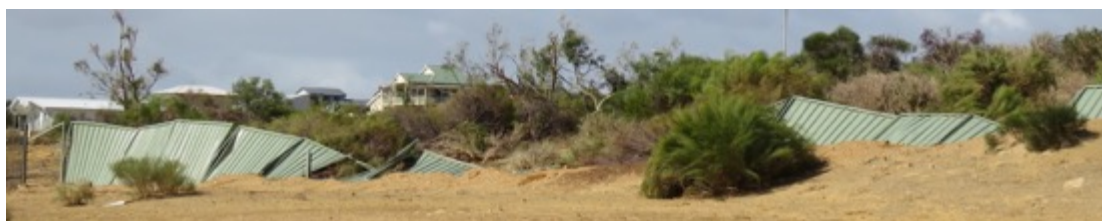
(a) Kalbarri

Many steel sheet fences were damaged during TC Seroja, as shown in Figure 7-4. Sheet metal panels that detached from fences became part of airborne debris that posed a risk to people and other buildings. Where the fence was part of the pool safety fence, then the loss of the fence presented pool safety risks as well. The images shown in Figure 7-4 were caused by wind pressures alone. Wind-borne debris also caused damage to fences.

Figure 7-4 Wind damage to steel sheet fences

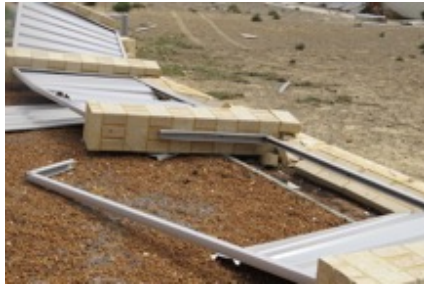
Figure 7-5 shows damage to fences constructed with reinforced masonry pillars and either metal infill or unreinforced masonry infill. Wind pressures damaged both types of fences. The reinforcement in the masonry pillars shown in Figure 7-5(a) was not bonded with the brickwork.

(a) Reinforced pillars with sheet steel infill panels

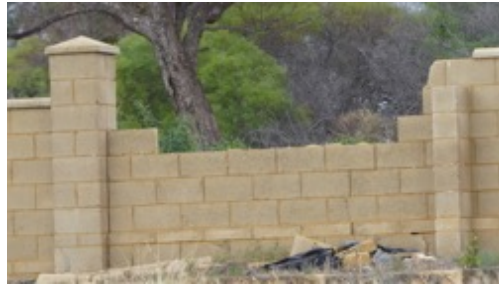
(b) Reinforced pillars with unreinforced blockwork

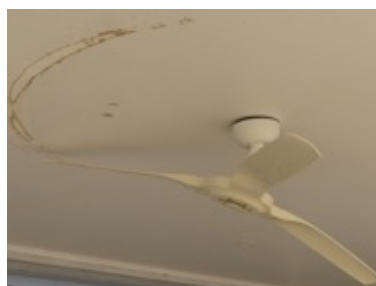
Figure 7-8 Damage to outdoor ceilings from ceiling fans

During TC Seroja, wind drag on the outdoor ceiling fans swung them against the ceiling and damaged their blades. In many cases, all blades and several ceiling panels were damaged. Figure 7-8 shows an example. This type of damage can be avoided by removing the blades as part of preparing for an approaching tropical cyclone (Boughton and Falck, 2020).

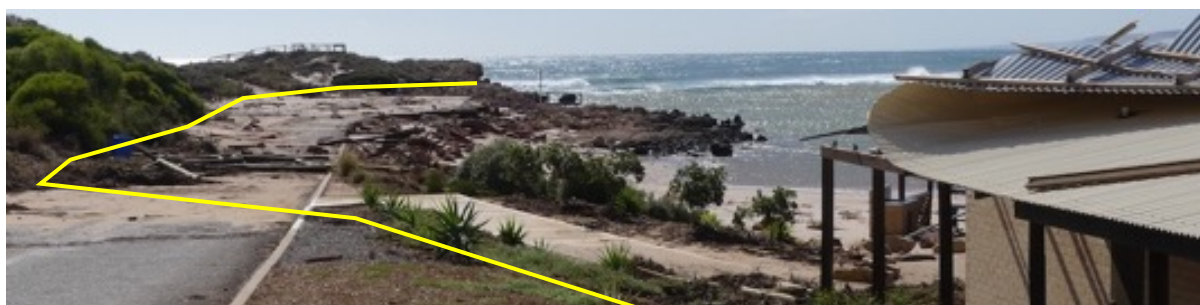
Figure 8-2 Inferred storm tide position at the mouth of the Murchison River at Kalbarri

TC Seroja crossed the coast near mid tide when the astronomical tide was predicted to be 0.5 m below Highest Astronomical Tide. Figure 8-3 shows photos of the foreshore in Kalbarri. The yellow line shows the approximate position of the storm tide position inferred from the deposits of marine sediment. It appeared that the maximum storm tide height was near 2 m above high tide, at around the floor level of the amenities block shown in the photo. At this location, the sediment line would have included wave runoff.

Because most buildings are not located close to the shore, the only potential storm surge damage to buildings would have been to the toilet block shown in Figure 8-2 where wave action may have contributed to the roof damage.

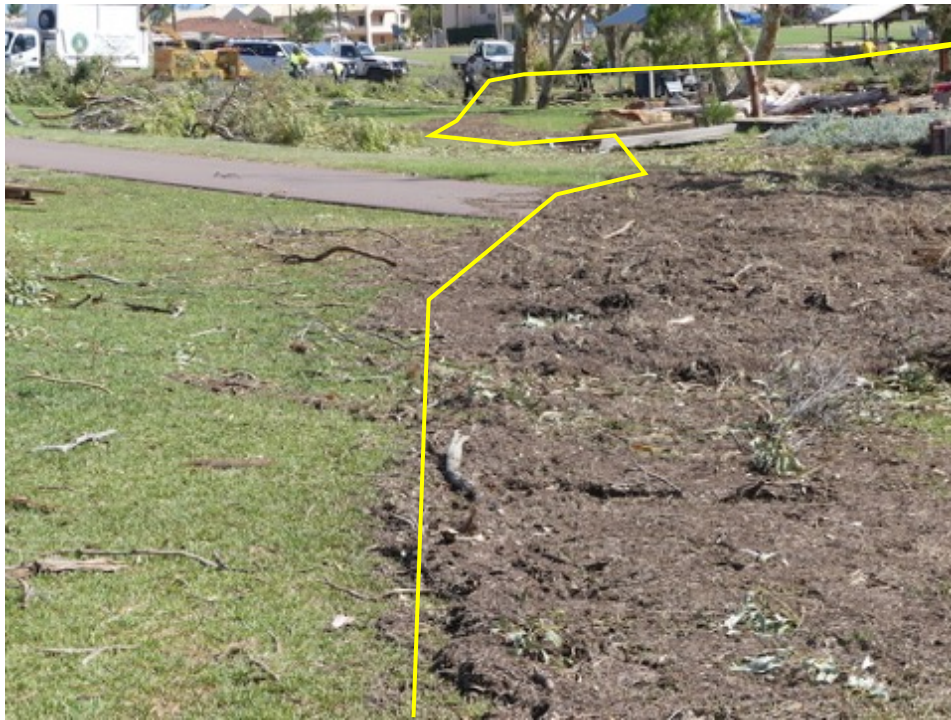
Figure 8-3 Inferred storm tide position at the foreshore near the town centre

A storm tide height of nearly 2 m is compatible with the marine debris line on the foreshore near the town centre, shown by the yellow line in Figure 8-3.
