North Queensland Study into Water Damage from Cyclones

Project partners: IAG and SUNCORP

Overview of study

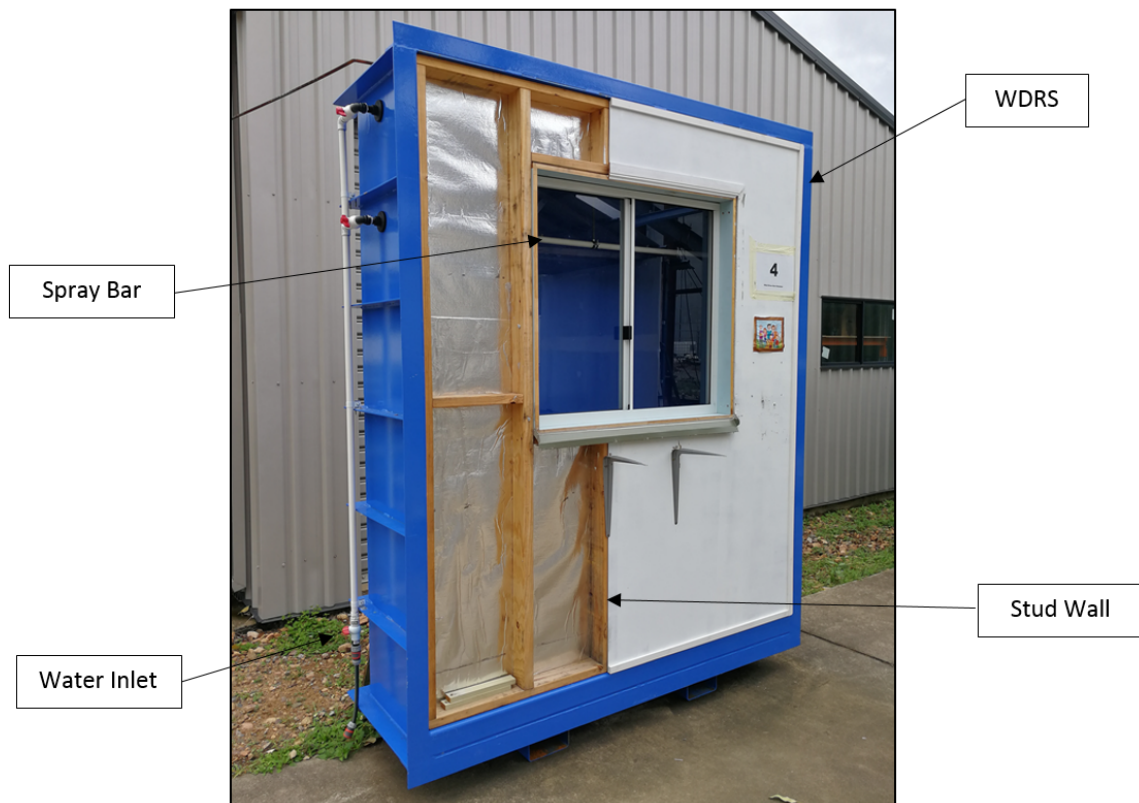
Figure 5: WDRS with Wall and Window Test Sample

Figure 5 shows the WDRS with the wall sample including a window fitted to its open face.

During the testing, all the modern window and door specimens tested were compliant with the AS 2047 rain flow rate and static test pressure of approximately 300 Pa standard, and did not let uncontrolled water into the inside of the building. However, for the fluctuating pressures encountered during wind storms the windows and door leaked, a lot.

Various mitigation strategies such as taping over the weep holes were trialled. The only configuration that greatly reduced the amount of water ingress was by using a strip of plastic sheet taped on the inside of the window sill (i.e. outside of WDRS). This strip of thin plastic increased the height of the window sill, caught the water and allowed it to drain back out of the house via the weep holes. Figure 6 shows results side by side during a pressure peak of a fluctuating pressure trace. A significant amount of water is being pushed through the seals and over the sill of the window on the left side, while the water is constrained by the plastic lining on the right side. This was a similar result for the sliding door tests.
