CYCLONE TESTING STATION

SIMULATED WIND TESTS ON A HOUSE

Part 1. Description

TECHNICAL REPORT NO. 12

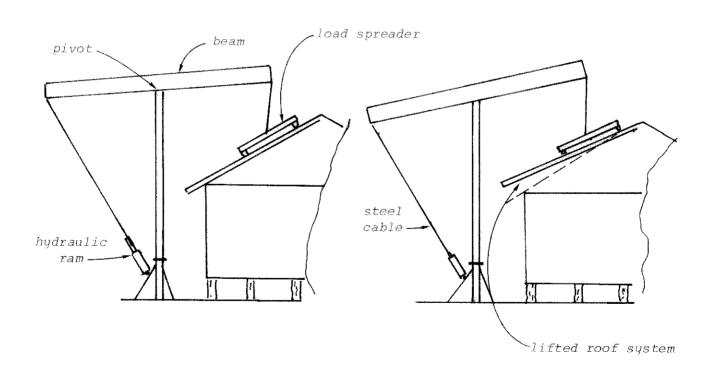
Figure 8. Loading frames during uplift test

(i) Uplift loads: Uplift loads were applied to the roof of the house using a hydraulic tension ram mounted on the column footing. This pulled down on one end of a large steel beam pivoted on the top of the steel column. The other end of the steel beam was connected to the roof using a cable. The load in the cable was transferred to 6 points on the purlins by a steel load spreader. The operation is sketched in Figure 8.

(ii) Roof Test - As discussed in Section 3, the roof structure was not typical of a house. The weak link in the uplift chain from purlins to footings, in this instance was the purlin to rafter connection. This detail failed quite suddenly by pull out of the nails driven through the purlin into the nailing block as shown in Figure 12. However, the trusses themselves did suffer some minor damage during the test.
