CYCLONE TESTING STATION

REPORT ON DAMAGE CAUSED BY CYCLONE ISAAC IN TONGA

TECHNICAL REPORT NO. 13

November 1982

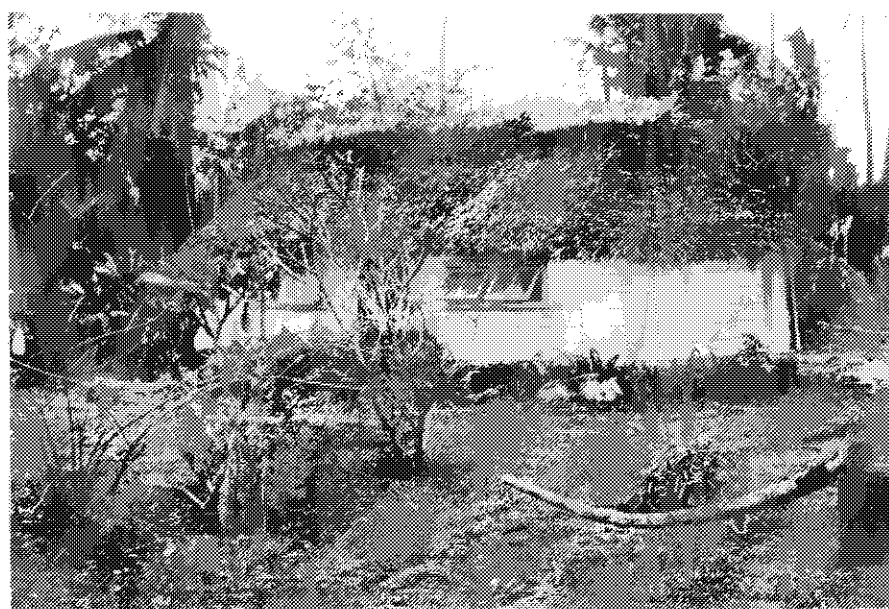
Figure 3. Fale with modern wall construction

On Tongatapu most houses were of European style rather than the traditional fale of woven palm leaves. Approximately sixty percent had timber framing with the rest being divided equally between concrete block and fale. Nearly all of the European style houses had corrugated galvanized steel roofing, although occasionally the two styles were combined, Figure 3.

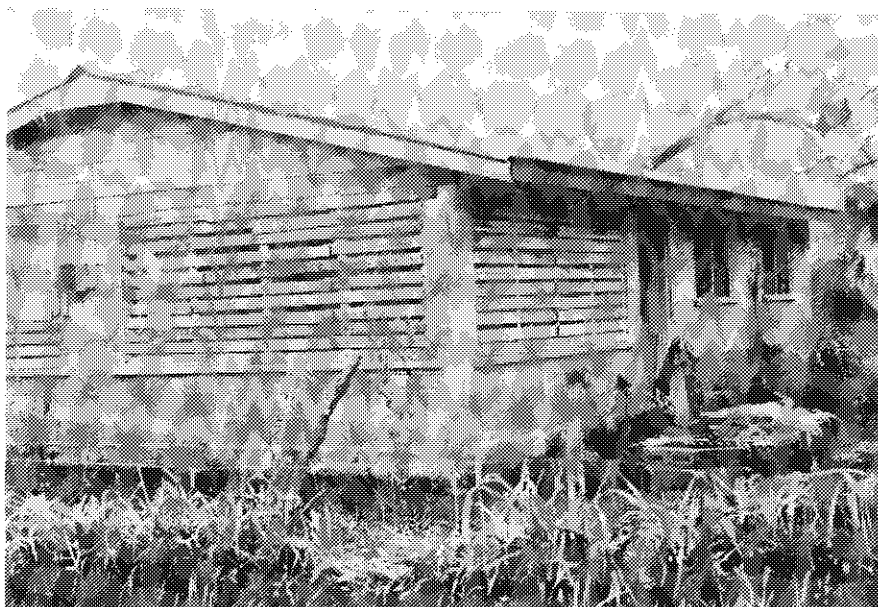
Although there was a considerable amount of building debris scattered about, there was little evidence of missile damage even to windows. However, many owners boarded up their windows during the cyclone warning period, Figure 16.

Figure 16. Windows boarded up prior to cyclone.

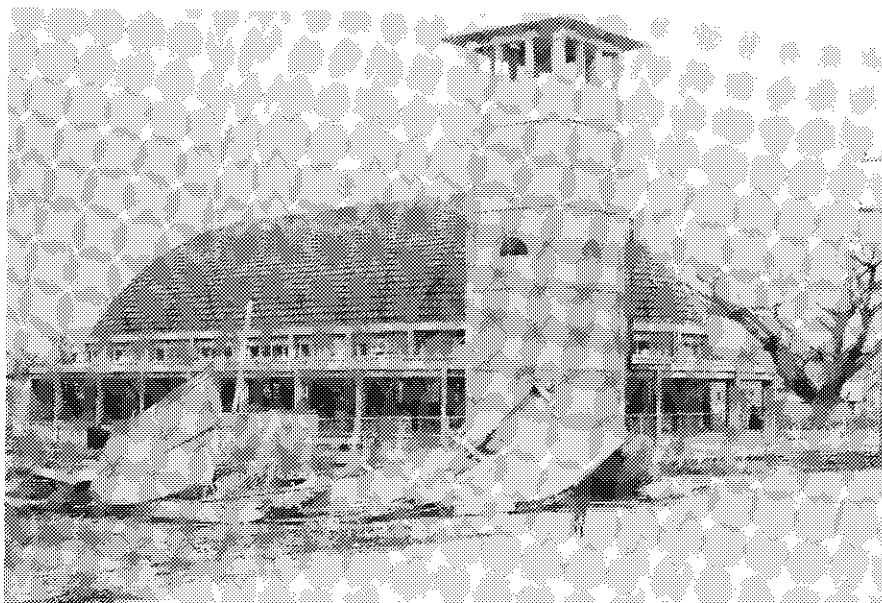
The performance of church structures varied considerably. One church at Kolovai, in the north-west of Tongatapu appeared to be completely untouched by the cyclone as illustrated in Figure 20; yet the church was located in an area where houses were badly damaged. The performance of this church probably reflects the building standards affordable by a more affluent community. Other smaller simple wooden churches in the same area were badly damaged by the winds of cyclone Isaac.

Figure 20. Undamaged church, north west Tongatapu.

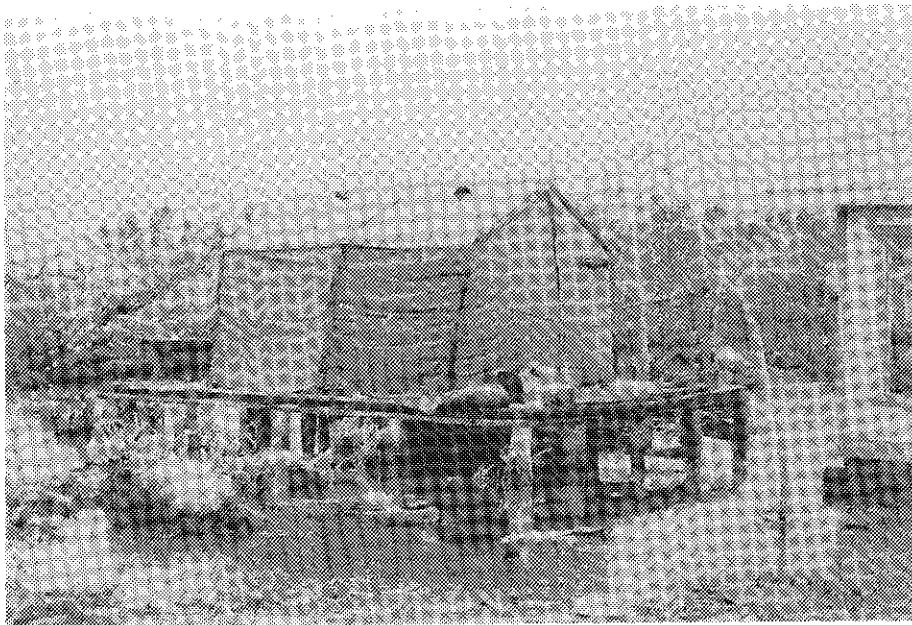
Family ties are very strong in Tonga. Therefore many of those made homeless were welcomed into the homes of relatives who were not so seriously affected by the event. There were still many others who had to rely on international relief aid to provide tents as temporary accommodation. Tents are not a very satisfactory means of accommodation in a tropical environment, but they were the only means of providing shelter in a relatively short time. Of course there were some hassels as the tents sometimes arrived with an inadequate number of supporting poles or with the wrong types of supports, but these were only short term problems. On Tongatapu the tents were sometimes erected on the site of the damaged house, Figure 25, but preferably tent cities were established on well drained sandy areas. Two such camps were located at Sopa to house the victims of the storm surge. Electricity was supplied to these camp sites just two weeks after the event.

Figure 25. Emergency accommodation.

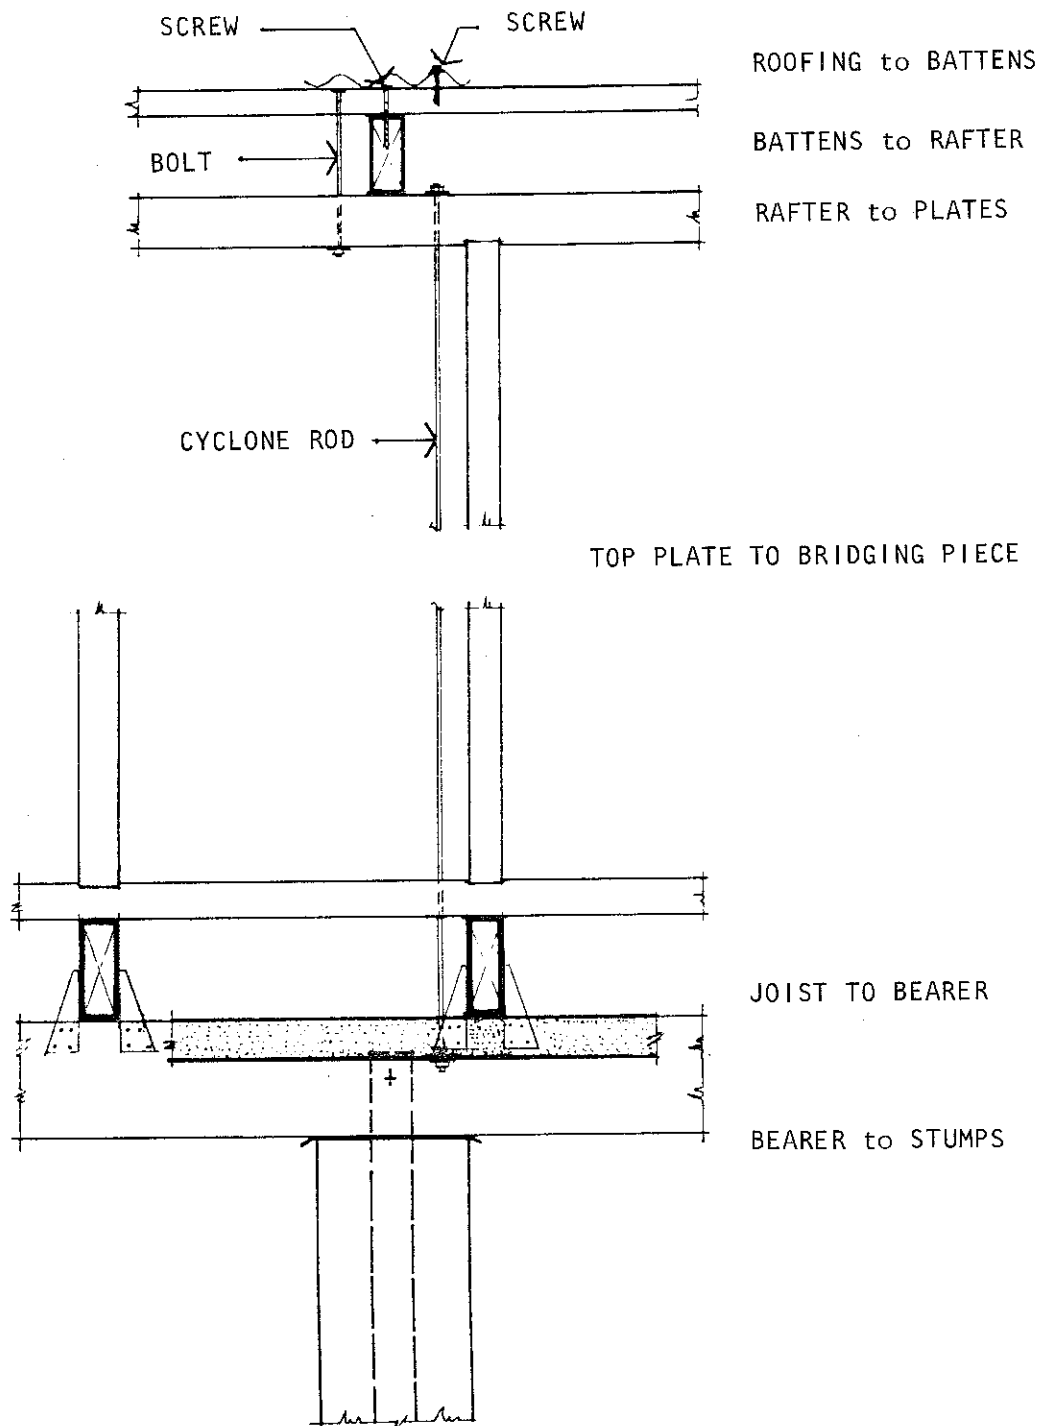
Figure 26. Typical hold down details.

The provision of a suitable hold down mechanism is an essential element in resisting wind uplift forces. In domestic construction the timber frame itself is usually sufficiently strong to be able to withstand the uplift forces, but problems occur with joints. A suitable chain of strength from roofing to foundations is illustrated in Figure 26 (Reardon and Aynsley, 1979). This is typical of that used for framed construction in the cyclone prone areas of Australia. Of course it demonstrates only one method of hold down, there are others that may be equally suitable. However the concept of securing one member to the other, or of capturing a number of members within the confines of one bolt is clearly shown.
