# CYCLONE TESTING STATION

## **SIMULATED WIND TESTS ON A HOUSE**

### Part 2 — Results

TECHNICAL REPORT No.14

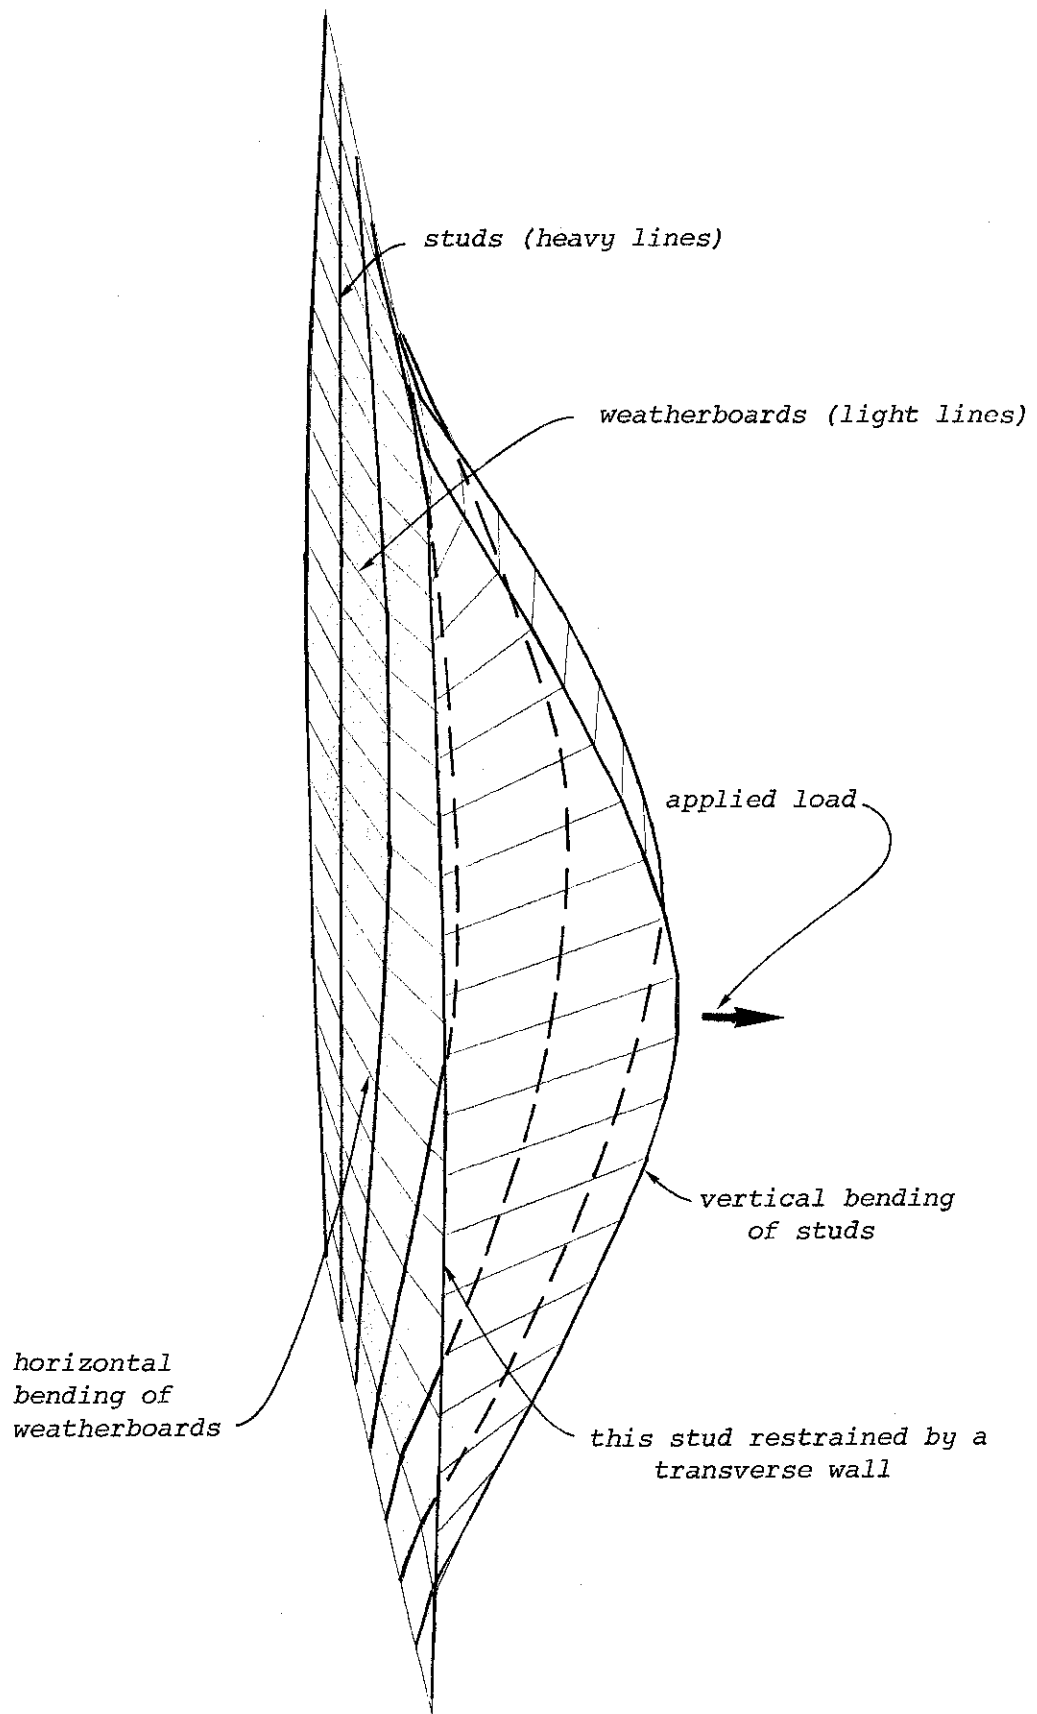
Figure 4. Deflected shape of wall during stud tests

In Figure 4, a plot of the deflected shape of the wall as predicted by the finite element program is shown. The transfer of load horizontally by bending of the external cladding can clearly be seen as well as the bending of studs to transfer load to top and bottom plates. The effect of a transverse wall in reducing the deflection at its junction with the loaded wall can also be seen.

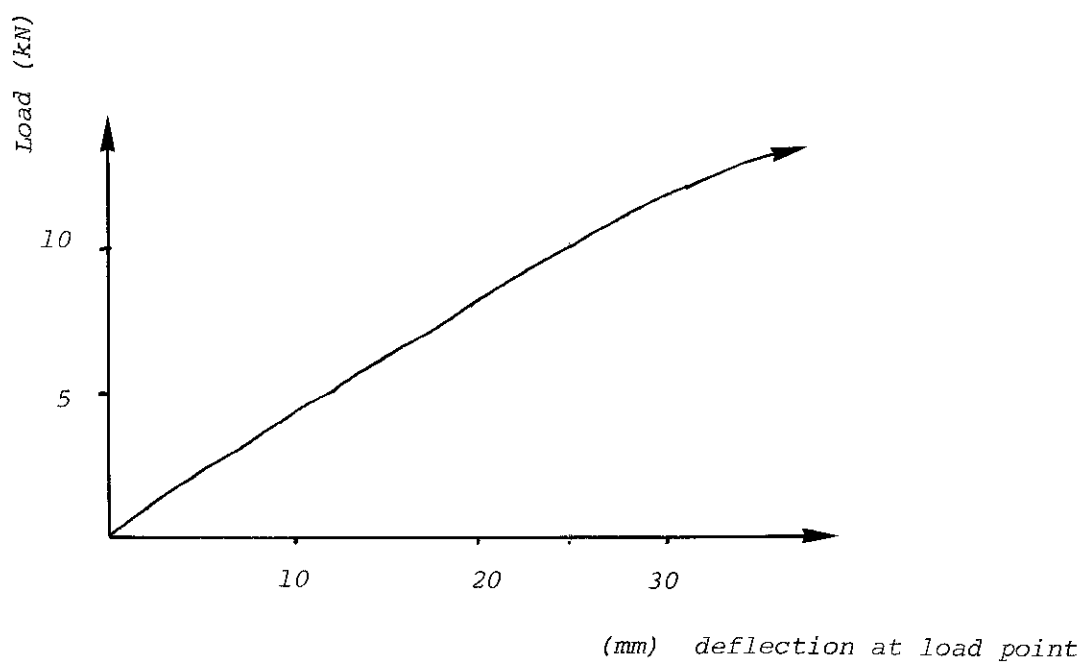
Figure A.5 Load-deflection curve for stud tests

None of the studs tested could be described as perfect. Many displayed significant cross grain and failure was precipitated at knots in tests 1 and 3 and at notches in test 4. Even so the load factors with respect to both cyclone 'Althea' and 'AS code' return period loads were high, commensurate with the observed performance of studs subjected to high wind loads. In many cases where stud failure details have been observed in high winds, the stud timber has remained intact and fastening with bottom or top plate has proved insufficient to carry the load. However, all of the studs tested failed by timber flexure failure near the point of maximum moment, and the end driven nails at both top and bottom plate connections bent, but still carried the required loads.

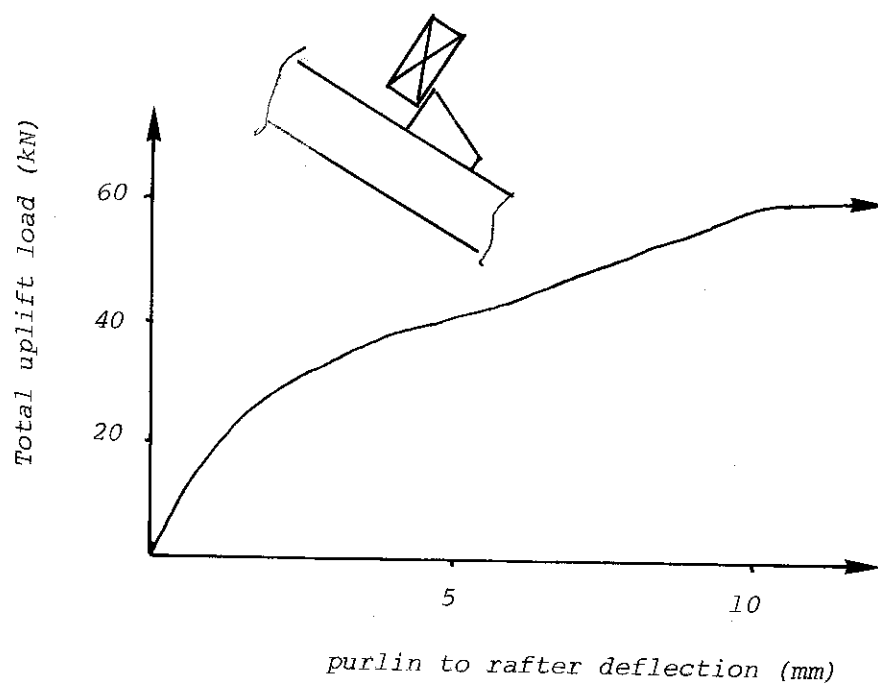
Figure A.7 Load-deflection curve for uplift test

The actual mode of failure was by withdrawal of the nails securing the purlins to the top chord nailing blocks. Forty nails in twenty locations were affected. This gave the average resistance of each nail at failure as 1.52 kN compared with the allowable design resistance of 0.63 kN (Australian Standard, 1975), i.e. average failure load was 2.4 times allowable load on that joint. The allowable load per joint gave a total permissible load on the test section of 1.01 kPa or 0.57 of the 'AS code' pressure. Thus it appears that the roof was significantly underdesigned with regard to current design rules. Appendix 4 to the Standard Building By Laws does not make a recommendation for holding down of purlins to trusses spaced at 3 metres, but holding down provisions for trusses at closer spacing are more substantial than those utilized in the tested roof.

Failure of the roof structure was sudden and simultaneous release of the twenty loaded joints. A failure of this kind during high wind conditions would have resulted in the sudden removal of a large part of the roof sheeting with purlins attached which would have become a very dangerous single piece of airborne debris.

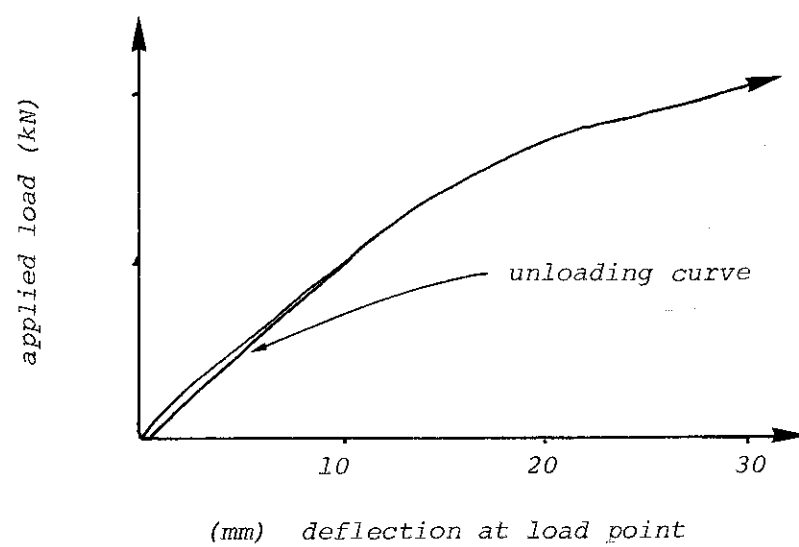
Figure A.13 Load-deflection curve - Top plate test 12

of the loads applied in tests Top Plate 2, 6 and 7. At this load some signs of distress were obvious near corner fasteners but unloading and subsequent reloading showed little deviation from elastic behaviour. Loading then continued until a failure occurred at 8.5 kN. The failure was due to tearing of the cane-ite sheeting at tension corners and the pull through of some edge fasteners.
