CYCLONE TESTING STATION

STRUCTURAL DAMAGE CAUSED BY
CYCLONE 'KATHY' AT BORROLOOLA, N.T.
MARCH 1984

Technical Report No. 21

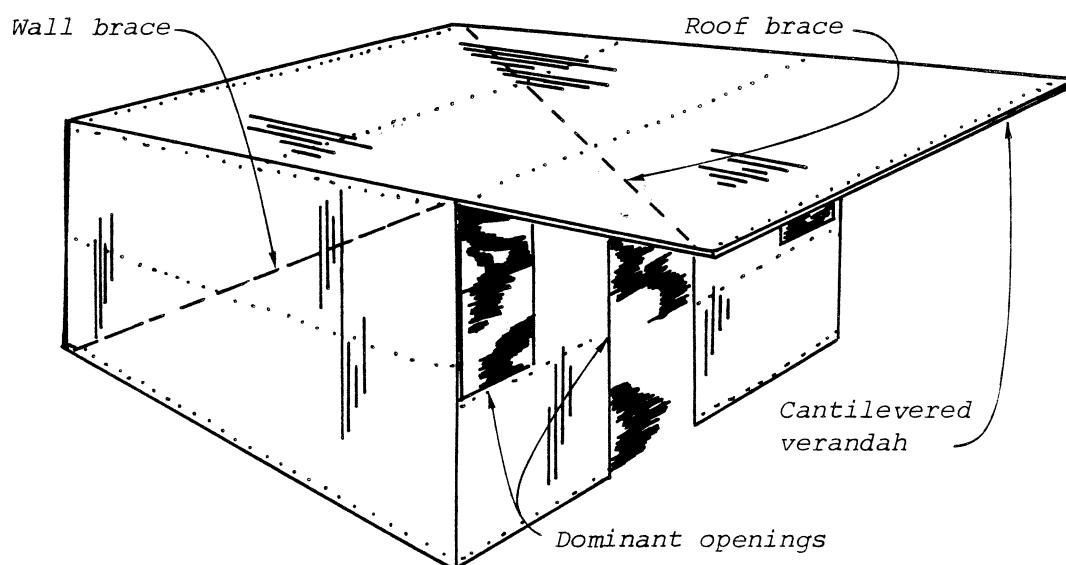
Figure 21 Sketch of Typical Aboriginal Camp Housing

- (iii) Small Steel Sheeted Homes of the Camps: There were parts of the town that were structured camp areas. They had reticulated electricity and water and the accommodation was mainly small shed type structures consisting of a frame with corrugated steel fastened to it. The size of these dwellings varied from 3 m x 3 m to 3 m x 6 m. One such camp area was visited and inspected. Most of the buildings in the camp that was inspected consisted of angle frames complete with bracing that had been welded together and had then had the corrugated cladding screwed onto it. A sketch of a typical section through one such dwelling is shown in Figure 21. In the camp examined, the buildings were of two main orientations - with the verandah on the windward side and with the verandah on the leeward side. The buildings with the verandah on the leeward side had little structural damage as shown in Figure 22. The dominant openings were on the leeward side so the net internal pressure would have been predominately negative. This would have helped to hold the roof down. However most of the buildings that had verandahs facing the direction from which the strongest winds came suffered major roofing damage. In nearly all of these cases the

sheeting had been blown off the cantilevered verandah leaving the frame behind, and in some cases, the roof sheeting had lifted off the enclosed part of the building too, as shown in Figure 23. The major openings in the enclosed space faced the verandah, so in the event of a door being left or blown open, significant positive pressures could be developed within the house and would have assisted in the removal of the roof which was fastened to frame members that were approximately 1200 mm apart. It appeared that internal pressures had played a big part in determining the fate of these buildings.

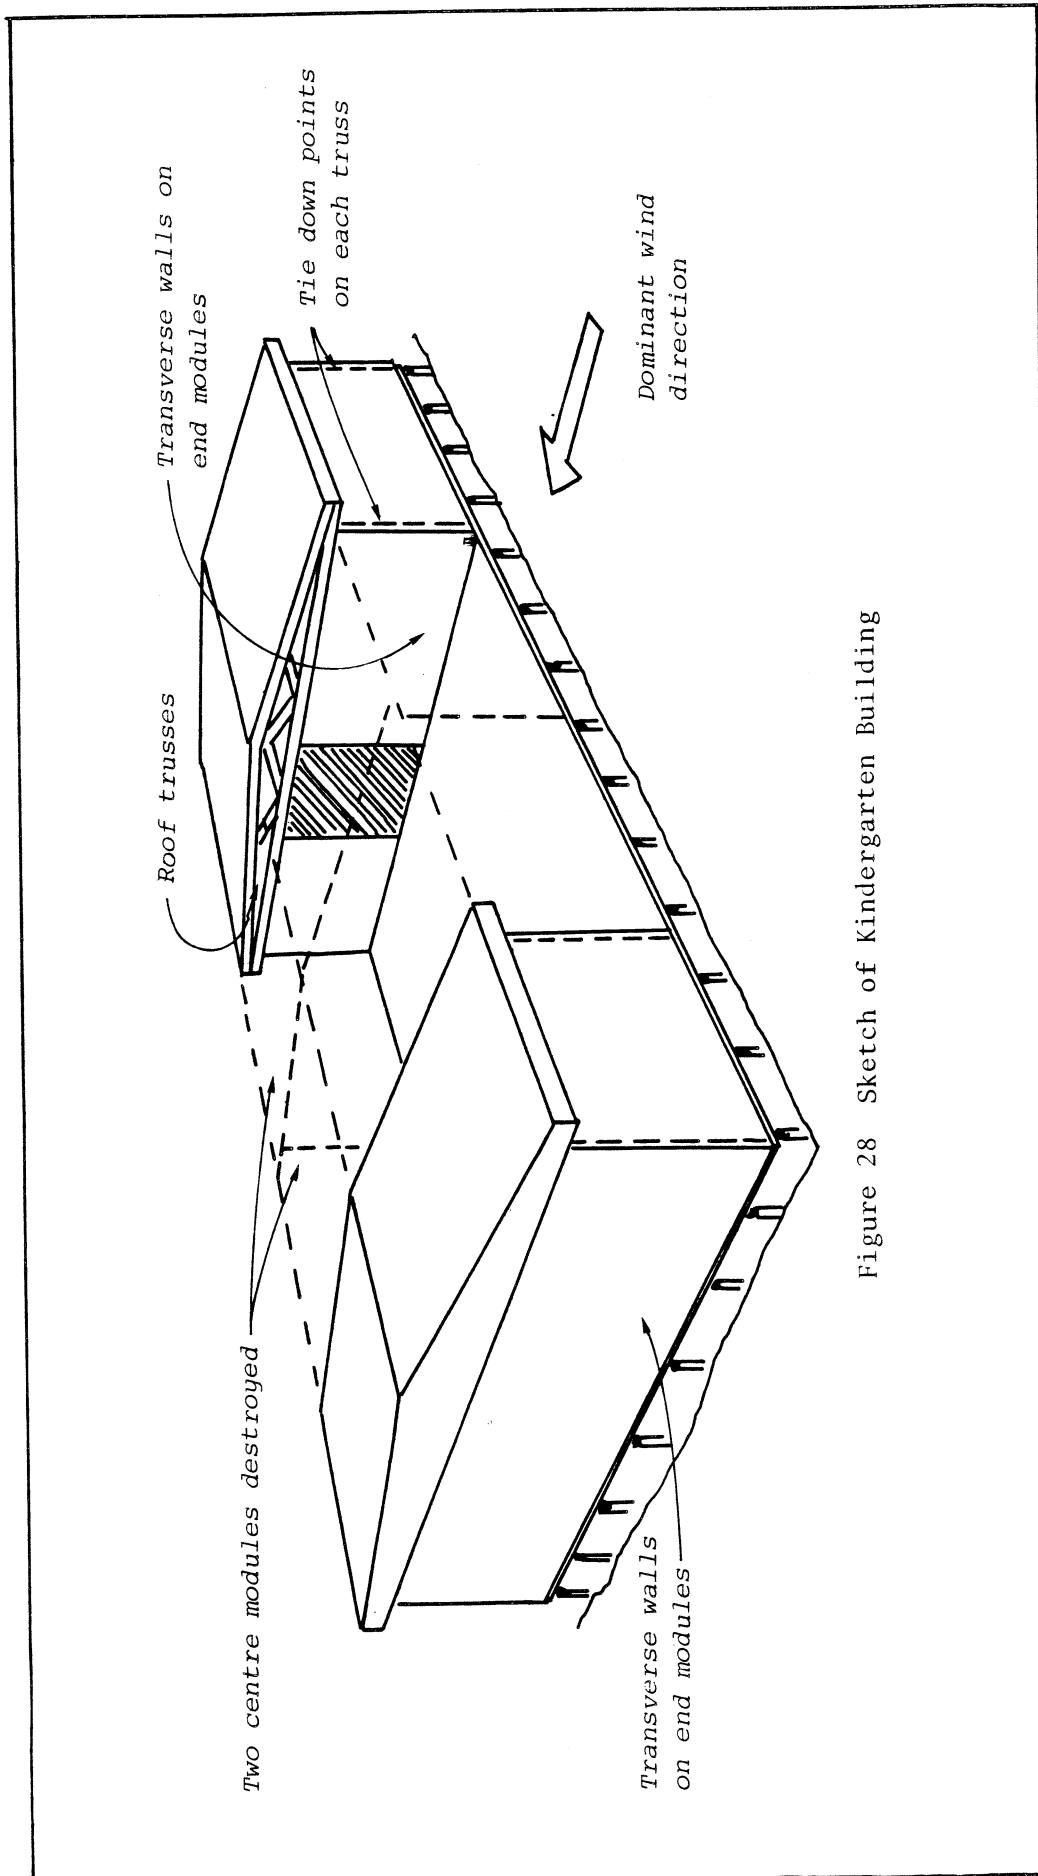
Figure 28 Sketch of Kindergarten Building

- (iii) The Kindergarten Building: This had obviously been assembled on site from four prefabricated sections placed side by side and is illustrated in Figure 28. The lines separating each of the modules ran at right angles to the ridge line of the low pitched roof. Each module was built complete with floor walls and roof and butted up to each other on site. The roof structure consisted of two trusses each of which spanned approximately 9 m and were placed at each side of the 3 m module. Plywood webbed deep purlins then spanned between the trusses and supported the corrugated roof sheeting, and each truss was tied to

the floor with a rod at each end. The ceiling was fixed to the bottom of the purlins, and the whole roof structure was tied to the walls in each module. Each end module had side walls and internal walls which made them rigid box type structures, however the centre two modules effectively consisted of only the roof, external wall at each end of the truss and the floor. With little intermodule connection there was no restraint to racking of the centre modules other than that lent by bracing action of the roof sheeting.
