TESTING A LOGAN UNIT HOUSE DESIGNED FOR 63m/s WINDS

TECHNICAL REPORT No. 22

G.F. REARDON

G.N. BOUGHTON

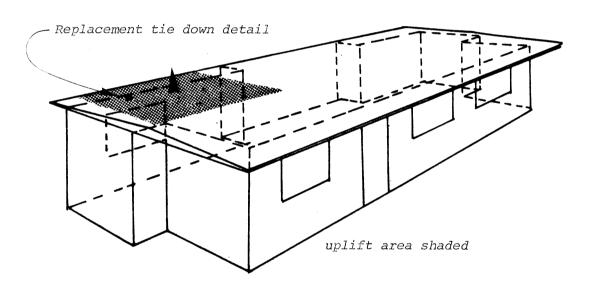
Figure 12. Area of roof loaded to stress new tie down bracket.

In consultation with Logan Units' Engineer, it was decided to recycle the kitchen/dining areas of the house using uplift forces only, see Figure 12. This would subject the new elements to the same number and degree of load cycles as the purlins in the lounge area of the house. It was acknowledged that the other purlins in the kitchen/dining area would therefore receive a

total of twice the number of cycles, but a close inspection had revealed no evidence of fatigue after the first set. This was to be expected as the span of those purlins was only about three metres compared with five metres for similar purlins in the lounge area. The roof sheeting in the kitchen/dining area would also be subjected to a total of 20000 load cycles, but this was considered to be of little consequence because of the method of loading the sheeting. The uplift forces were applied immediately adjacent to each purlin, thus although the roofing had to transfer all that force there were virtually no bending stresses on the sheet. Laboratory tests on other roof sheeting have shown that bending moment plays a very significant part in the failure of roof sheeting.

8000 load/unload cycles of 5/8 design uplift load was therefore applied to the 4.2 m length of roof over the kitchen/dining area. No other uplift loads or lateral racking loads were applied.
