CYCLONE TESTING STATION

SIMULATED WIND LOAD TESTS ON THE TONGAN HURRICANE HOUSE

Technical Report No. 23

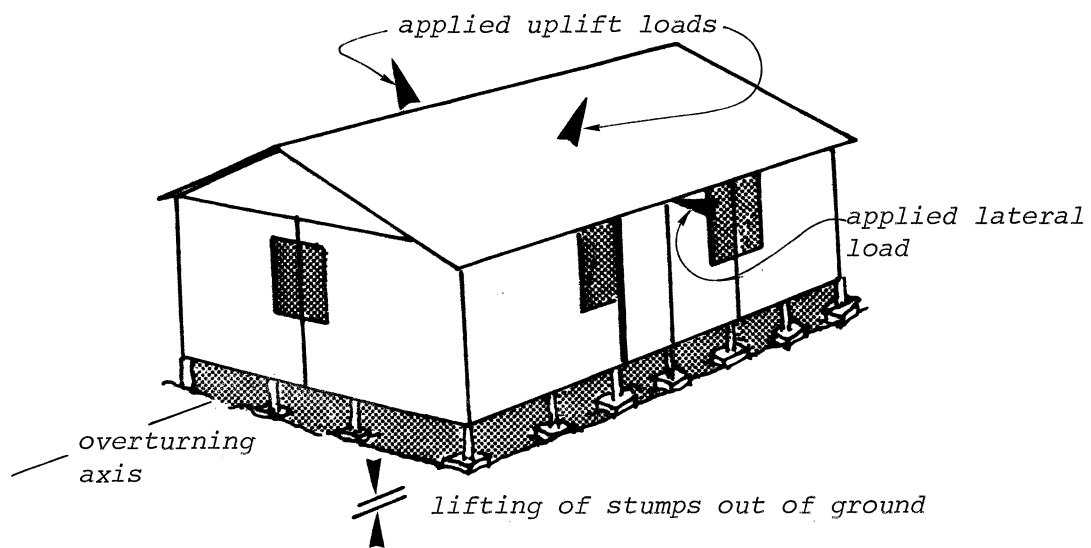
Figure 8 Response of House to Applied Loads

Generally the house behaved as a rigid box at loads less than Design Loads. The overall pattern of movement was that of a stiff box being rolled about one edge. This is depicted in Figure 8.

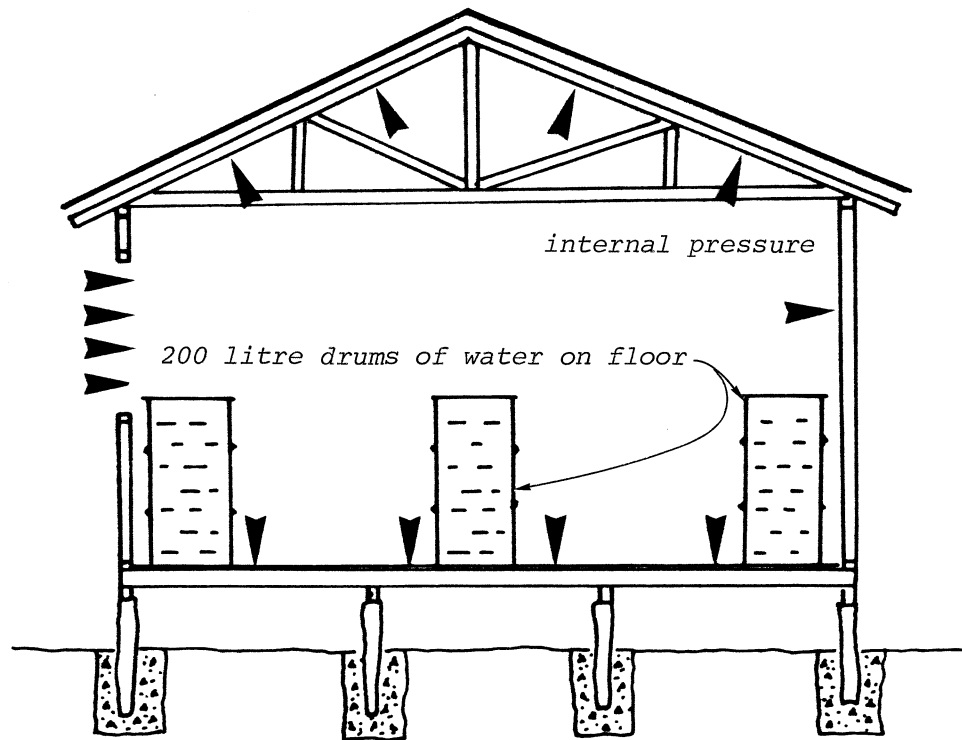
Figure 13 The Use of Drums of Water to Simulate Internal Pressure

account had been taken of internal pressure acting downwards on the floor. The floor was therefore loaded with 200 litre drums filled with water to apply a downwards load equivalent to the internal pressure. They were distributed evenly over the floor area to give the same effect as a uniformly distributed pressure loading as shown in Figure 13.

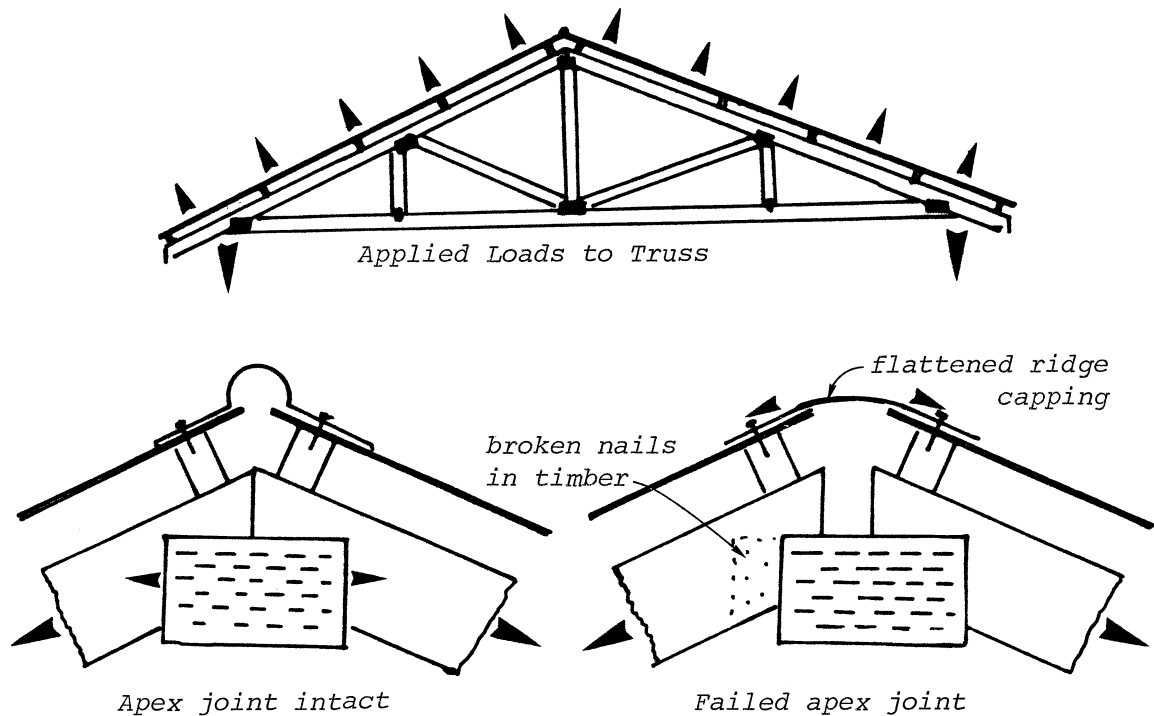
Figure 15 Load Transfer through Ridge Capping

nail plate. The failure mechanism was identical to that depicted in Figure 12, and as mentioned in Section 6.1.2 was probably initiated during the 3/4 design load cycles. However, in spite of the failure of this important joint, the house was still able to resist load. The tension that was previously carried through the apex of the truss by the failed plates was now being transmitted to the roof sheeting and over the apex by the ridge capping as shown in Figure 15. The ridge capping had deformed considerably, and the broken joint in the truss was opening at least 30 mm with each load cycle. Laboratory tests reported by Nash and Boughton (1981) show that the roofing nails at the ridge should be capable of transferring up to 16 kN of tension per truss over the apex before the ridge capping started to tear. An analysis of loads in the truss suggested that the tension at that point would have been less than 12 kN, so the good performance of the ridge capping was to be expected.

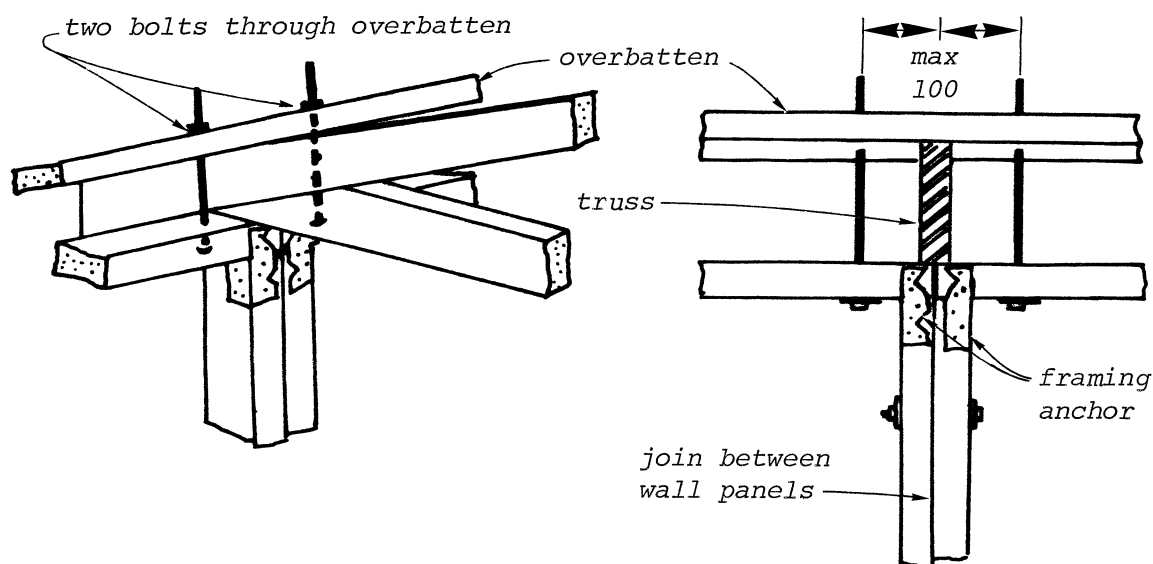
Figure 21 Overbatten at Joints in Top Plate

two M12 bolts were used, one each side of the truss. At the other trusses only one bolt was installed. Whilst one bolt is sufficient to transfer the uplift forces to the wall, the discontinuity of the top plate meant that the framing anchor securing it to the stud was positioned at the extreme end of the plate. It is probable that the uplift force would cause the plate to split and not allow the framing anchor to develop its full strength. Hence two bolts were used for those situations. Figure 21 illustrates this case.

Testing of the house was continued using this system.

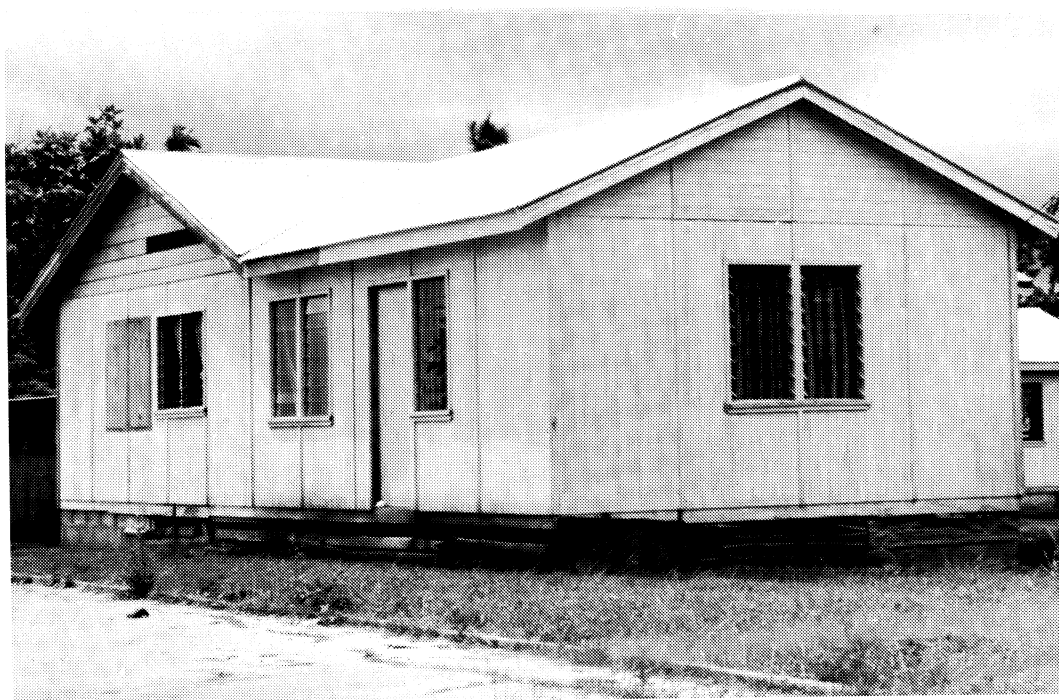
Figure 22 L-shaped extended house.

and additions have been made. Figure 22 shows how a house has been extended to an L-shaped plan. This form of extension is probably the easiest to achieve as it involves removal of one or two panels in the so-called non-loadbearing end wall. (Whilst the end wall may not support the roof structure it certainly acts in a load bearing capacity by bracing the house against lateral wind forces!)

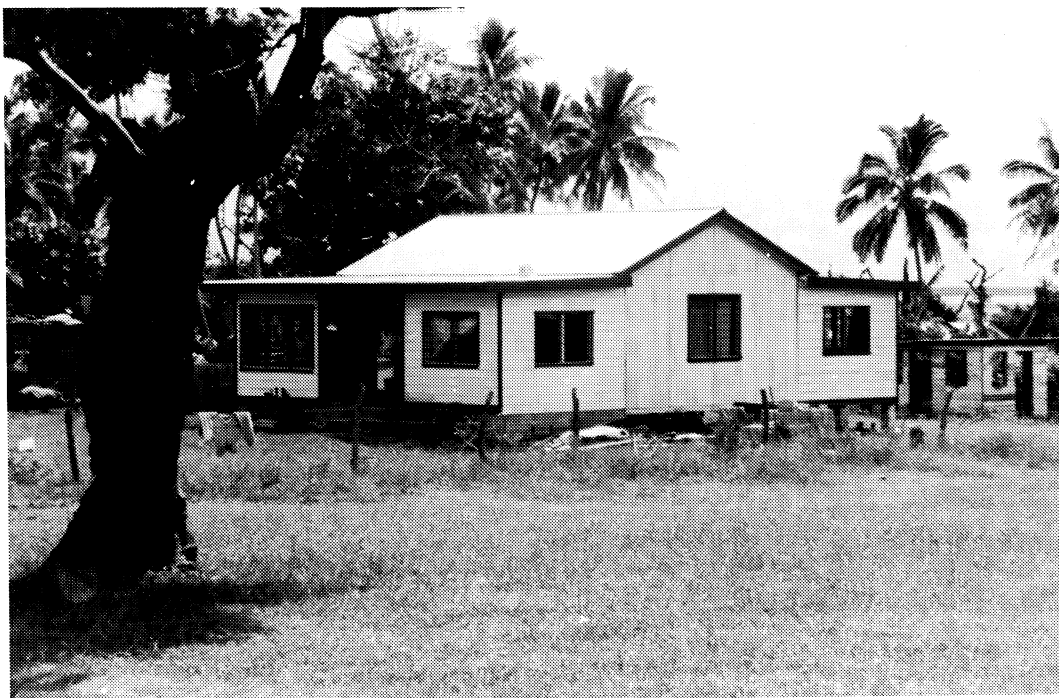
Figure 23 shows extensive additions to the basic hurricane house. Extra rooms have been added to both front and back to give a floor area of about $2\frac{1}{2}$ times the original.

Extreme care must be taken with any extensions in the lateral direction, such as shown in Figure 23. If the roof structure of the extension is supported by the longitudinal load-bearing wall of the original house, that wall may be severely overloaded during a cyclone. Even worse, if the lean-to roof structure is fastened to the overhang of the trusses, the truss hold-down detail will be severely overloaded. The situation would be exacerbated if any of the studs were removed to provide a wider door opening or to gain access to the bedroom.

It should be remembered that laboratory tests on the wall joint (see Section 7.1) showed it to have only a marginal reserve of strength. This reserve would almost certainly be eroded by the additional forces due to wind uplift on the roof of the lean-to.

Figure 23 Additions to Tongan house.

No specific recommendations for this type of addition can be made. Each case should be assessed separately. In general the strength of the wall, and possibly the truss hold-down connections, should be improved. The addition of plywood lining on the internal face of the wall, fastened in the same manner as the external plywood, would certainly increase the strength of the wall. The use of two bolts per truss as illustrated in Figure 21 for all trusses would help by reducing stresses in both the top plate and the overbatten.
