JAMES COOK CYCLONE STRUCTURAL TESTING STATION

EFFECTS OF CYCLONE WINIFRED ON BUILDINGS

TECHNICAL REPORT No. 27

G.F. Reardon
G.R. Walker
E.D. Jancauskas

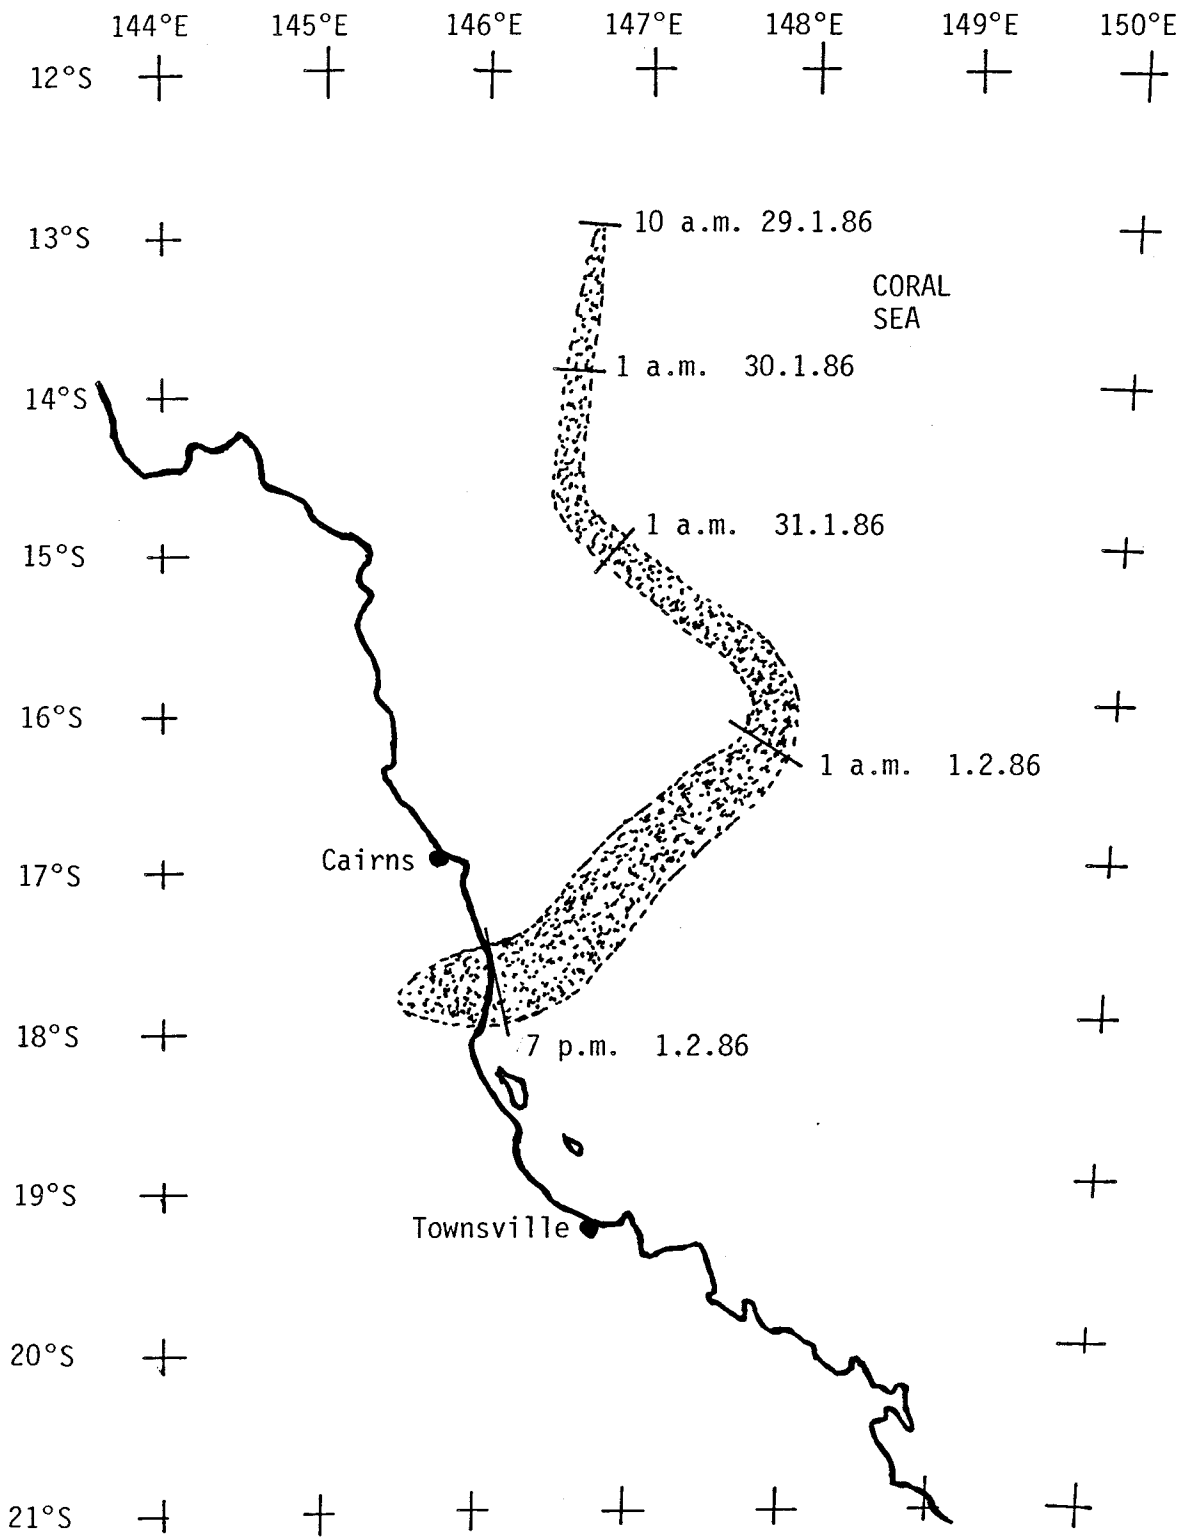
Cyclone Winifred formed out of a tropical low approximately 450 km north of Cairns on 29 January 1986. After slowly moving roughly parallel to the coast to approximately 250 km ENE of Cairns it turned and moved in a southwesterly direction towards the coast late in the evening of 31 January 1986 (see Fig. 3). Winifred crossed the coast in the vicinity of Innisfail late in the afternoon of 1 February 1986. At that time Winifred had a central pressure of 957 mb and had been continuing to intensify. When it crossed the coast Winifred was travelling in a roughly westerly direction at a speed of approximately 15 km/h and had an unusually large eye of the order of 50 km in diameter stretching from just north of Innisfail to around Mission Beach (see Fig. 4). As it crossed the coast the eye decreased in size and does not appear to have persisted more than 60 km inland.

Figure 3 Approximate Track of Cyclone Winifred.
(Based on information supplied by Bureau of Meteorology)

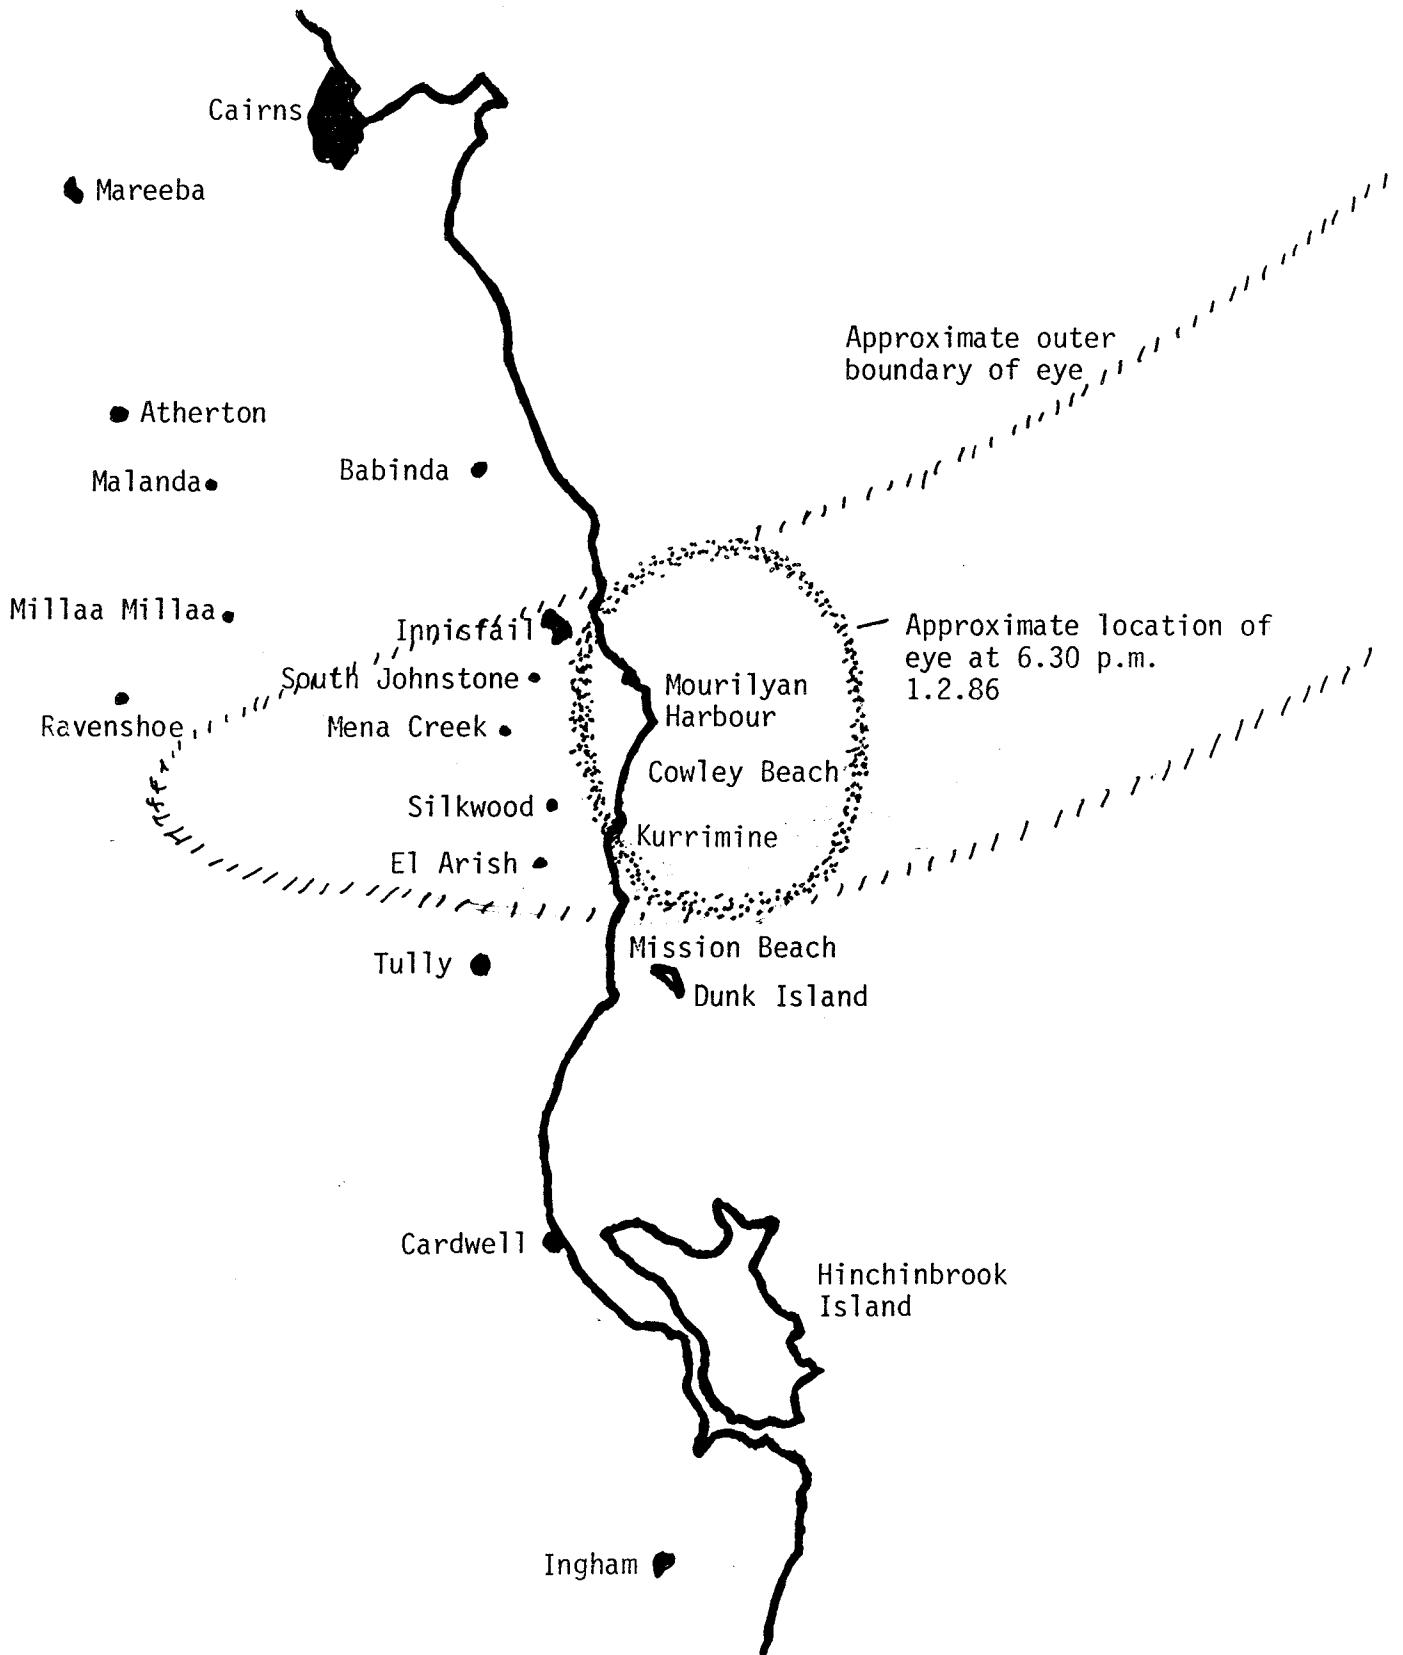
Figure 4 Location of Cyclone Winifred as it crossed the coast

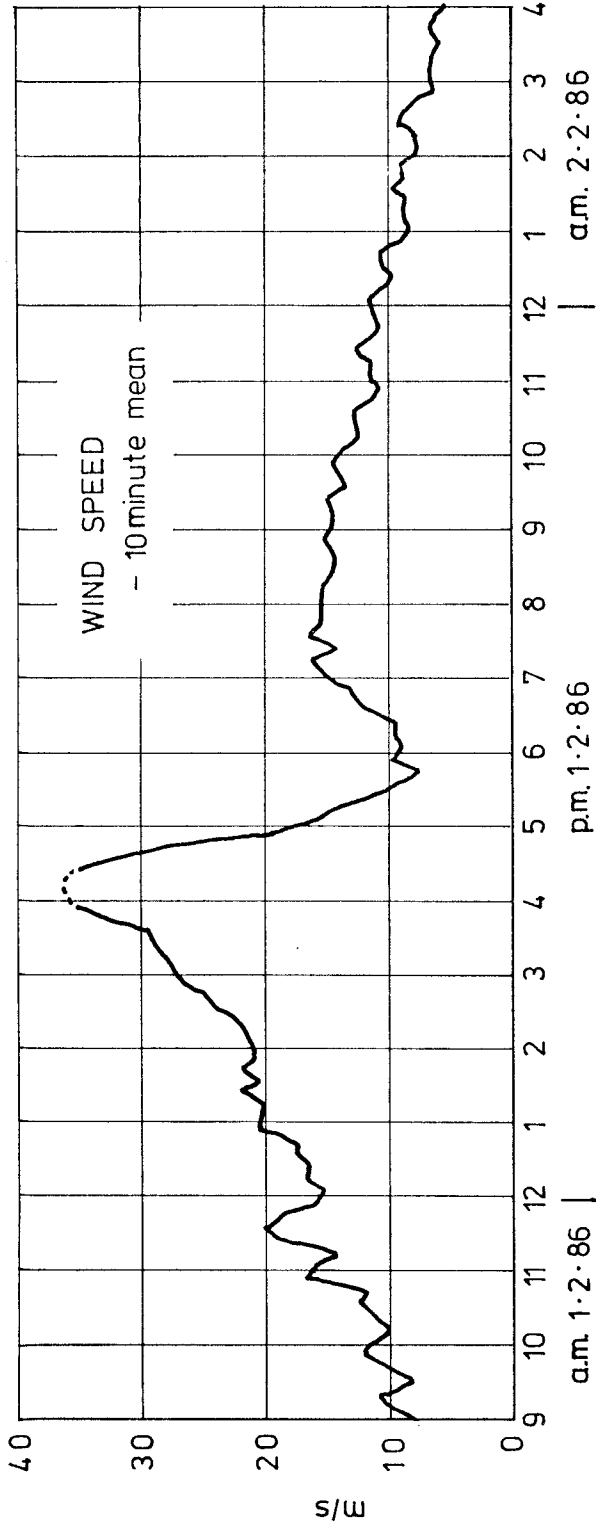
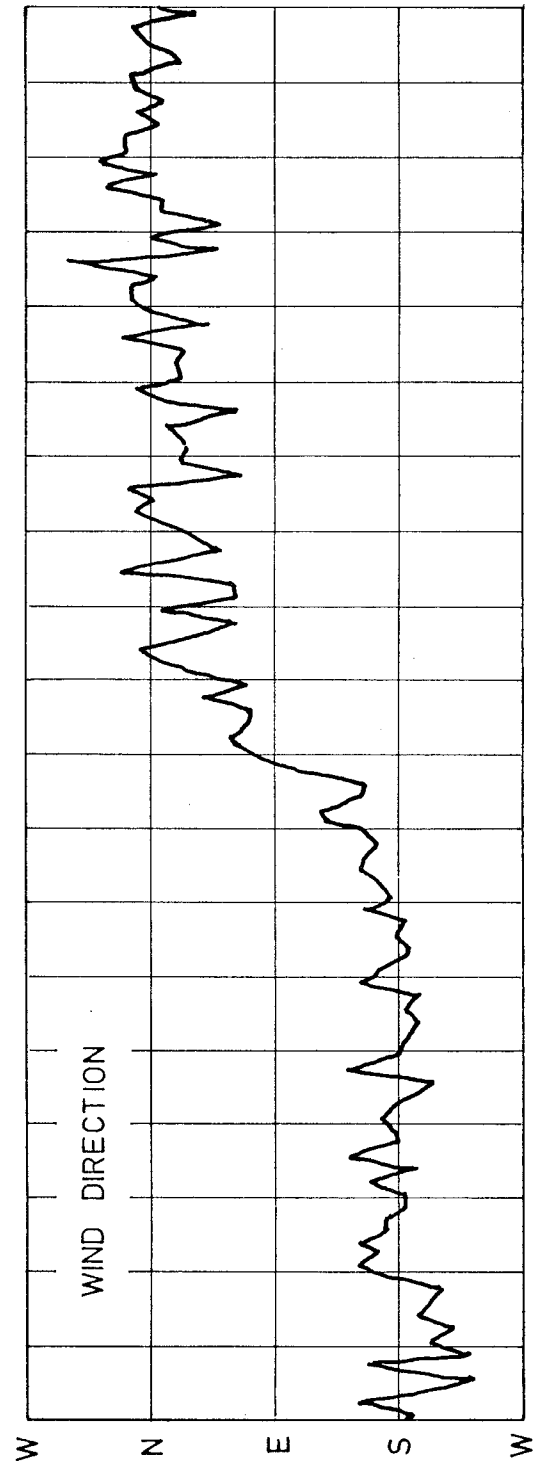
CYCLONE WINIFRED - COWLEY BEACH

The Cowley Beach instrument is a synchrotac anemometer and gives ten minute mean wind speeds for successive ten minute periods throughout the day as well as the instantaneous wind direction every ten minutes. Plots of the recorded wind speeds and wind directions are shown in Figure 5.

Figure 5 Wind Records Obtained at Cowley Beach During Cyclone Winifred

Unfortunately due to limitations in the instrument's recording system there is a question mark regarding the reliability of the three maximum wind speed readings. However comparison with past records of wind speeds near the centre of tropical cyclones suggest that the indicated values are close to the actual values that occurred. On the basis of this record it appears reasonable to assign a maximum ten minute mean wind speed at 10 m height of 35 m/s at Cowley Beach.

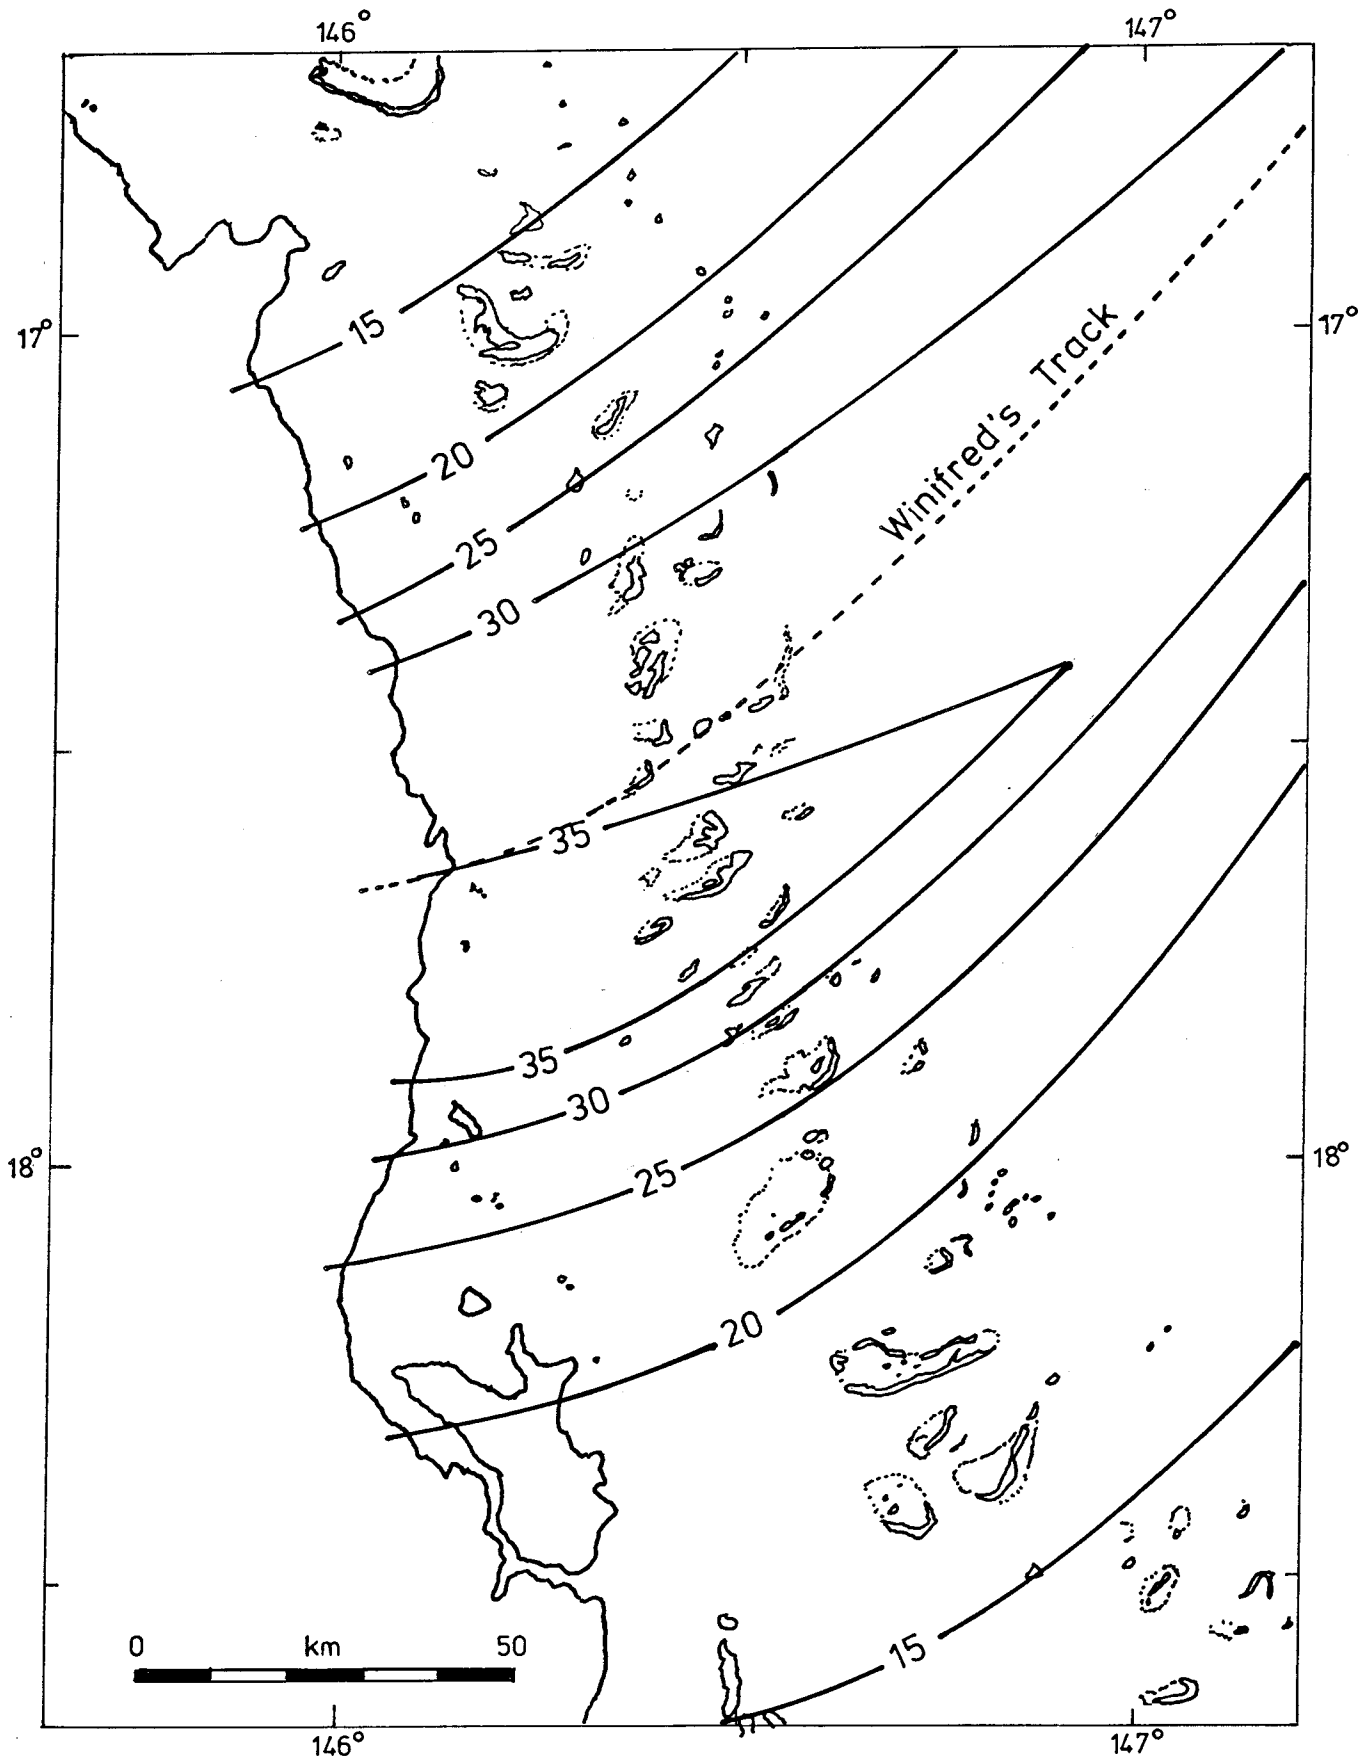
For Winifred, C and k can be determined from the Cowley Beach record, since it was close enough to the centre of the cyclone for the maximum recorded wind speed of 35 m/s to be assumed as the maximum wind speed along the track when the central pressure was 957 mb. The plot of increasing wind speed as Winifred approached could then be used to evaluate k, assuming a steady forward speed of approach of the order of 15 m/s. This gives as a reasonable approximation C = 4.8 and k = 0.67. Using these constants in the above formulae in conjunction with information supplied by the Bureau of Meteorology on central pressure along the track as Winifred approached the coast, the wind field map shown in Figure 6 was obtained.

Figure 6 Map of Estimated Maximum 10 Minute Mean Windspeeds Over the Great Barrier Reef Area During Winifred.

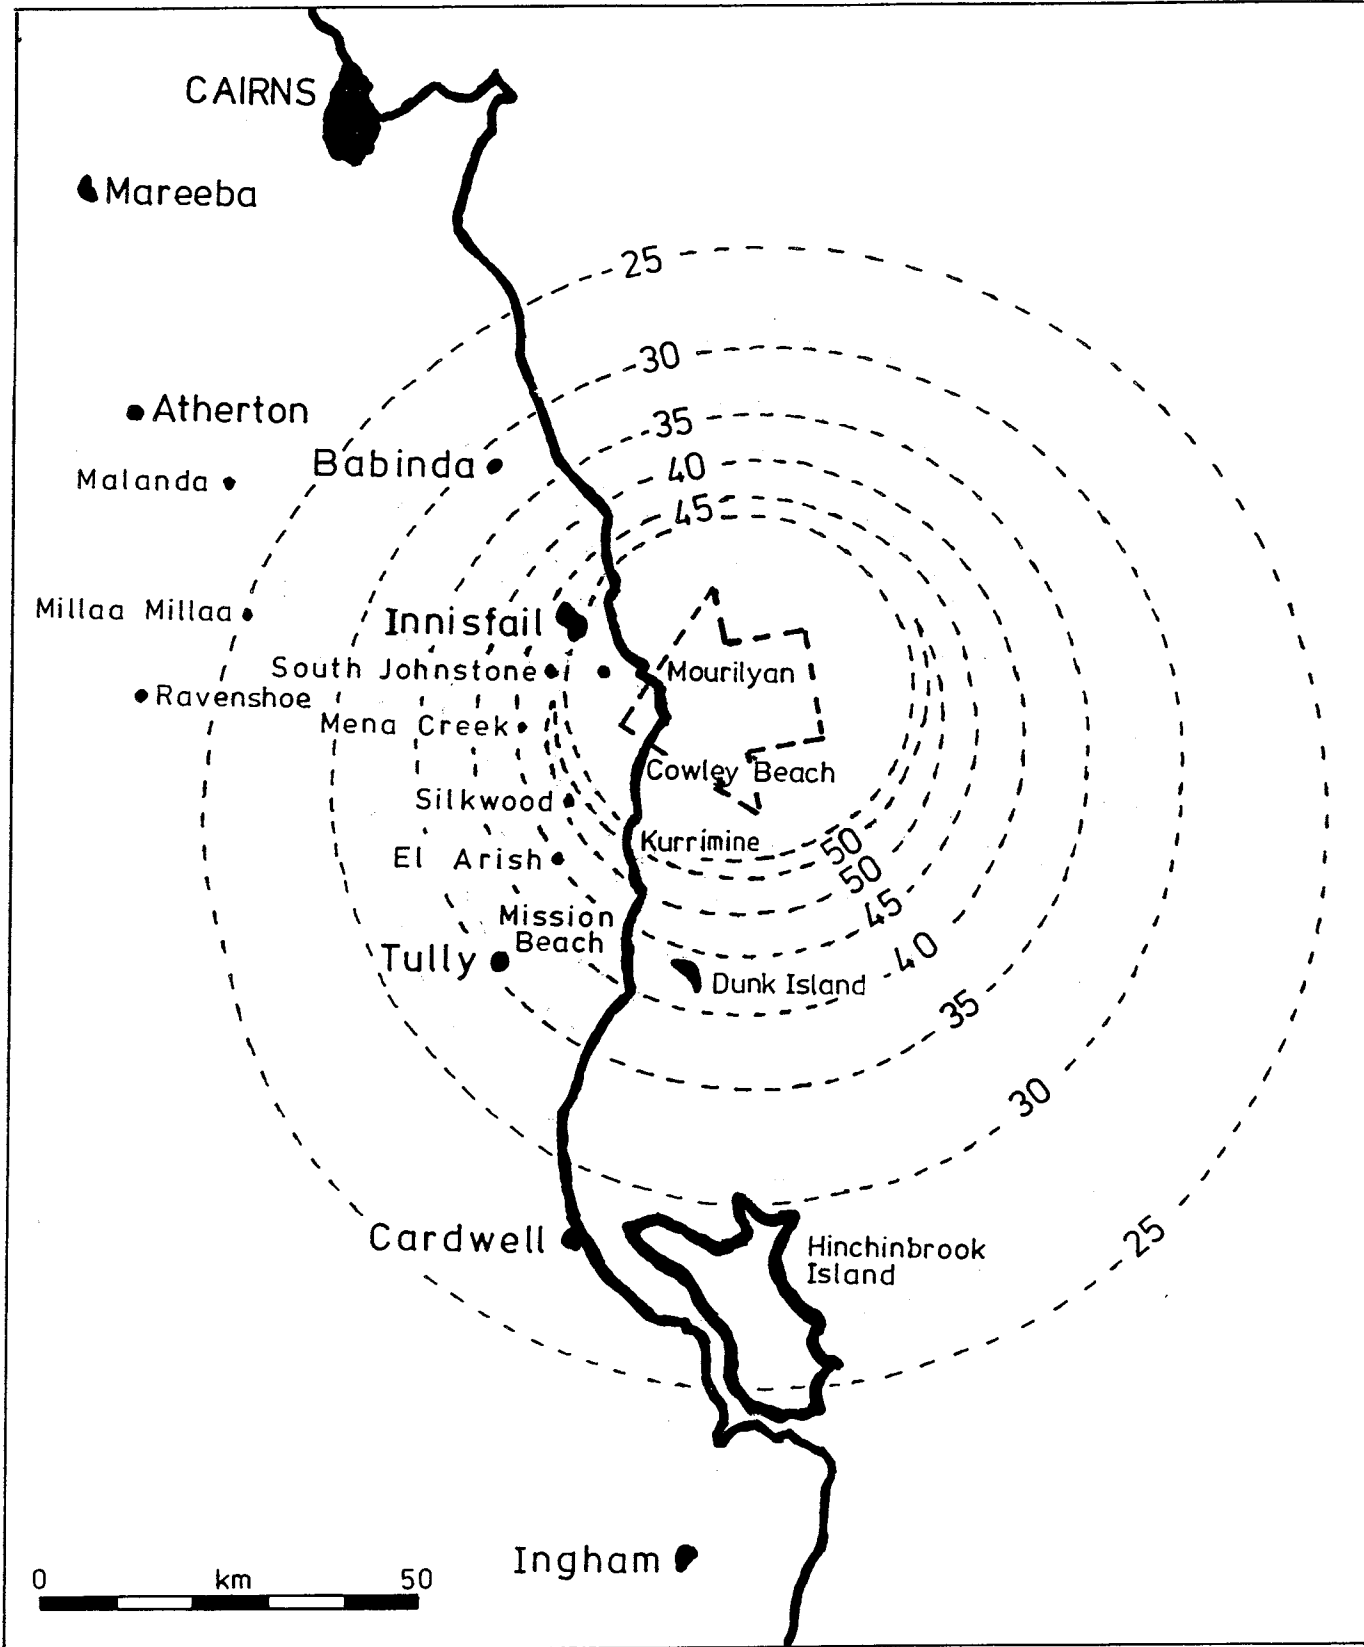
However rarely is the land flat and featureless and cyclone Winifred highlighted how misleading this approach can be when the topography is very rough as it is in North Queensland. Figure 7 shows the pattern of estimated maximum gust speeds based on a gust ratio of 1.45 just prior to Winifred crossing the coast. Apart from near the centre of the cyclone the pattern of building damage and the measured wind speeds at Cairns indicate this is a poor representation of the actual wind gust speeds that occurred in Winifred. The reason for this is believed to be the very rugged topography of the area.

Figure 7 suggests that the highest wind speeds would have been experienced in the Kurrimine Beach to Bingil Bay area with maximum wind gusts between 50 and 55 m/s occurring, which is consistent with observed wind damage. Away from this area however there are many inconsistencies. For instance Figure 7 suggests that Tully and Innisfail should have experienced similar wind speeds with maximum wind gusts between 45 and 50 m/s and Babinda and Cardwell much less with maximum wind gusts of the order of 35 m/s and 30 m/s respectively. Yet observations of wind damage suggest that while the wind speeds in Innisfail may have agreed with this estimate, the wind speeds in Tully were much less than in Innisfail, the wind speeds in Babinda were similar to those experienced in Innisfail, and the wind speeds in Cardwell were less than would have been expected from this analysis.

Figure 7 Postulated Maximum Gust Speeds as Winifred Approached Land. Based on Cyclone Windspeed Model Over the Sea.

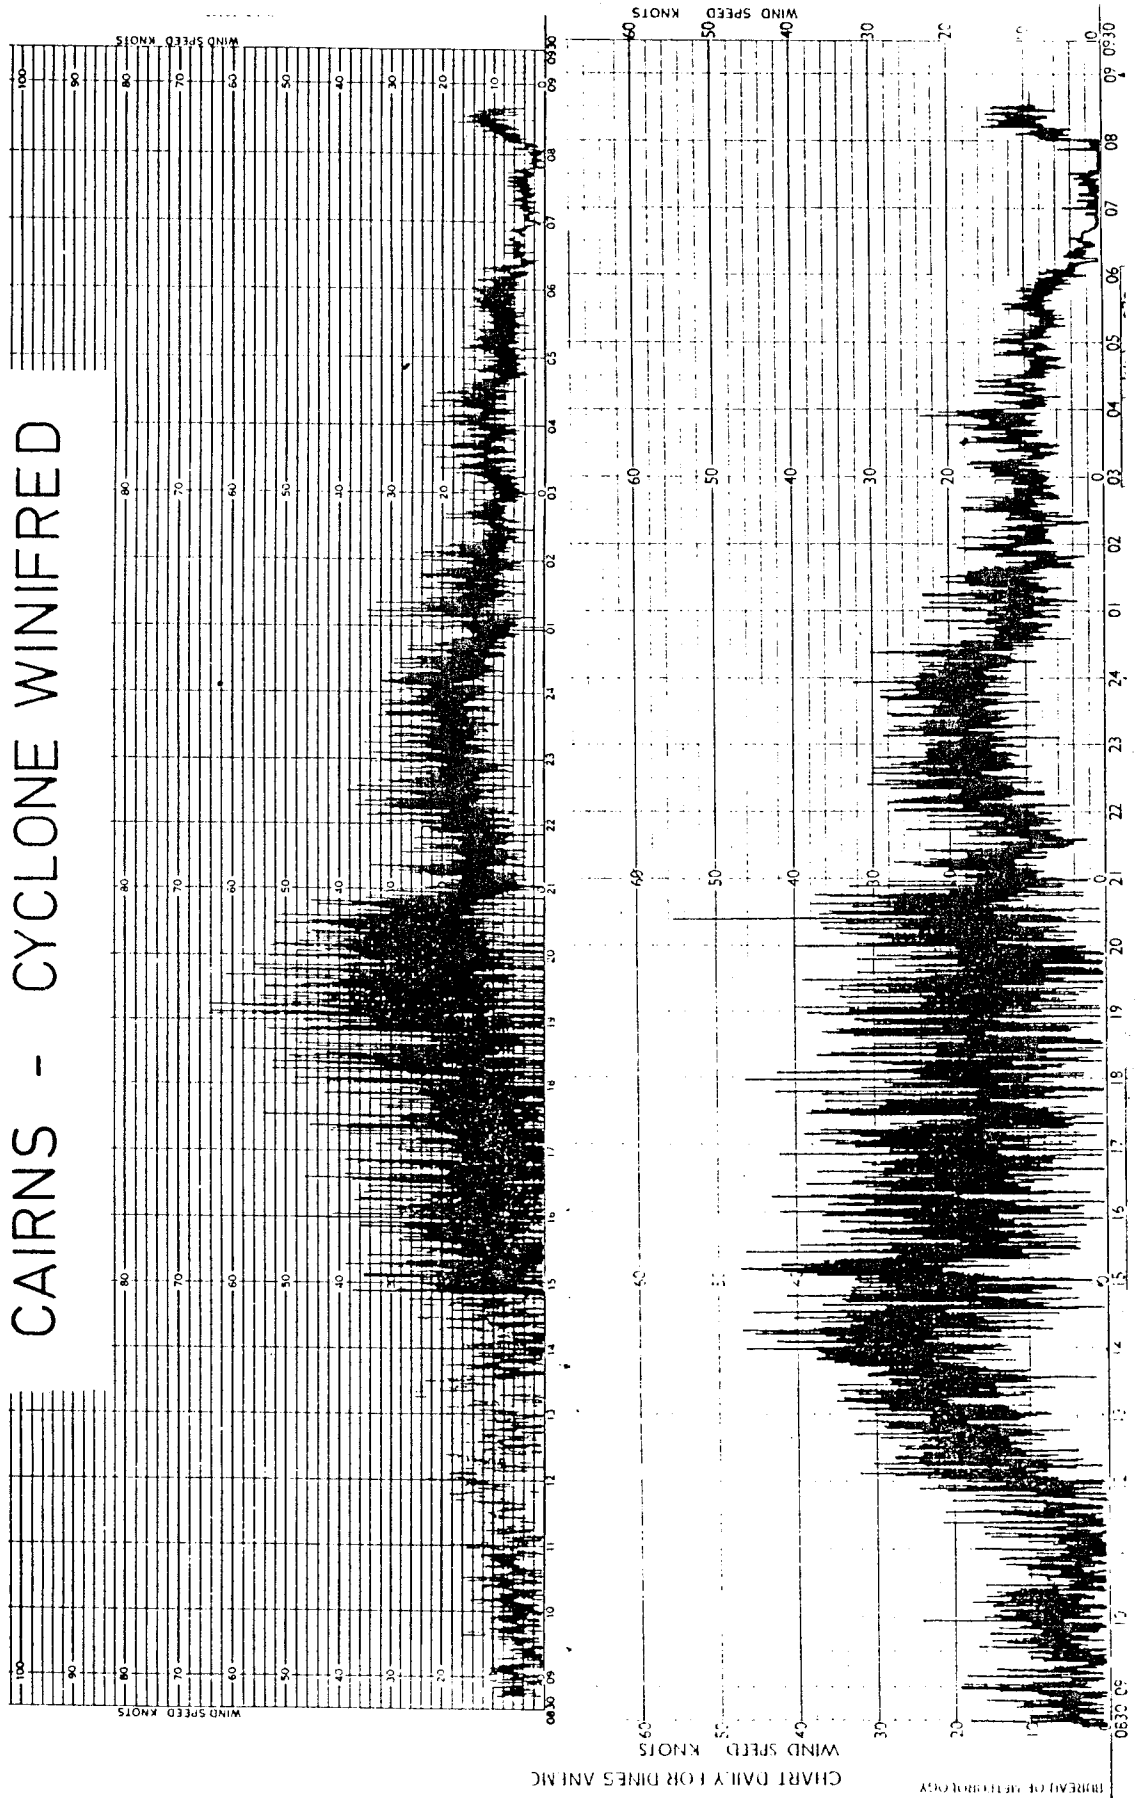
The wind records obtained at Cairns by the Bureau of Meteorology highlight the effect that topography can have on wind speed patterns. The Bureau operates two anemometers at Cairns Airport approximately a kilometre apart. Figure 8 shows the two wind speed records obtained from these during Winifred. The most striking feature is the difference between the two records. One measured a maximum wind gust of 33 m/s at about 7.15 p.m. and the other a maximum of 29 m/s over an hour later, and the shape of the two records is quite different. The difference is believed to be due to the close proximity of a large hill, with the highest reading being obtained from the anemometer closest to the hill due to local acceleration of wind around the edge of the hill. It will also be noticed that both the maximums are well above the expected value based on Figure 7. However closer inspection will show that the mean wind speeds were at all times less than 15 m/s which is consistent with Figure 6 and indicates that it is high gust ratios in excess of 2 due to very high levels of turbulence that are the principal reasons for the high maximum gust speeds, again highlighting the significance of topographic effects on wind speeds over land.

Figure 8 Records of Windspeed Obtained at Cairns Airport During Cyclone Winifred.
