CYCLONE TESTING STATION

SIMULATED CYCLONE WIND LOADING OF A BRICK VENEER HOUSE

TECHNICAL REPORT No. 28

G.F. REARDON

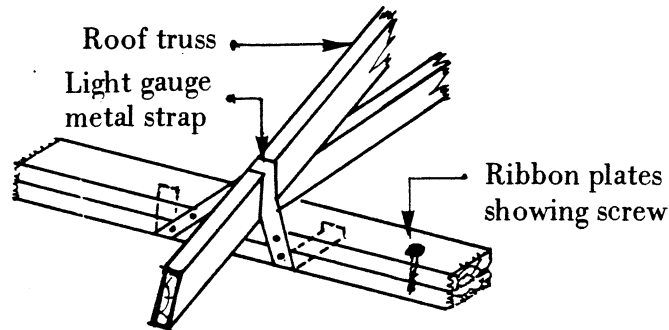
Figure 4 Looped Metal Strap as Truss Tie Down

Combined cyclic uplift and lateral loads were applied to the house to simulate the gustiness that occurs during a tropical cyclone. This form of loading caused failure by cracking of the light gauge metal straps tying down the trusses, prior to completion of the loading schedule. The metal straps were replaced by framing anchors and the cyclic load testing repeated. The framing anchors performed somewhat better than the straps although some of them cracked also.

Roof fixings: Trusses were secured to wall plates with looped metal straps, as defined in the Home Building Code. They were 30 x 0.8 mm perforated metal straps taken over the top of the roof truss, looped under the top plate and up the inside face where it was fastened with two 30 x 2.8 mm nails. Figure 4 shows the detail. The trusses in the garage were attached to the deep lintel over the doorway with two framing anchors, as would be the case in practice.

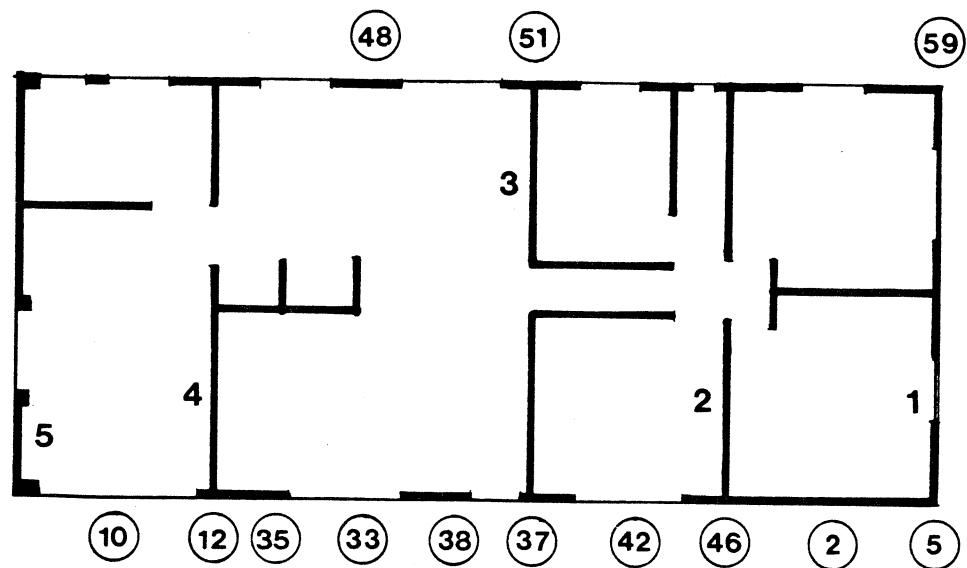
Figure 18 Location of Gauges Measuring Horizontal Displacement

The location of the internal transverse walls braced with diagonal light gauge steel has already been indicated, but Figure 18 shows the position of those walls again together with the location of the horizontal displacement gauges that showed the most movement.

The new house configuration was then tested by incrementing the uniform horizontal load to a total of 60 kN. At this load gauge 2 registered 2.6 mm, gauge 42 read 2.2 mm and gauge 38 indicated 2.8 mm. All other gauges

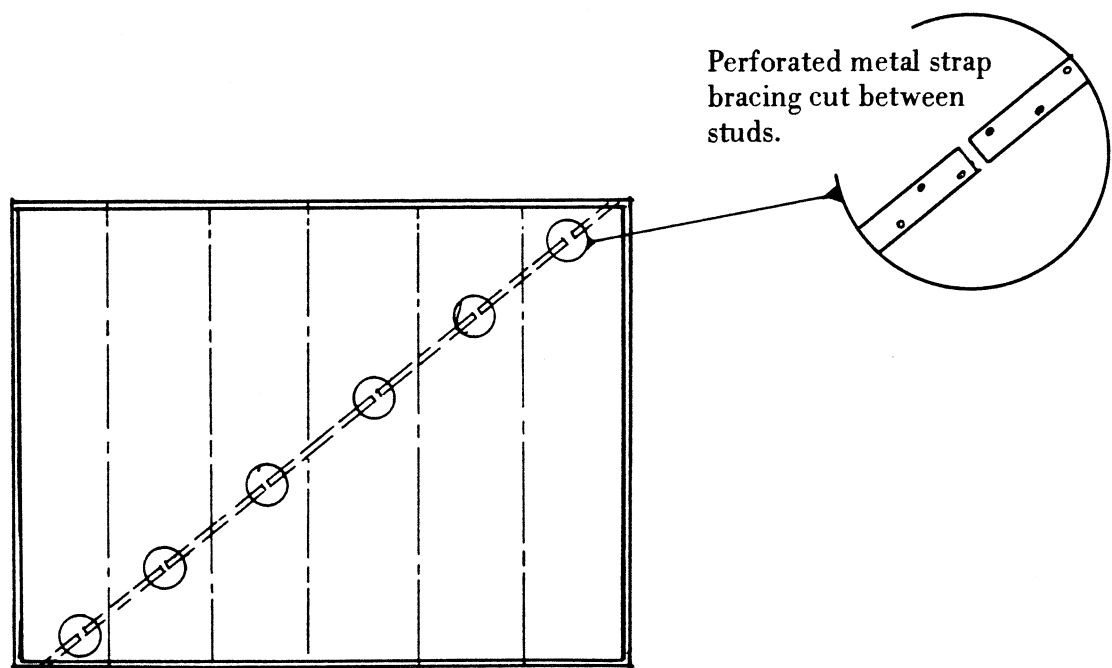
Figure 19 Method of Disabling Bracing Walls

The diagonal braces in wall 3 were then disabled by drilling holes in the plasterboard and fibre cement linings and cutting the braces between each stud and between the appropriate stud and the top or bottom plate. Figure 19 illustrates the effect. The connection between the top of the bracing wall and the roof trusses, as shown in Figure 3, was also dismantled. This alteration meant that there was no specified bracing wall between bracing walls 2 and 4 which were just more than 9 metres apart.

registered less than 2 mm. This overall response of the house indicated that it was stiffer without bracing wall 3 than with that wall. Of course this is a most unlikely situation. The outcome of less displacement probably reflects the usual response of a nailed timber structure by "settling in". This process of settling in means that the timber frame absorbs all tolerances and any other non-elastic deformation in the first load cycle and therefore appears to be stiffer on subsequent loadings. The main result from this test is the indication that the house is not noticeably weaker or more flexible because the braces were disabled.
