SIMULATED WIND LOADING OF A MELBOURNE STYLE BRICK VENEER HOUSE

TECHNICAL REPORT No 34

November 1988

G. F. Reardon
and
M. Mahendran

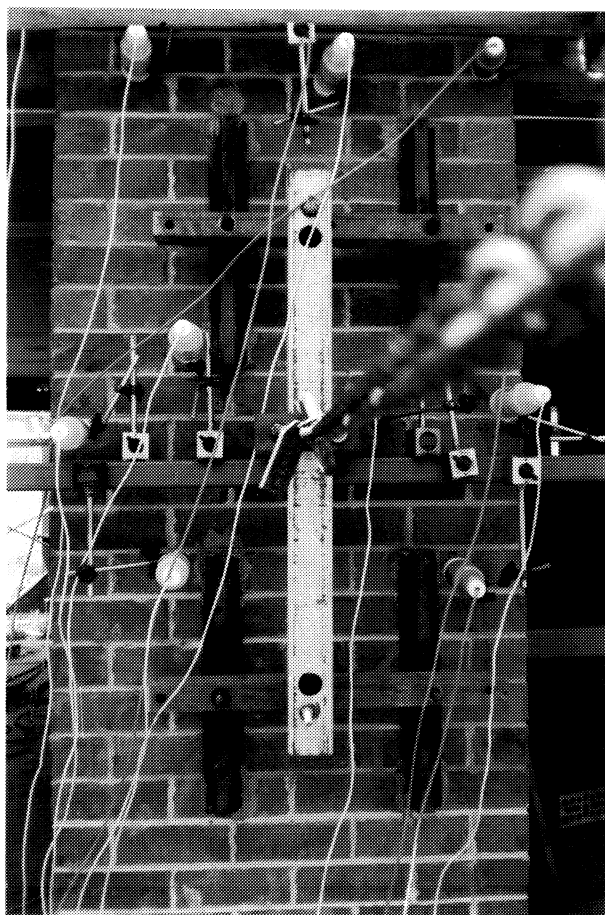
FIGURE 17 Simulated Suction on Brickwork

The suction forces acting on the brickwork were simulated by glueing individual loading pads at uniform spacing over an area of brickwork and pulling on them with a hydraulic ram via a wiffle tree. Figure 17 illustrates the principle. Constraints on the loading system were such that only short panels of wall could easily be tested. The system was ideal for testing the short lengths of new brickwork in the lounge and it was tried on some other lengths between window openings. As the strength of the panels loaded in this manner would be very much dependent upon the wall ties, care was taken to ensure that the load was applied symmetrically with respect to the ties. Also, in some instances, the extra ties that are required alongside an opening were cut so that those left for test would be at approximately normal spacing.

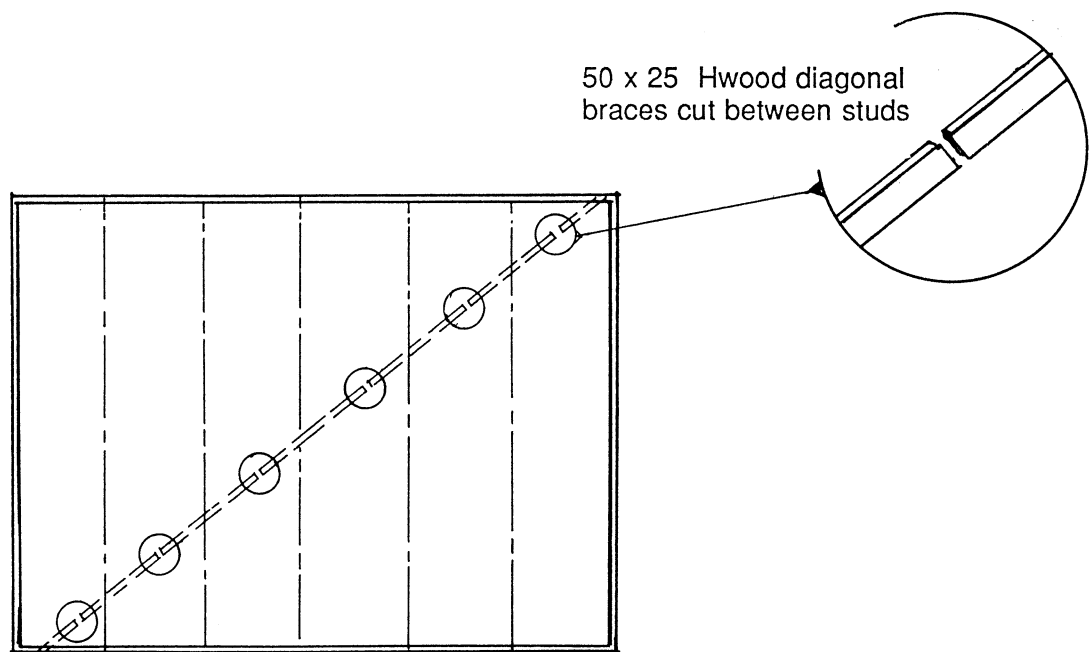
FIGURE 22 Disabling Wall Braces

Almost all of the timber framed walls were braced with diagonal timber members, the only exception was the short kitchen/laundry wall. In this series of tests the braces in each wall were in turn cut between each of the studs and then a racking test was conducted. The studs and braces were located with the aid of a stud finder. As a basis for comparison, a racking test was also conducted before any of the braces were cut. When cutting the braces between each stud, care was taken to ensure minimal damage to the plasterboard. Figure 22 shows the technique. The procedure of disabling the braces in a wall and testing was then continued until all braces had been cut.

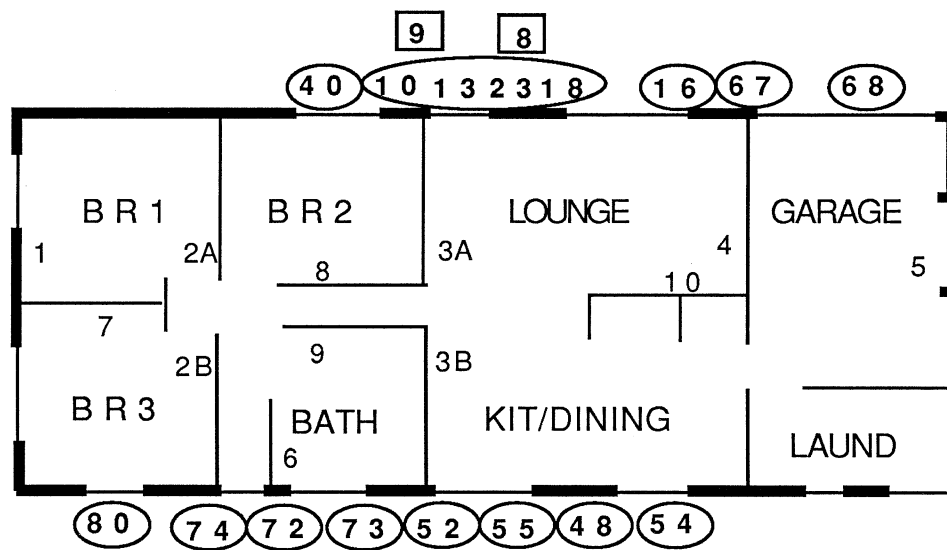
FIGURE 23 Location of Bracing Walls and Important Displacement Transducers for Exploratory Wall Racking Tests

Figure 23 shows the wall numbering system used for these tests as well as the location of the lateral displacement transducers that responded the most during the series of tests on disabling. The numbers in circles represent gauges on the timber top plate and those in squares represent gauges measuring movement at the top of the brickwork. The other numbers represent the walls, 1 to 5 being the main transverse walls, 6 being the bathroom wall and 7, 8, 9 and 10 being longitudinal walls. Walls 2 and 3 have been designated A and B to allow separate reference to each of the diagonal braces in them.

As can be seen from gauge positions shown in Figure 23, almost all of the major lateral displacements occurred on the windward face. The only significant movement on the leeward face was measured by gauge 48 at the middle of the top plate in the kitchen/dining area wall. This lack of

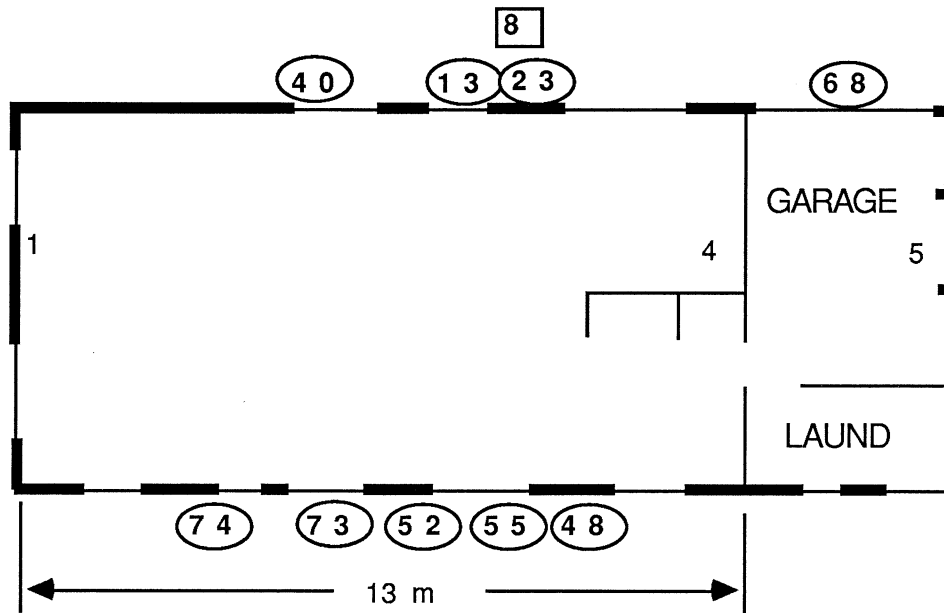
FIGURE 24 Nominal Plan after Removing Internal Wall Lining

Virtually removing the internal walls meant that the ceiling must act as a horizontal diaphragm spanning from wall 1 to wall 4, a distance of approximately 13 m. Figure 24 shows the nominal plan of the house with its open area. Even with the house in this condition the ceiling was able to transfer the horizontal forces by acting as a very deep beam between the remaining transverse walls. In doing so, it caused significantly greater lateral displacement at the top plate of the leeward wall. Table 15 lists the displacements measured along the leeward wall during the sequence of removing the plasterboard. The gauge locations and wall numbers have been given in Figure 23.

Again, putting the results into perspective, maximum displacements of only 7 mm were recorded for the house with a nominal plan as shown in Figure 24, when loaded by racking forces equivalent to 8.1 times the design lateral pressure for Melbourne. These racking forces were also equivalent to 6.5 times the design lateral pressure for Sydney and 5.0 times that for Brisbane. (For Regions A and B the ratios are 7.4 and 5.2, respectively.)

A final uplift and racking test was conducted to determine if the house with its very open plan (Figure 24) could still resist significantly high wind forces. The overall performance and the mode of failure have already been described in Section 6.4. The pressures at which failure occurred was equivalent to 6.0 times the design wind conditions for Melbourne. Just prior to failure the windward wall had a maximum lateral displacement of 15.4 mm at gauge 40, 13 mm at gauges 13 and 23 and 12 mm at gauge 68 and at gauge 8 on the brickwork. On the leeward face maximum displacements of 9.5 mm were measured at gauges 73 and 55, with 8.4 mm at gauge 52 and 7.7 mm at gauges 74 and

48. These greater displacements at lower lateral loads are caused by the uplift pressures removing the benefit of the mass of the tile roof. There would have been a frictional effect between the roof structure and the top plates during the racking tests without uplift loading.
