**Damage investigation of buildings at Minjilang, Cape
Don and Smith Point in NT following Cyclone Ingrid**

Report: TR50
September, 2005

TECHNICAL REPORT NO. 50

**By
David Henderson and Cam Leitch**

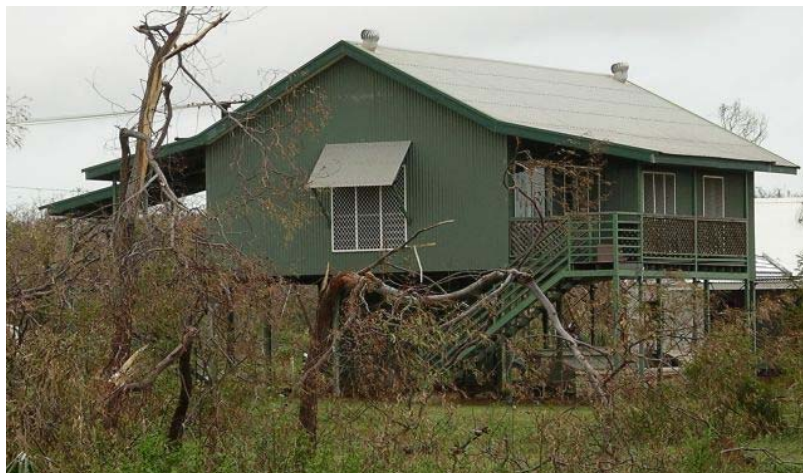
Typically housing that was constructed in the past 10 to 15 years survived with minimal structural damage from wind loads observed (Figure 9 and Figure 10). Impact from wind driven debris, fallen trees, flashing loss (Figure 11) and soffit loss was noted.

Figure 9: Recent construction

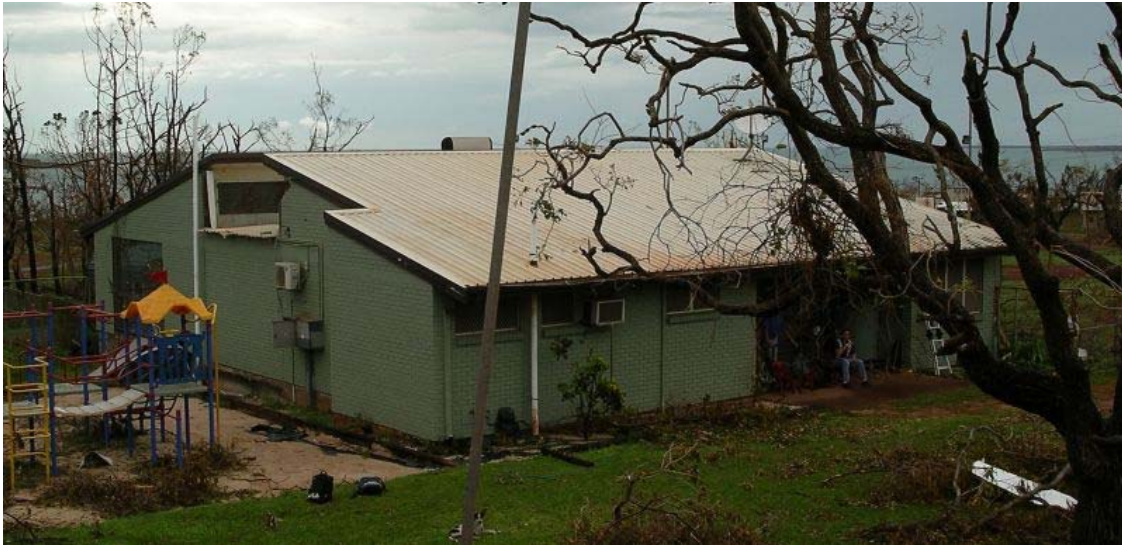
The brick single storey early childhood centre (Figure 22) acted as a shelter for some of the residents including teaching staff. Although structurally withstanding the severe wind forces, we were advised that the water ingress added to the trauma of the situation.

Minor structural damage was observed;

- loss of some flashings,
- damage to the brick skin adjacent to a gable truss end where a satellite dish was attached, and

- damage to polycarbonate cladding which was adding some wind and water protection along the central glass louvred skylight.

Figure 22: Early childhood building
