# **Tropical Cyclone Larry**

**Damage to buildings in the Innisfail area**

**CTS Technical report: TR51**

**September 2006**

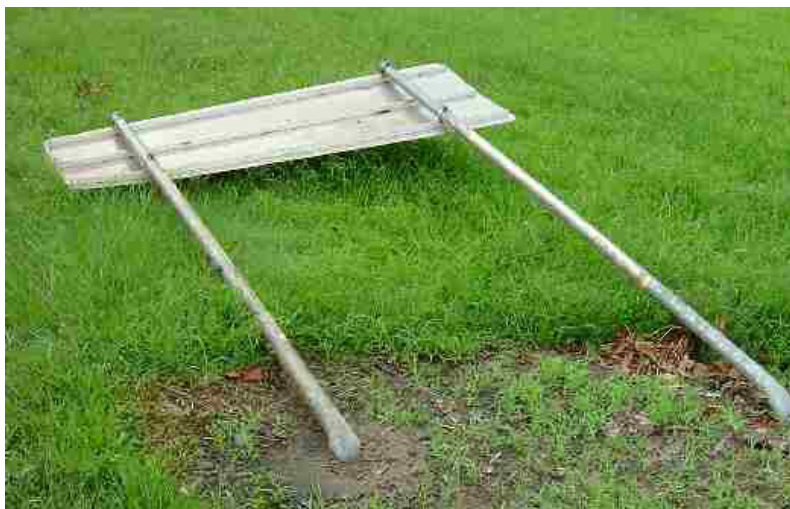
A large number of road-signs were examined during the study, and from these several were selected as providing the most reliable wind speed information. Figure 2.4 shows a bent-over road sign. Three point bending tests carried out on sample lengths of these posts give a plastic moment capacity of 4.1 kNm and a yield strength of about 420 MPa. The corresponding 10m height Terrain Category 2 (TC2) wind speed, to create the plastic hinge in the legs of that sign, is 43 m/s (L).

**Figure 2.4: Lower bound wind sign**

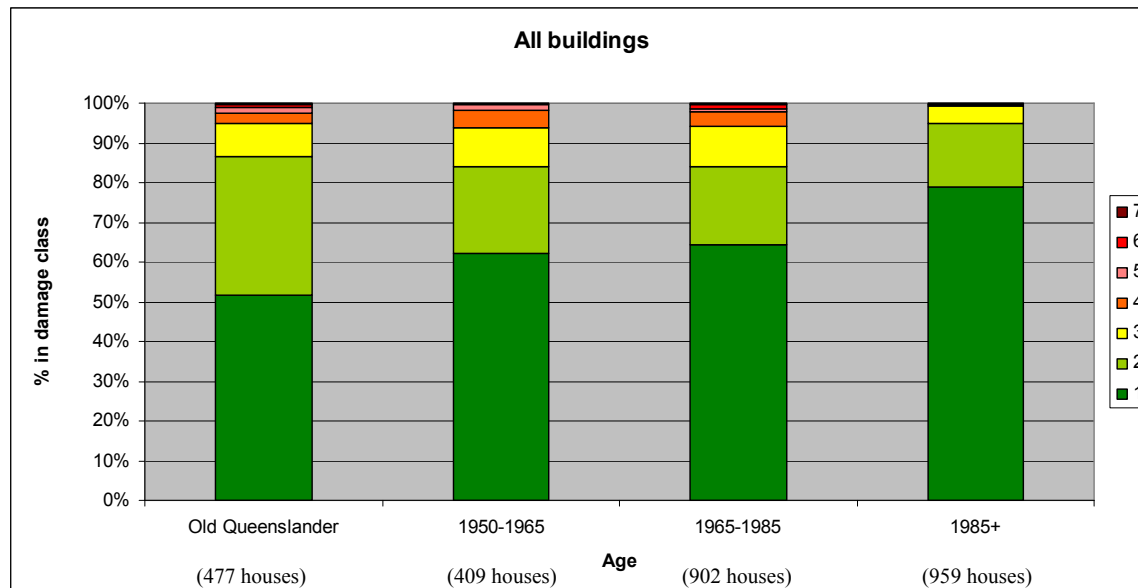
The results are presented as Percent of housing damaged vs Damage Index. Figure 5.1 presents this data for entire sampled housing stock (sample size 2747 houses), but subdivided amongst the four age classes of housing stock. It can be seen that overall, the more recent housing (1985+) had a much higher percentage of negligible damage (DI-1) than other age groups. This is reflected in the higher bar corresponding to damage index 1 for the 1985+ class compared with the other classes.

**Figure 5.1: Percentage of Houses vs Damage Index (All houses sampled)**

Figure 5.1 showed that housing of this era suffered the highest percentage of roof damage of all of the housing types.

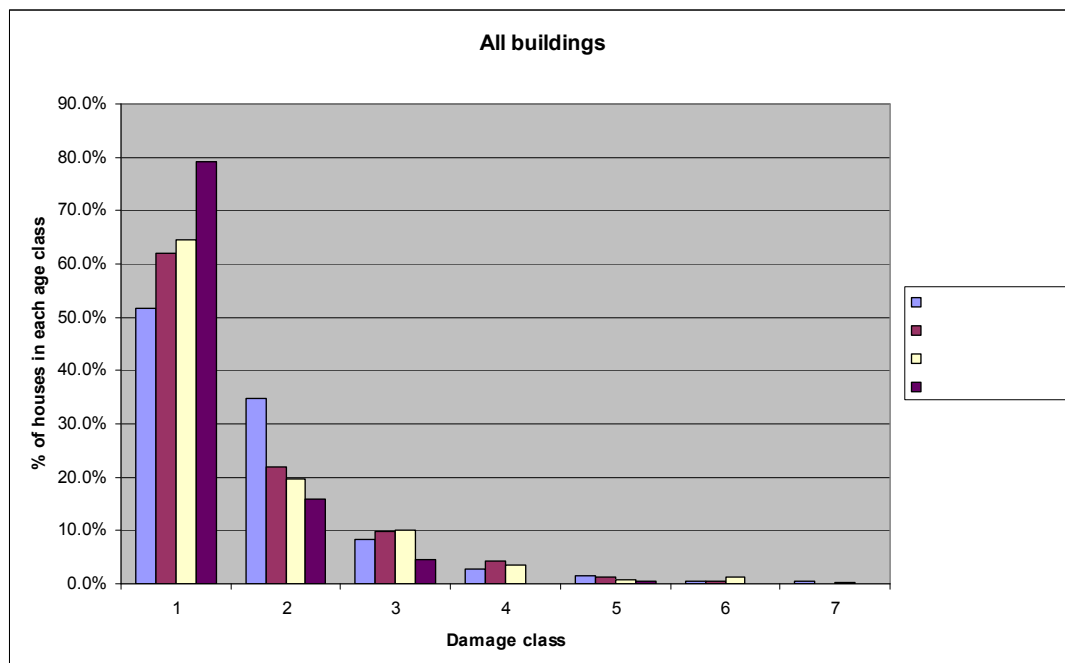
Figure 5.2 shows similar data across the whole damage survey area. However, in examining each damage class, it can be seen that the recent housing performed best when compared with other age groups for each of the damage classes.

**Figure 5.2: Percentage of Houses by Damage Index (All houses sampled)**

Figure 5.1 and Figure 5.2 show that contemporary housing has the least structural damage of all of the age classes.

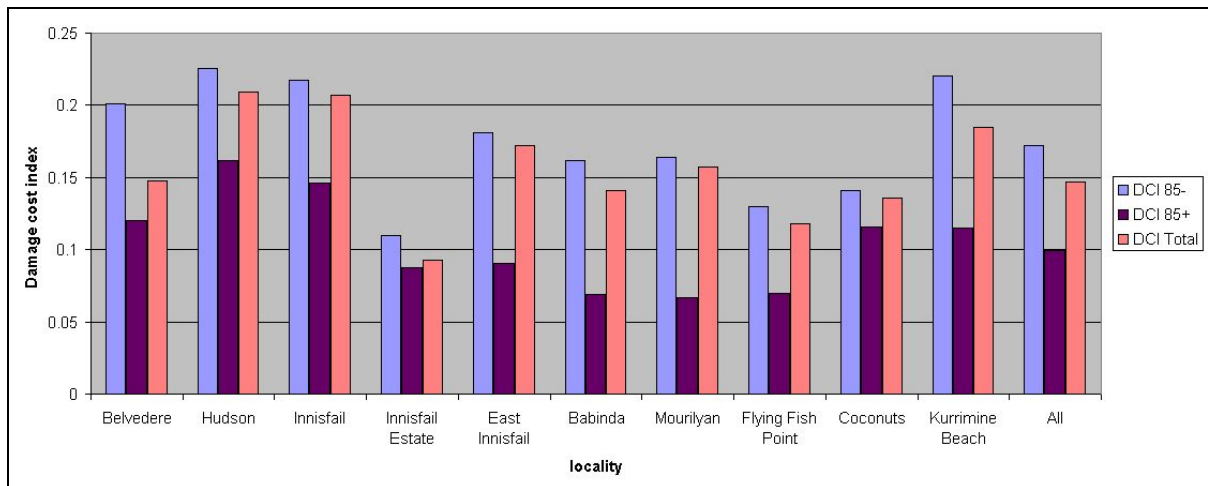
Figure 5.3 shows that in comparing contemporary housing (DCI 85+) with housing that was built before the Home Building Code (DCI 85-), the contemporary housing has the lowest Damage Cost Index.

**Figure 5.3: Damage cost index by age and locality**

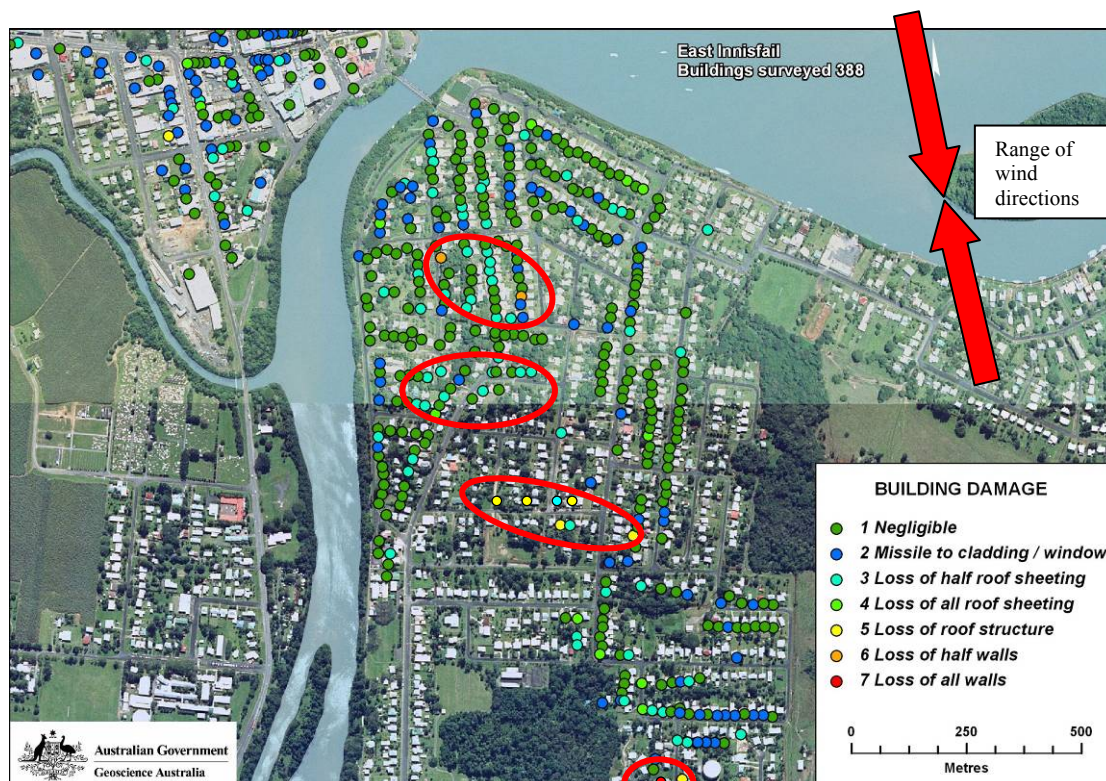
Figure 5.4 shows the damage index of surveyed buildings in East Innisfail superimposed on aerial photos taken prior to the cyclone. It shows that the damage to houses in East Innisfail appears to be concentrated around four hill tops (highlighted with red ovals). Many of the damaged houses pre-dated the 1981 Building Code [4] changes, but there was a noticeable difference in performance of hill-top houses with nearby houses of similar age in flat topography. A few recently constructed hill top houses also sustained significant damage.

**Figure 5.4: Damage map for Innisfail East**  
(Map courtesy of Geoscience Australia)

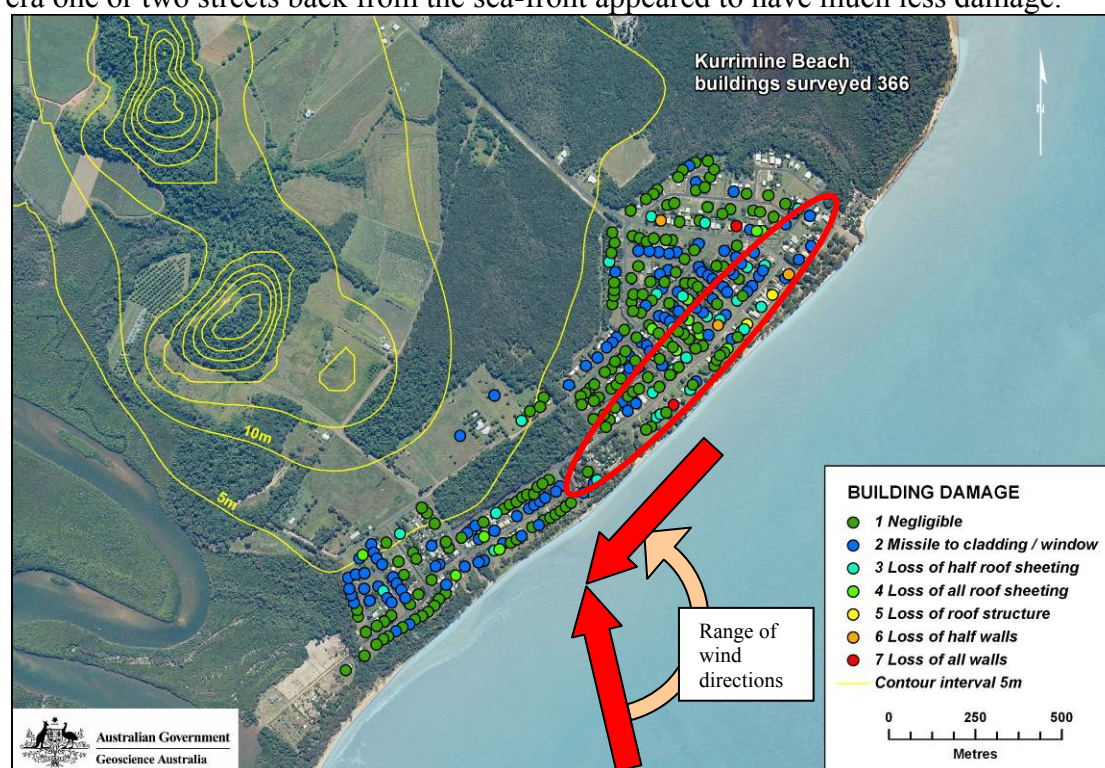
Many of the older houses along the ocean-front at Kurrimine Beach performed poorly, and a significant percentage sustained severe damage (Damage Index 5-7 – shown in Figure 5.5). The debris from these homes contributed to the failure of houses in adjacent streets. The upwind terrain during the early part of the cyclone was ocean, then a few coconut trees. The trees offered no shielding, but some of the failures in the first row of beach-front houses were initiated by coconuts or palm fronds breaking windows, producing internal pressurization. Where inadequate batten to rafter or rafter to top plate connections failed, significant roof loss occurred. Houses from a similar era one or two streets back from the sea-front appeared to have much less damage.

**Figure 5.5: Damage on Map of Kurrimine Beach**  
(Map courtesy of Geoscience Australia)

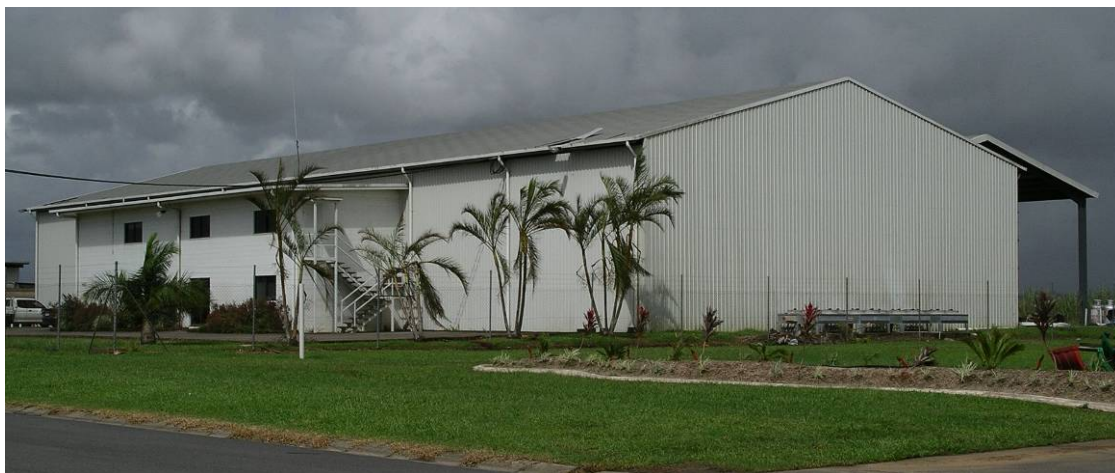
**Figure 5.6: Hot rolled steel framed shed**

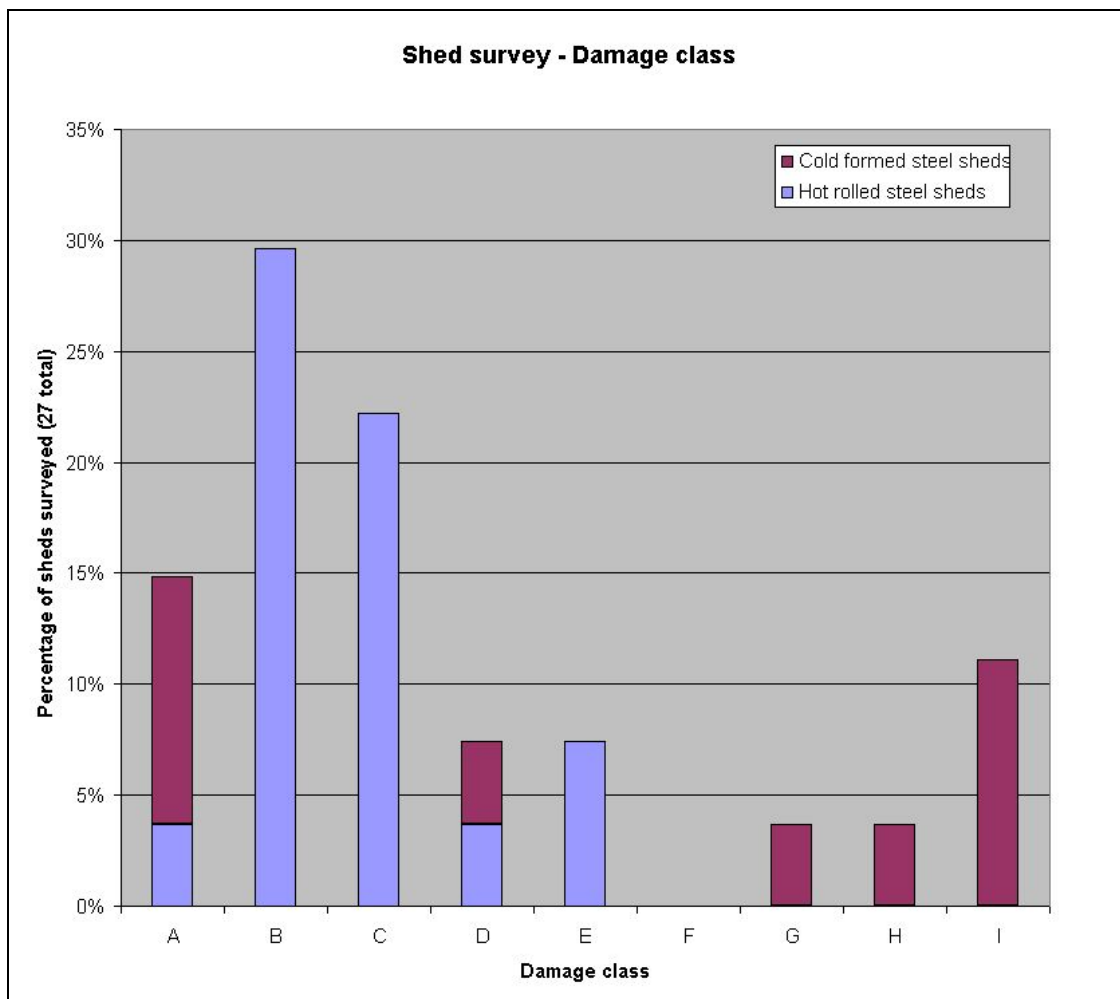
A street side assessment used the damage classes as given in Table 5.2. Although more than 40 sheds were surveyed, only 27 are presented in Figure 5.7, as they are from roughly the same Innisfail area. This is to minimise potential bias from varying terrain, wind speeds, etc. As only one damage category is allotted to each shed, the most severe one is reported.

Approximately 30% of these engineered structures suffered loss of cladding through to complete collapse. This is at wind loads less than the region's design wind speed where no structural failures should be expected. From the street survey the major structural failures (G, H, I) were all in the cold formed steel frame sheds. This is consistent with all the other shed inspection data, where major structural failures were observed in either cold formed sheds (Figure 5.8) or old timber trussed sheds (Figure 5.9).

**Figure 5.7: Street side survey of industrial sheds**

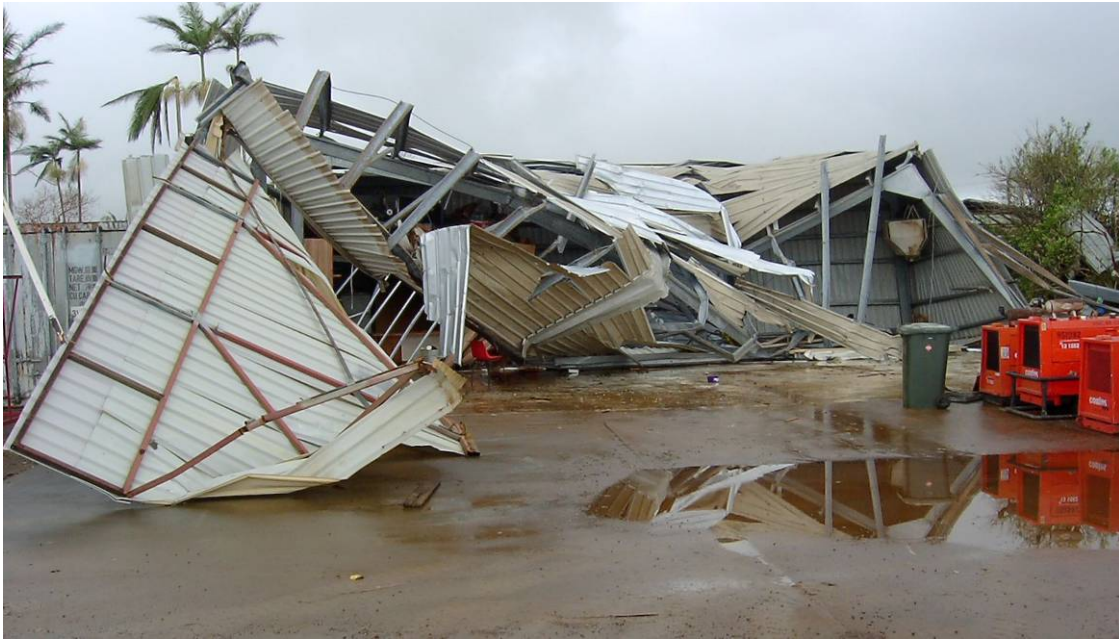
**Figure 5.8: Collapse of cold formed steel industrial shed**

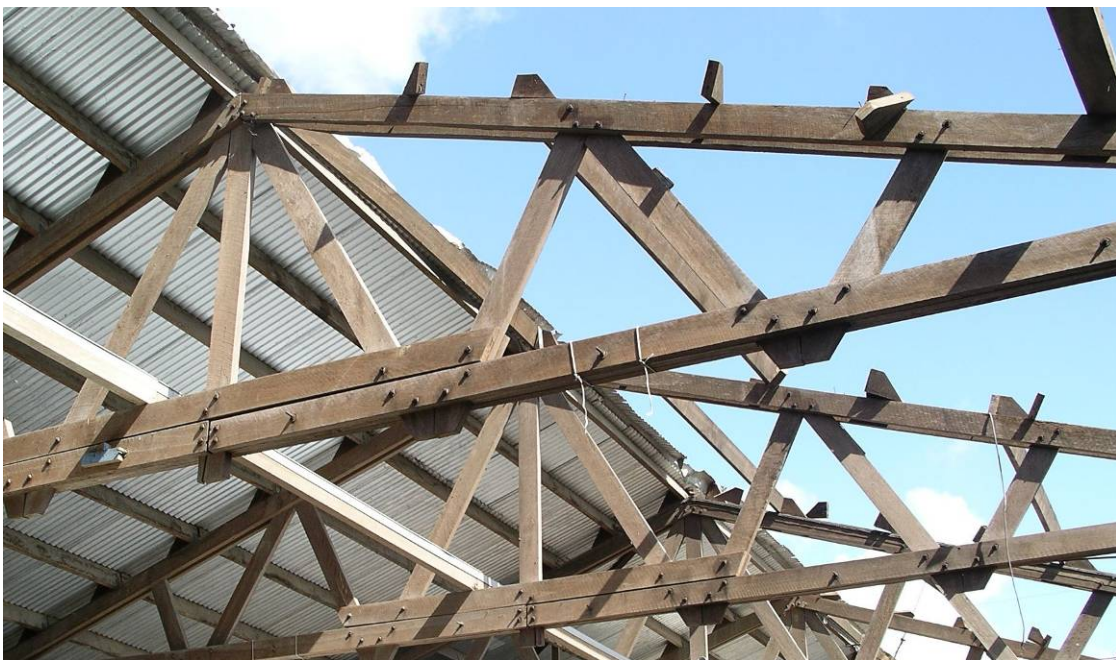
**Figure 5.9: Loss of timber purlins and new cladding from old industrial shed**

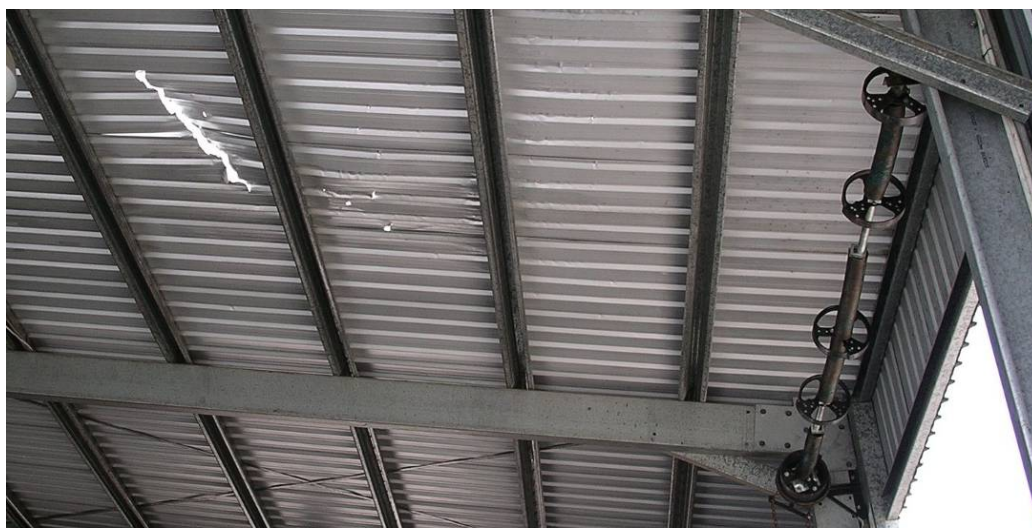
The ratio of the depth of the roller door slats or ribs to the span across the door opening is very small and so they are not very stiff when loaded with wind pressure (for either inwards or outwards loading). Consequently, the door midspan region undergoes large deflections when subjected to wind loads and this causes the ends of the slats or panel to be pulled inwards followed by the roller door failure when the sides become disengaged from the tracks. Figure 5.10 and Figure 5.11 show examples of roller door failure.

**Figure 5.11: Roller door curtain punctured roof cladding**

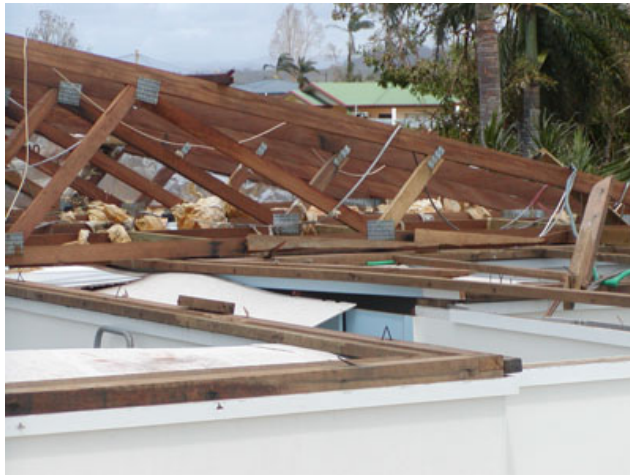
(a) trussed roofs

- The long span of trusses required more significant truss to wall plate anchorage than the previous rafter to top plate connections. Where insufficient uplift capacity was available in those connections, whole trusses complete with battens and roofing were lost.
- Graded-purlin roofs also suffered from the same problem as also shown in Figure 6.7 (b). Often in these cases, the anchorage at the edge of the roof was

**Figure 6.7: Total roof loss**

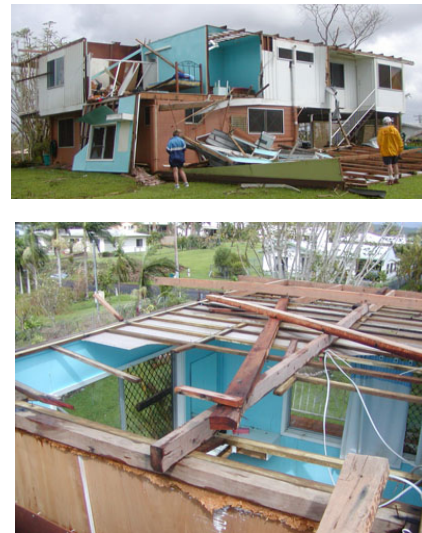
(b) graded purlin roofs

barely sufficient, but at the centre of the roof, there was a significant mismatch between uplift load and connection capacity. These roofs often opened up from the centre and rotated about the external walls.

For the roof shown in Figure 6.7 (b), the roof parted down the centre with the wind parallel to the ridge line and the two halves of the roof were found on opposite sides of the house.

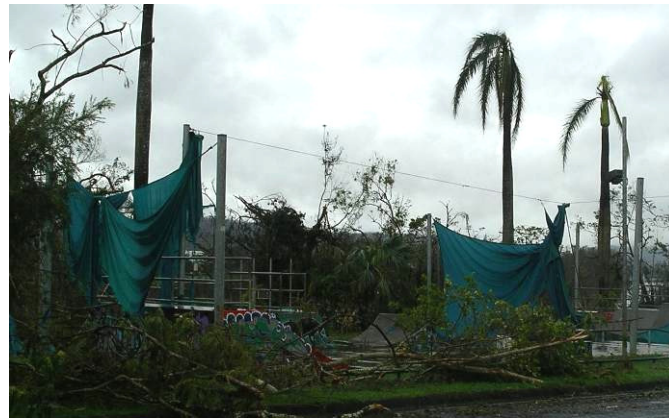
Failures of both tension membrane shadecloth and draped shadecloth structures were observed in some carparks, nurseries, entertainment areas and farms. It appears that these structures are designed for wind speeds lower than design and that the sunlight porosity is mistakenly used for wind load porosity. Once the shade cloth is ripped, the risk of the cables failing at the supports is minimal.

**Figure 6.15 Damage to shade cloth structures**

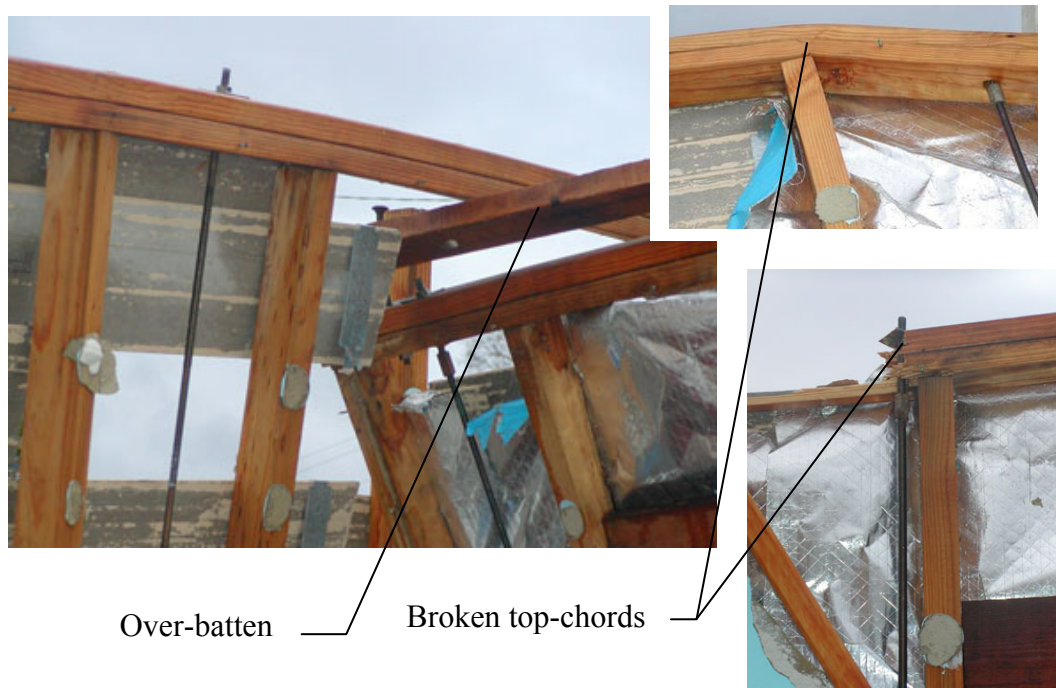
Overall, attention had been paid to anchorage of the structure in the house as shown by the extensive use of tie-down rods in the walls. Figure 7.1 shows that most of the wall tie-down rods remained effective, and though the walls were damaged once the restraint of the top edge was lost, most were still attached to the house.

**Figure 7.1: Wall anchorage intact**

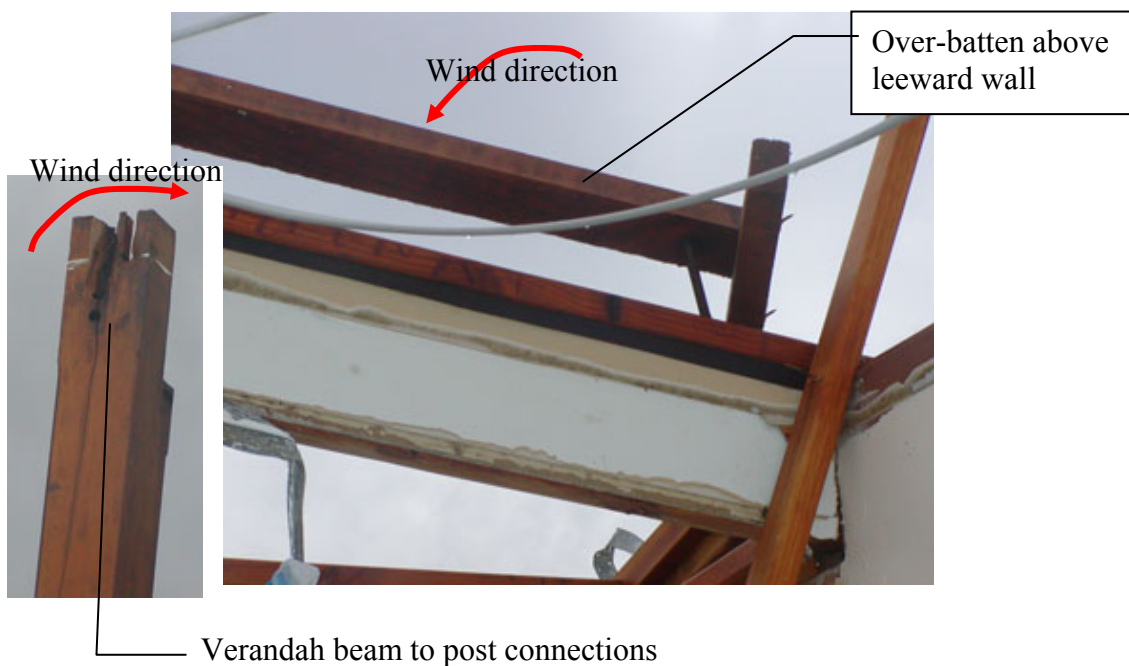
The roof was attached with bolted over battens ( $75 \times 38$  hardwood) over most of the external walls, but at the verandah which was exposed to the windward side, the verandah beam was bolted to the top of hardwood posts with two M12 bolts in halved joints. These bolts had pulled out of the top of the post at the windward end of the verandah and out of the verandah beam at the other locations. In other places on the windward wall, the over battens had broken and allowed the trusses to lift.

**Figure 7.2: Roof anchorage**

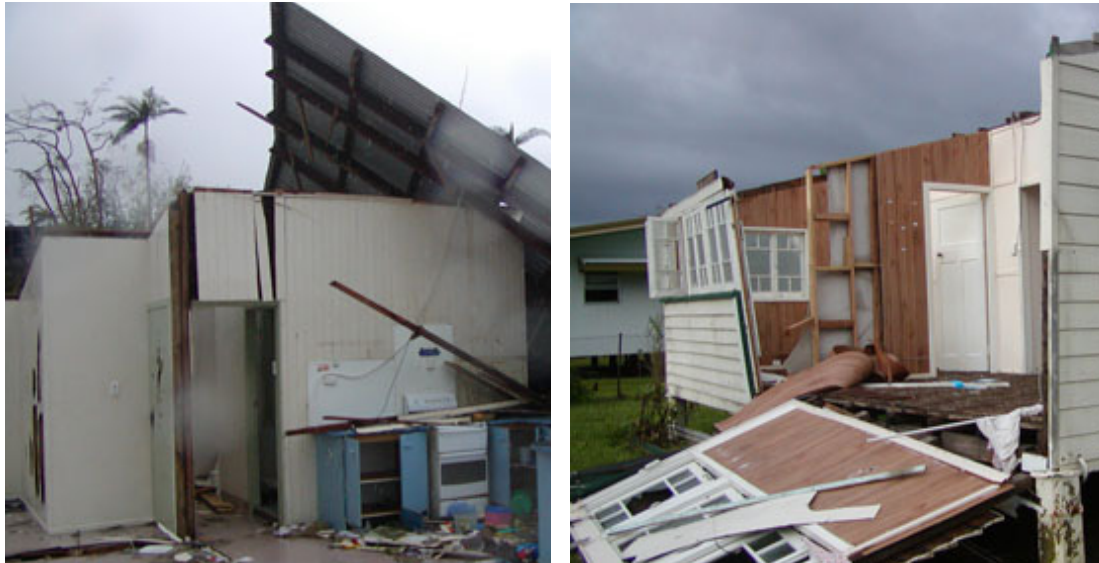
In this case, the failure of the roof was followed by failure of a number of the external and internal walls. It is shown in Figure 7.7(a).

This case was also an older house and here all of the roof structure had lifted off in one piece. The roofing was again screwed to battens with large cyclone washers to spread the load. However, there was no sign of framing anchors or overbattens in tying the rafters to the top plate. Rafters were skew nailed to the top plate through the birdsmouth in the rafter.

Some rafters near the ridge was supported on struts and these were still attached to the rafters, but had become separated from the ceiling plane at the base. The house without its rafters is shown in Figure 7.7(b).

(a) Spliced rafters separated from walls

(b) Total roof loss

**Figure 7.7: Rafter loss with skew nailing to top plate**

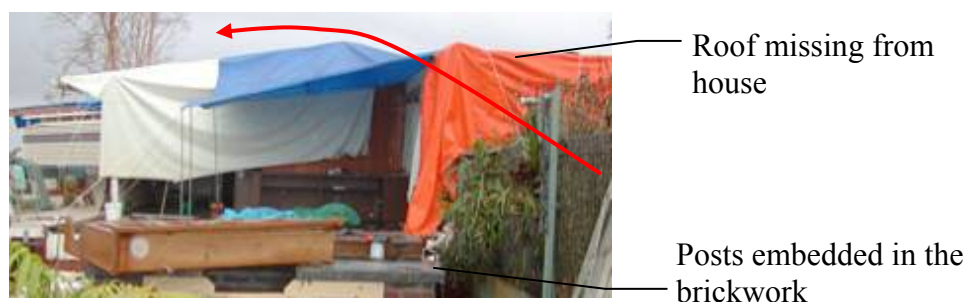
In this building, a barbeque area had been added to the house. Heavy timbers had been used, large diameter posts, and the owner believed that the structure was stronger than the roof structure of the house. It had been fixed to the house roof using heavy gauge steel brackets.

**Figure 7.12: Missing barbeque area roof**

However, the posts did not appear to have been bolted to the ground, but were simply encased in the brickwork that was part of the bar-be-que area. The early part of the cyclone had winds that placed the barbeque area on the windward side of the house and under high uplift generated by the roof, the posts pulled out of the brickwork and the roof folded back against the rest of the house. In being dragged backwards, the heavy steel brackets to the house roof tore off the roof over two rooms in the main house (Figure 7.12).

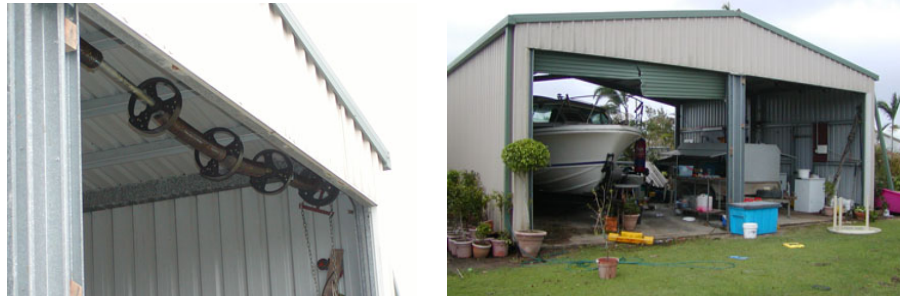
In this small shed, two roller doors failed. The doors were on the windward side at first and blew inwards. The slats bent sufficiently to also bend the spindle. The internal pressurisation of the building blew the leeward wall out.

**Figure 7.19: Failure of roller doors and back wall of shed**

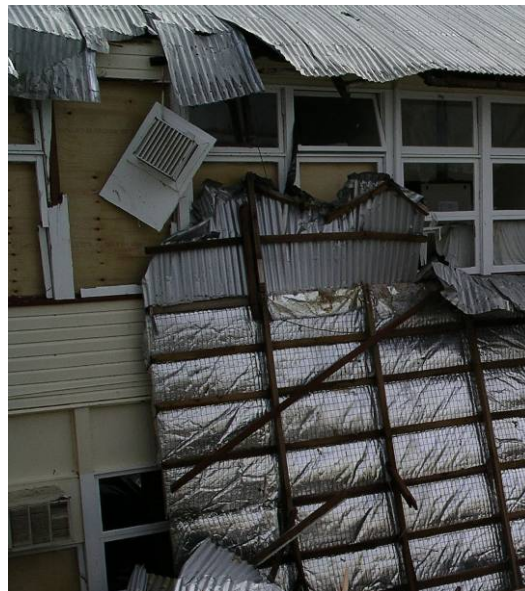
A class room block suffered severe damage with the loss of roof and walls as shown in Figure 7.20. The failure was at the rafter top plate connection with the resulting large sections of roof (cladding, battens and rafters) causing severe damage to adjacent blocks and accommodation (Figure 7.21). Due to the cleanup operations, close inspection of the wall top plate was not possible. It is postulated that the birds mouthed rafter connection to top plate was the weak link in the wind load path due to the upgrading of the roof cladding and batten connections. The windward wall collapsed inwards with the loss of support from the failed roof structure. It is interesting to note that an adjoining classroom block suffered similar damage during Cyclone Winifred [3].

**Figure 7.21: Impact damage from leaf of roof**

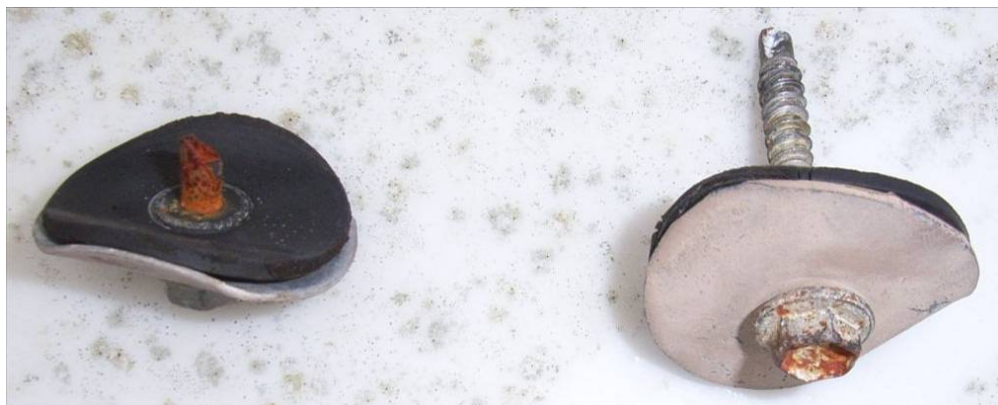
a) screw from unlined edge of roof

b) screw from main roof section

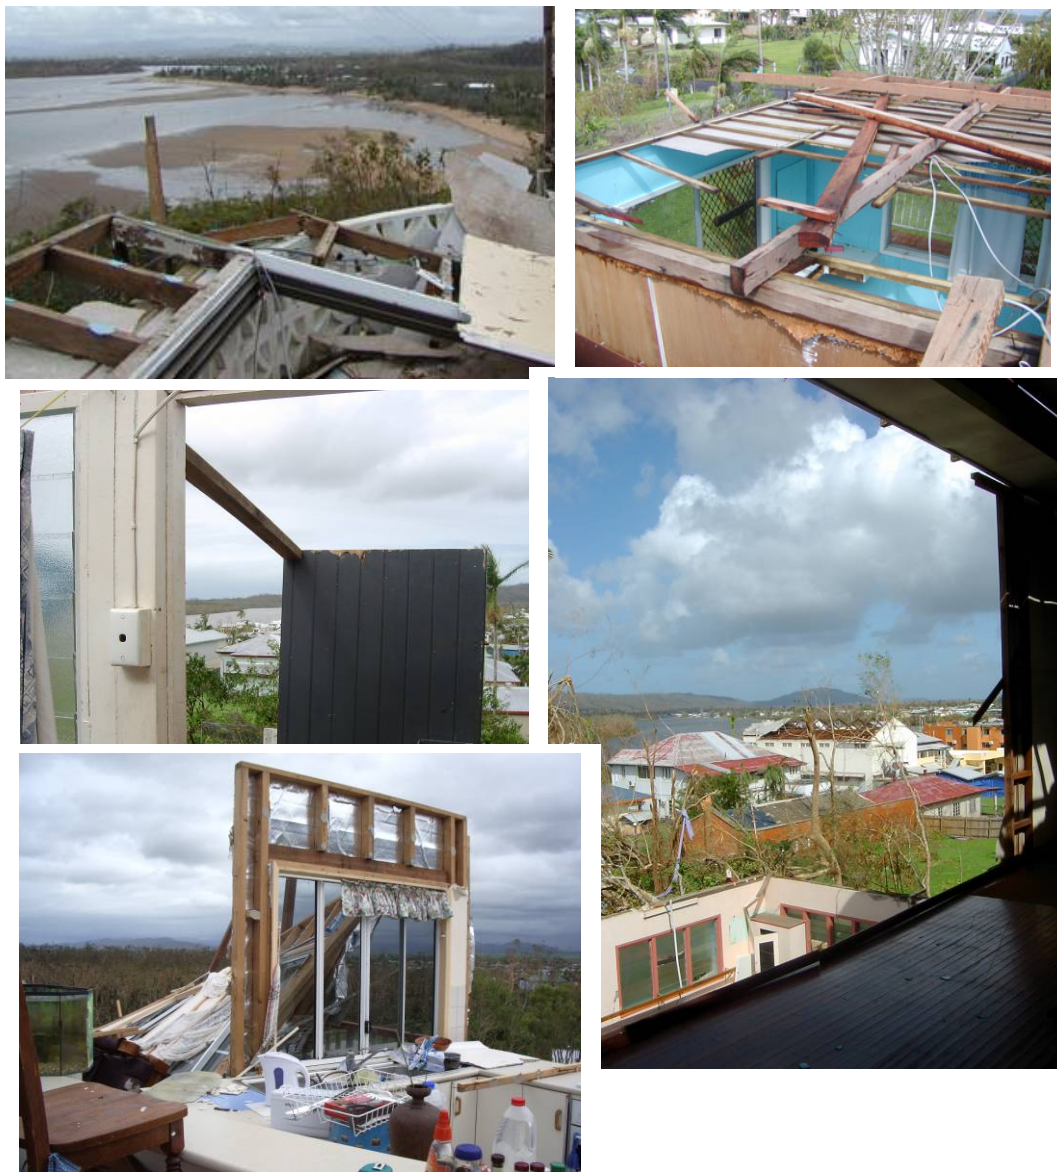
Figure 10.1 illustrates a number of sites in which a great view was accompanied by significant topographic speed up of the wind and resulting structural damage.

**Figure 10.1: High correlation between great view and very high wind speeds**

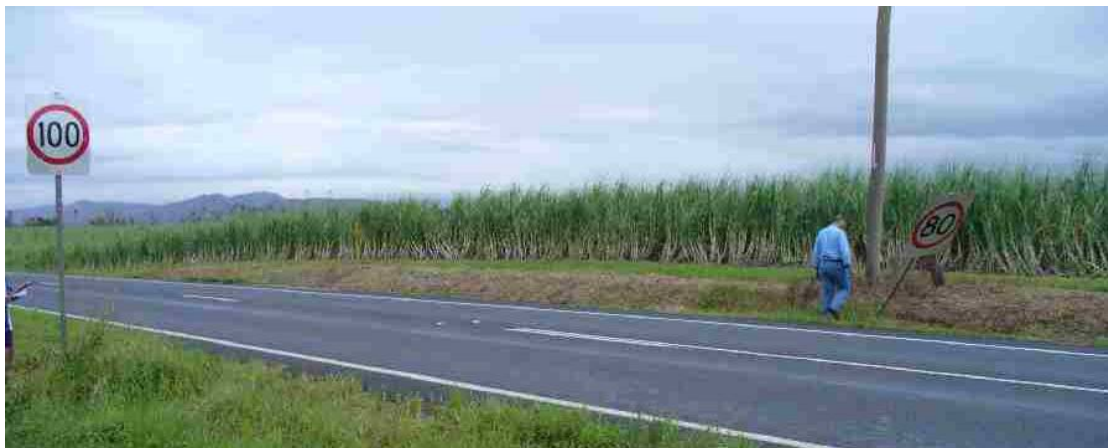
Figure A.3 shows a bent-over large signage area road sign and an upright smaller signage area road sign located across the Bruce Hwy just South of Innisfail. Three point bending tests carried out on sample lengths of these posts give plastic moment capacities of 4.2 and 4.1 kNm respectively. The corresponding 10m TC2 wind speeds required to create the plastic hinges are 51 (L) and 72 (U) m/s respectively, indicating that the maximum gust wind speed was between these two values in this area.

**Figure A.3: Upper (on left) and Lower (on right) bound wind sign (Bruce Hwy, south of Innisfail)**
