Investigation of Townsville Tornado, 20 March 2012

Report: TR58

June, 2012

Cyclone Testing Station
School of Engineering and Physical Sciences
James Cook University
Queensland, 4811, Australia

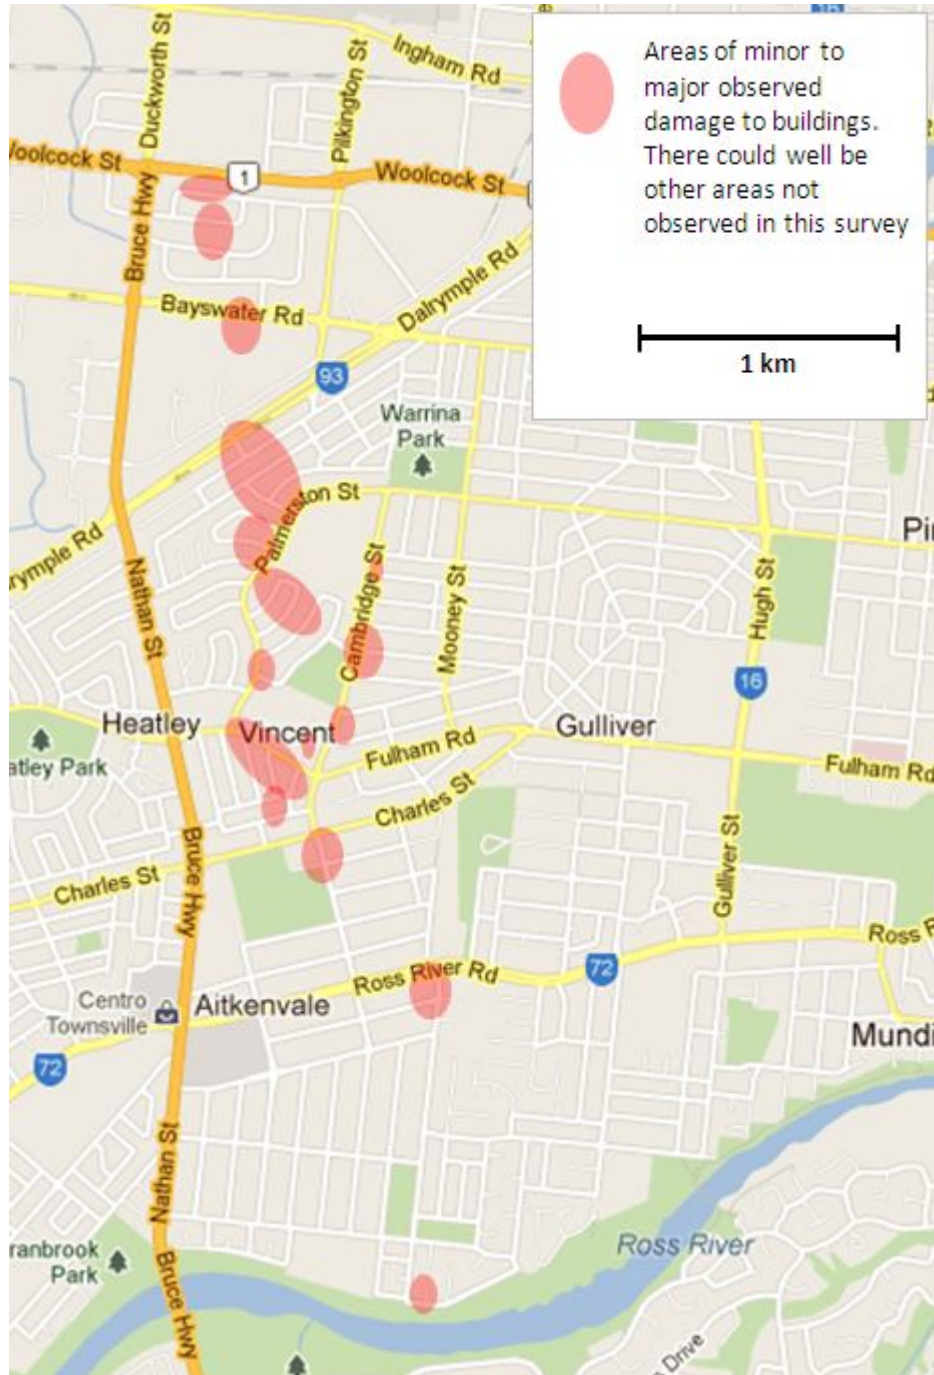
An overview of the observed damage footprint is shown in Figure 2.4. The storm track is devised by analysing the observed building damage and windborne debris patterns. The path runs for approximately 7 km in a NNW to SSE direction from Garbutt to Annandale. Vegetation damage (e.g. snapped and uprooted trees) was in a corridor of less than a kilometre wide with the observed structural damage in an inner 0.5 km band within this path.

Figure 2.4: Overview of damage footprint
(Base image reference: Google Maps, 2012)

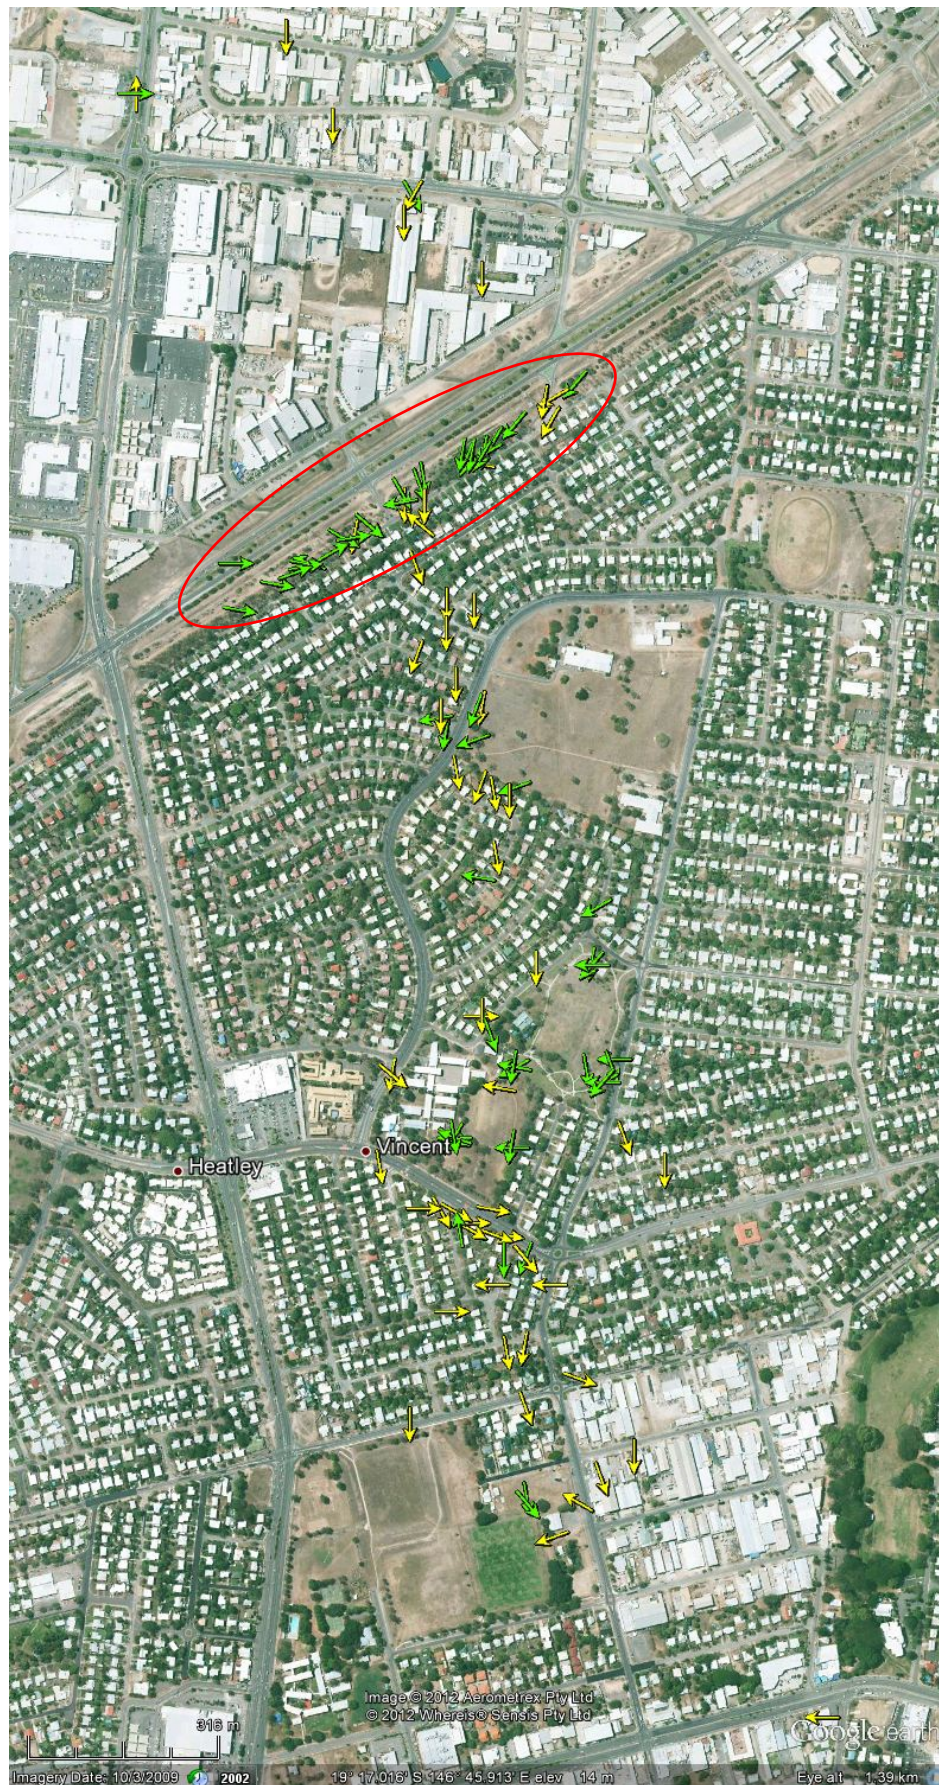
The damage survey also tracked windborne debris and snapped and fallen trees to determine wind directions during the event. Changing wind directions during the event will cause the debris to move in a composite path, thus only giving a general wind direction at a location of interest. The wind directions, summarised in Figure 2.5, are based on building damage, bent road signs, debris locations and vegetation damage.

The oval shown in Figure 2.5 highlights a region of tree damage along Dalrymple Rd (diagonal road running NE across near the top of figure). These trees are a mix of similar species planted in the same periods and were subjected to “similar” approach terrain winds. There is a pattern of tree damage directions (mix of up-rooting and snapping) pointing towards the centreline of the storm track (where the major damage to housing occurred). This indicates convergent wind direction associated with a tornado passage unlike divergent flows which might be expected in a thunderstorm down-burst event (ref: email correspondence; B. Harper and M. Mason, April 2012).

Figure 2.5: Wind directions estimated from debris locations and tree damage
(Red oval marking the tree fall/damage along Dalrymple Road; Base image reference: Google Maps, 2012)
