Investigation of Damage: Brisbane 27 Nov 2014 Severe Storm Event

CTS Technical Report No 60

February 2015

Investigation of Damage: Brisbane, 27 November 2014 Severe Storm Event

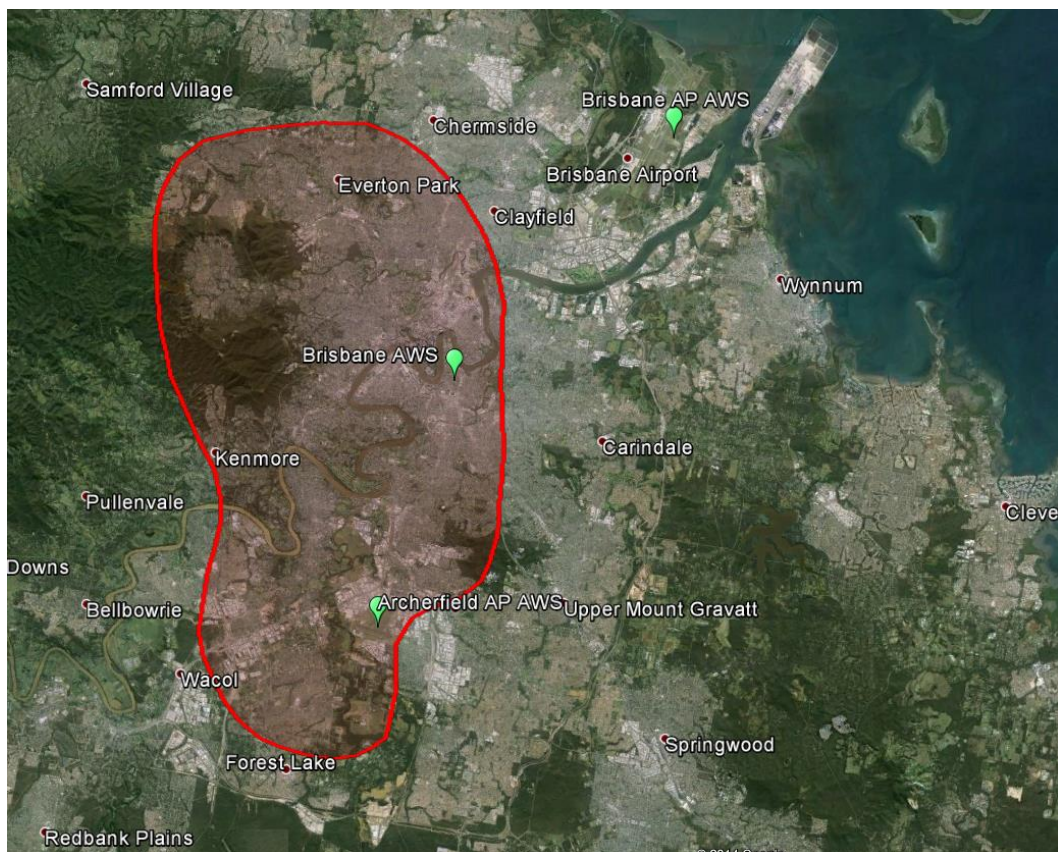
Figure 7 Envelope of areas with Doppler recorded wind speeds greater than 90 km/h.

In summary, it is believed that the storm's maximum wind speeds would have occurred in the vicinity of the Archerfield Airport AWS, and are unlikely to have been significantly higher than the 141 km/h (39 m/s) recorded at that site. Given the observed gust of 84 km/h at the Brisbane AWS and similar, but less reliable, "Weather Underground" based observations at Bardon, Ashgrove and Fig Tree Pocket, it is believed that wind gusts up to 100 km/h (28 m/s) in open terrain and 80 km/h in suburban terrain (22 m/s) could have been felt throughout much of the 'high wind speed' region shown in Figure 7.

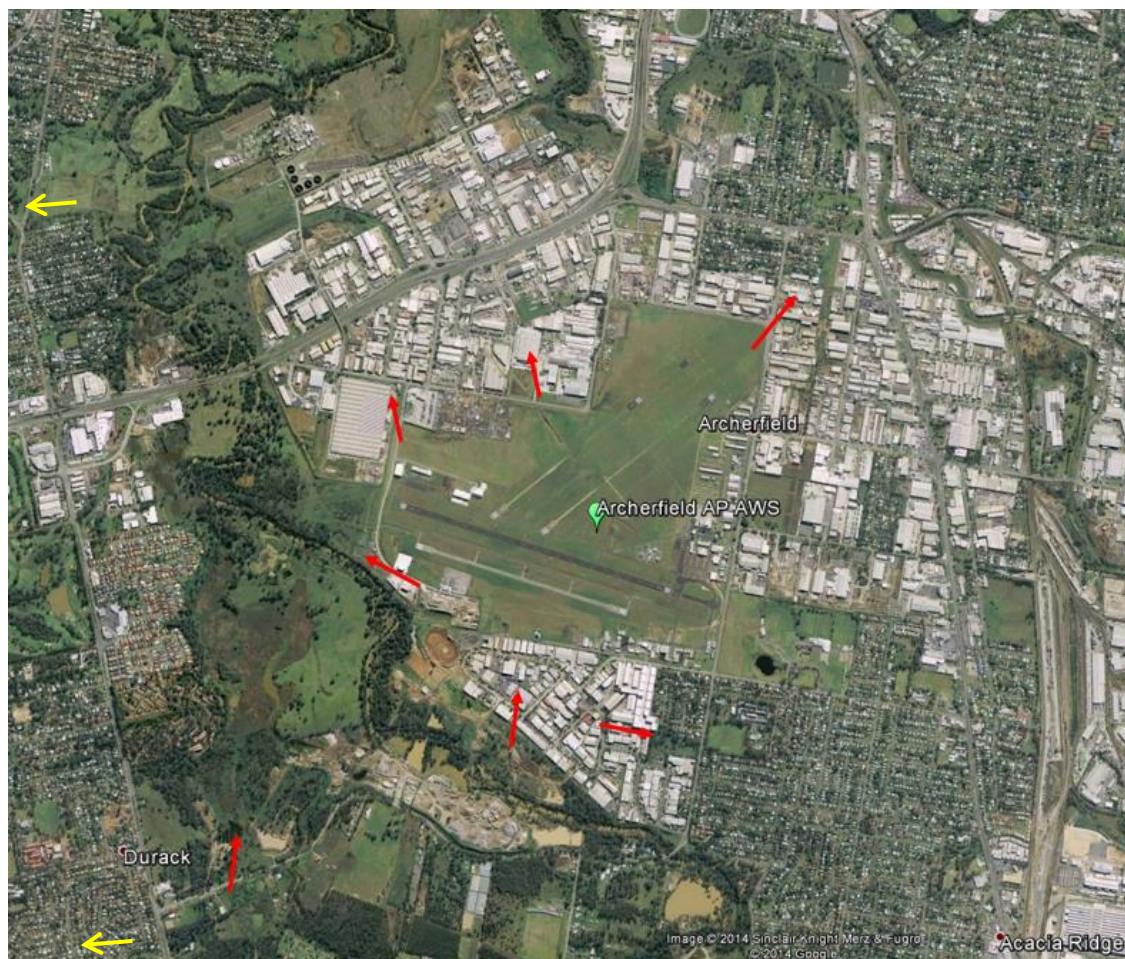
Evidence suggests that the gust recorded at Archerfield was close to the maximum that occurred during the storm. Observations of damage to trees, signage, buildings and road signs around the airport show signs of diverging winds, suggesting downdraft impingement occurred in the area. Figure 8 shows the estimated direction of winds at a number of locations in the area. Some divergence to the east and west was evident, but no signs of complete reversal of winds (i.e. from the north) were found in the area. Similarly the Archerfield AWS did not record any reversal of flow. This is not uncommon for outflows that occur with fast moving storm systems, and/or within existing sheared environments (the latter can tilt the downdraft in the direction of flow). At the Archerfield AWS gust wind speeds greater than 100 km/h were sustained for 5 minutes, but dropped off rapidly as the outflow moved north of the site. Given there was no apparent intensification of wind speeds (as per Doppler imagery) as the storm moved north of this point, and that winds will have begun to be influenced by the rough suburban terrain, it is expected that wind speeds less than the 141 km/h recorded at Archerfield were recorded throughout the suburbs north of the airport. An absence of widespread structural failures also suggests this to be the case.

Figure 8 Estimates of direction of strong winds in the Archerfield Airport area based on observed damage to buildings, trees and signage. Note that arrow length is arbitrary. *Base image source: Google Earth 2014.*

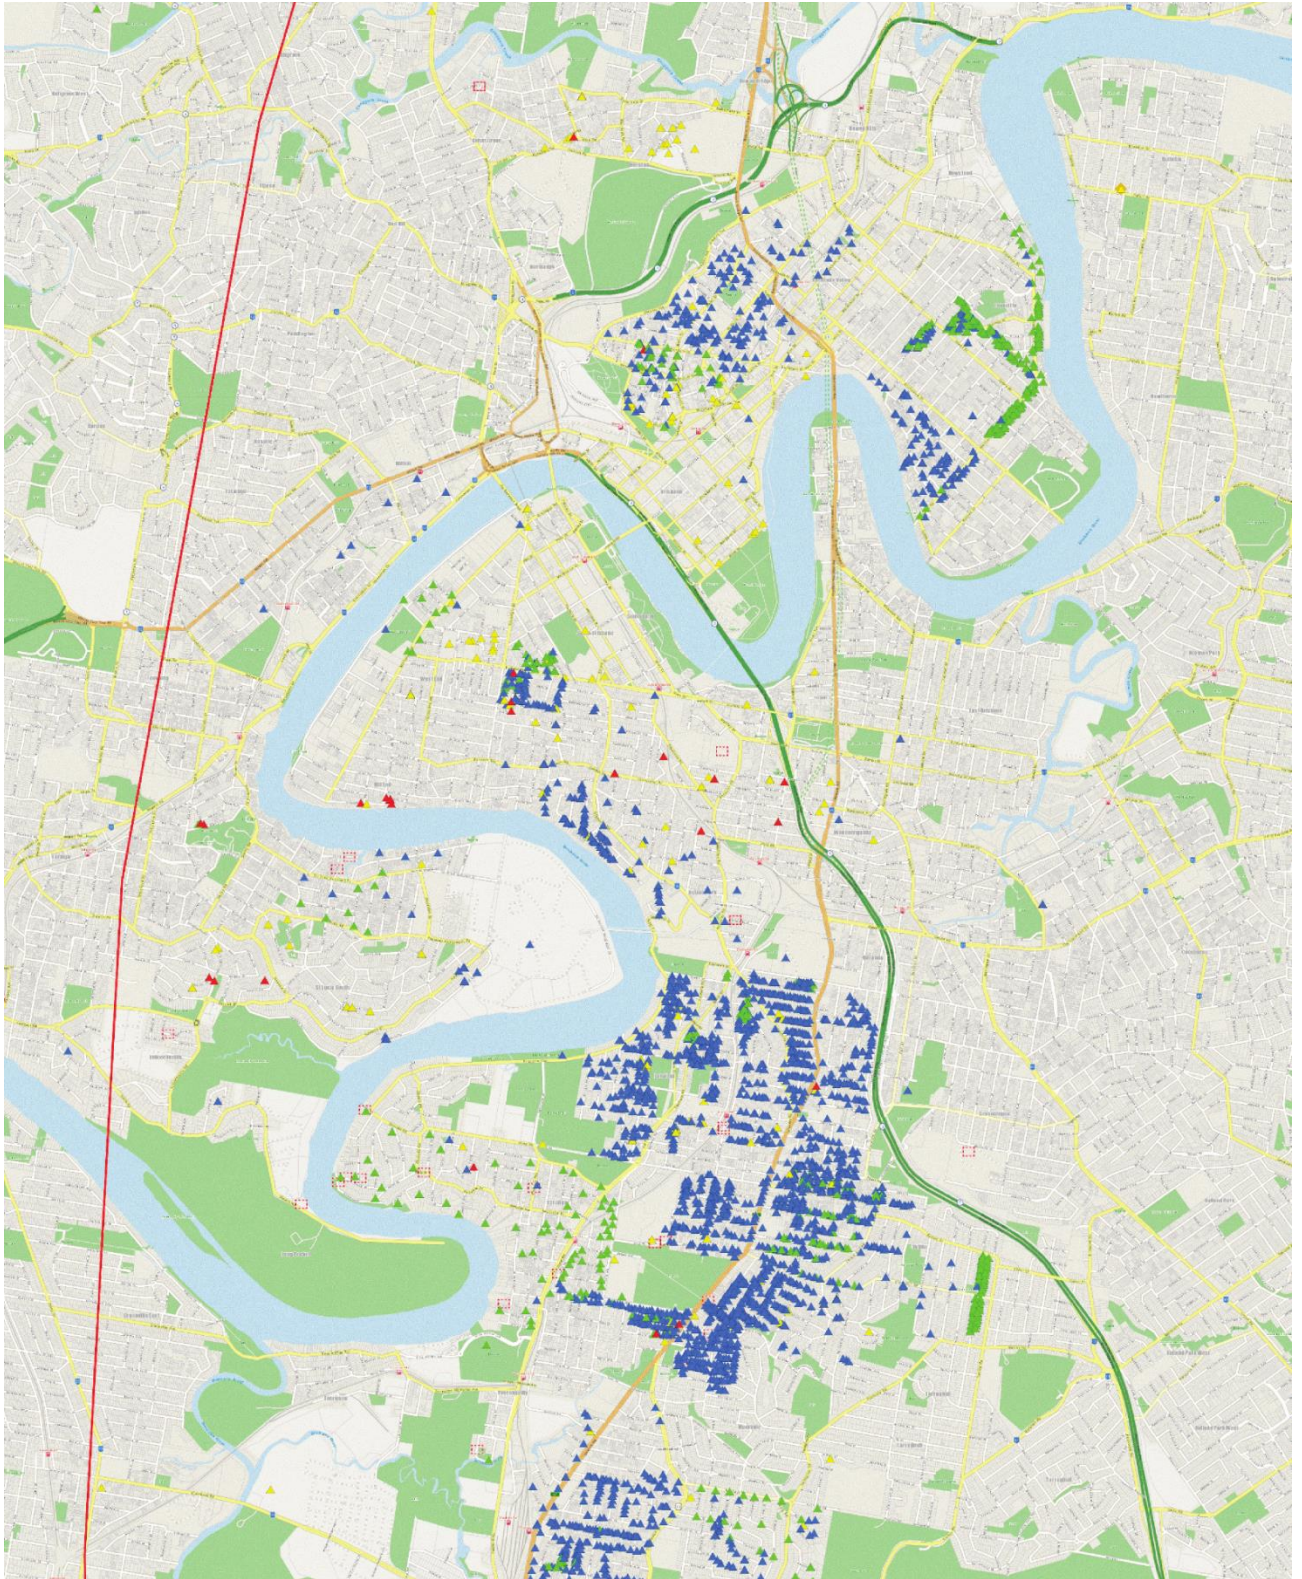
Over 2800 damaged properties were observed during the RDA; approximately 80% of these were houses. The RDA also classified such records as 'minor', 'moderate' and 'severe'. Of the damaged properties, approximately 92% of these were considered 'minor' damage, 7% 'moderate' and 1% 'severe'. Considering houses only: a similar breakdown of 94%, 5% and 1% of 'minor', 'moderate' and 'severe' damage was observed. For other building types such as commercial, Industrial, community halls and churches; a breakdown of 84% 14% and 2% was observed. This slightly higher percentage of moderate and severe damage is likely due to more time being spent surveying residential areas whereas industrial and commercial areas were likely surveyed only based on reports of significant damage occurring. During this event most 'minor' damage was from broken windows due to hail, 'moderate' and 'severe' damage from debris or tree impact and in a few cases roof failure due to wind load.

Figure 9: Records of damage from the QFES rapid damage assessment: blue triangles: minor damage, yellow: moderate and red: severe.

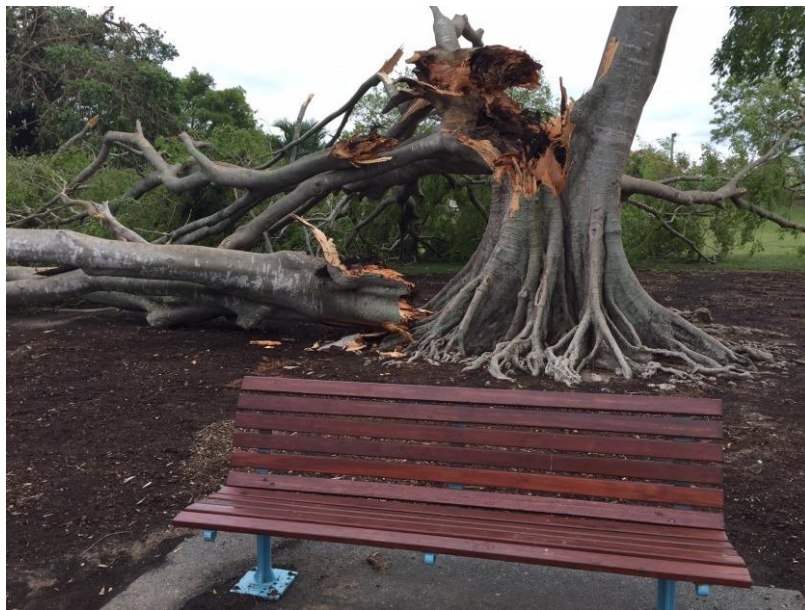
Orleigh Park West End Brisbane Times. *Source:* Brisbane Times <http://www.brisbanetimes.com.au/environment/weather/violent-storm-lashes-brisbane-thursday-november-27-20141127-11viro.html>

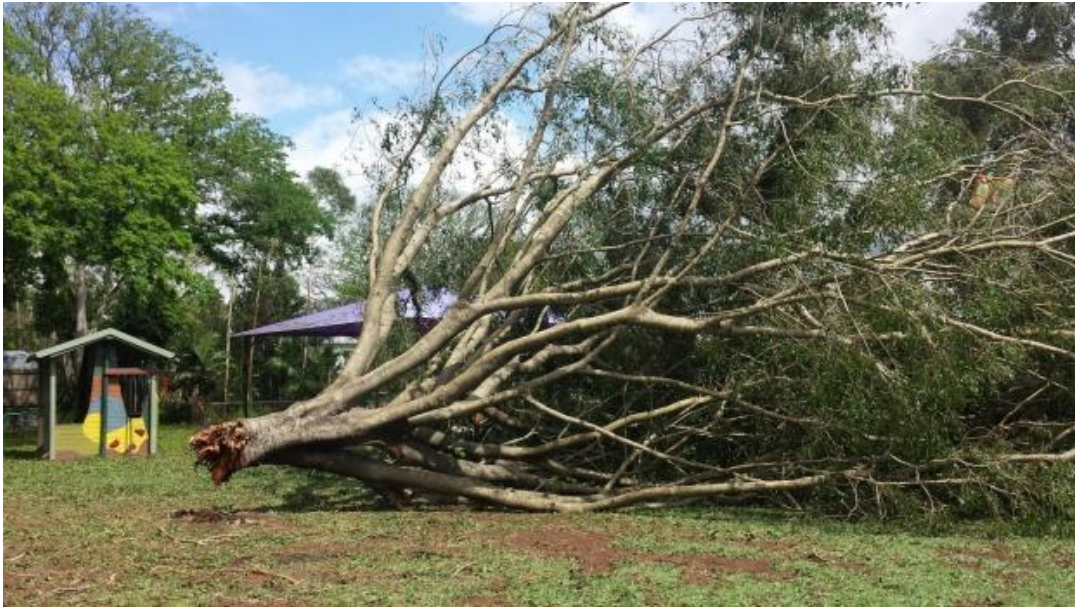
Robinsons Park Fairfield. *Source:* Brisbane Times

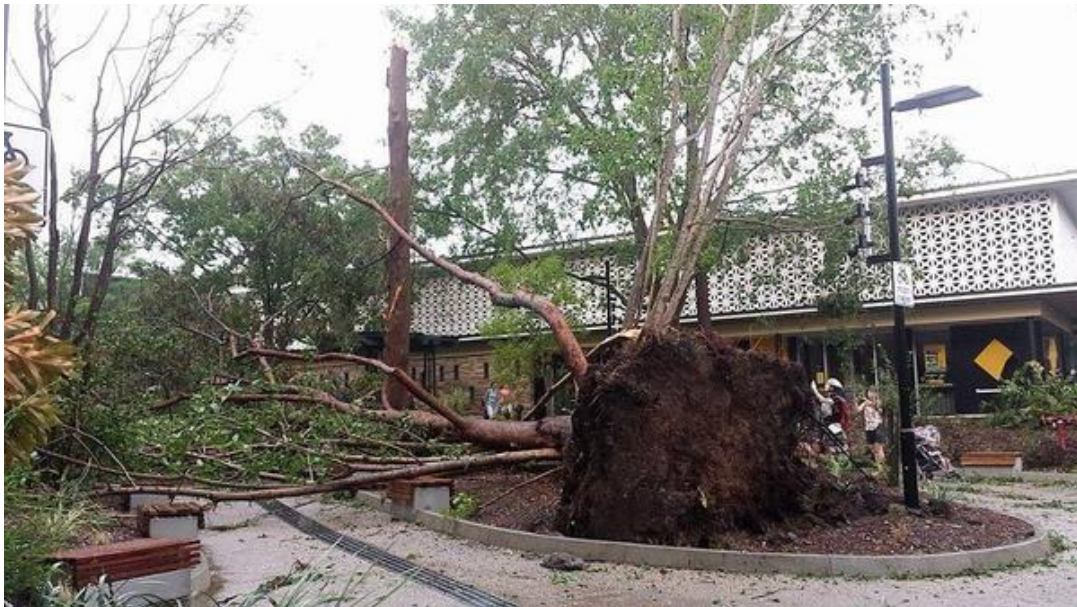
UQ St Lucia Campus. *Source:* Brisbane Times

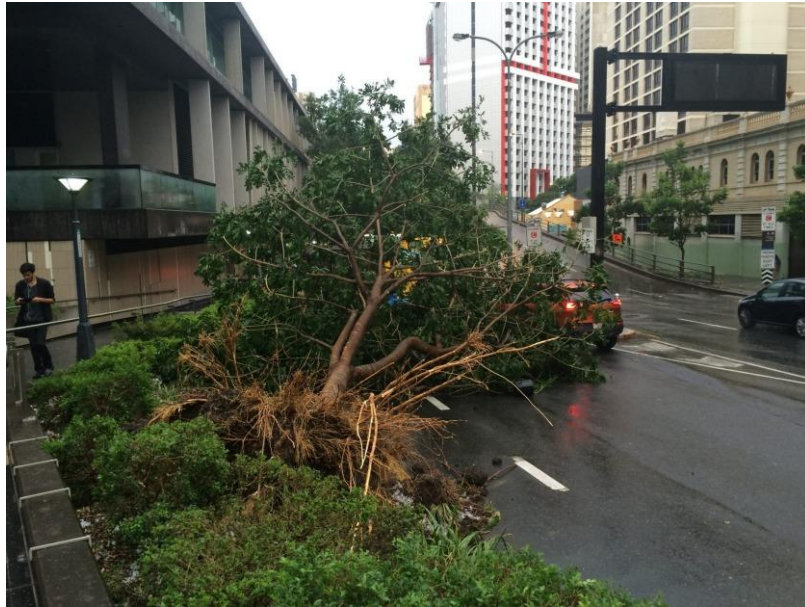
Brisbane Times Turbot Street. *Source: Cameron Atfield*
